VEHICLE INSPECTION REPORT

DV73PXW

Vauxhall Vivaro 3100 2.0D 145PS PRIME

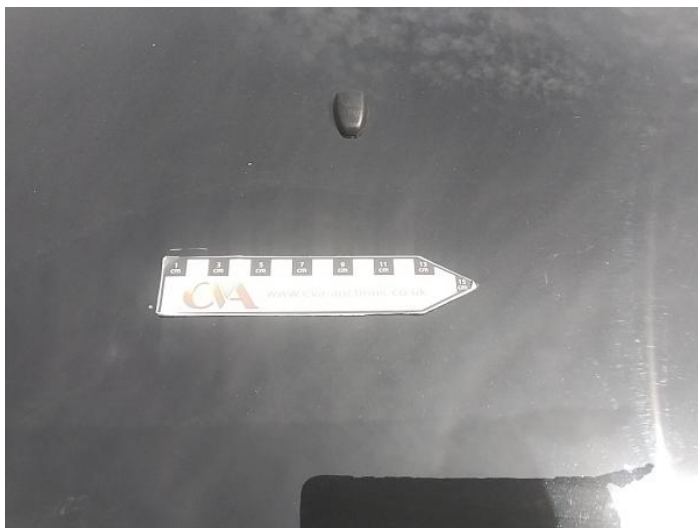
1: Bonnet
Scratched
Over 25mm Thru Paint

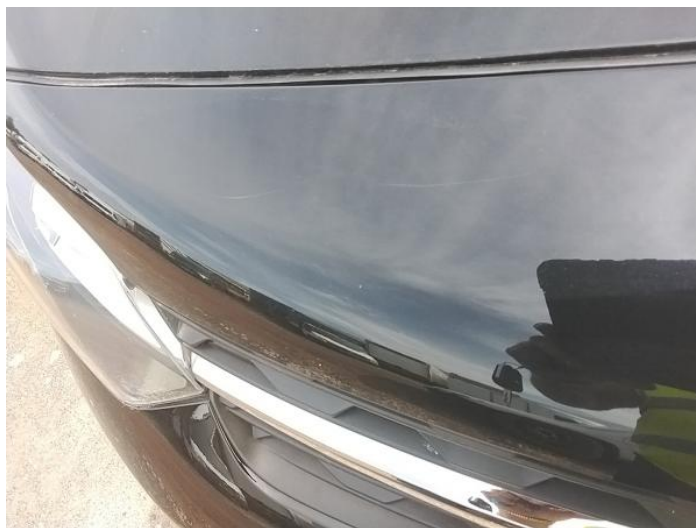
2: Panel Front
Scratched
Over 25mm Thru Paint

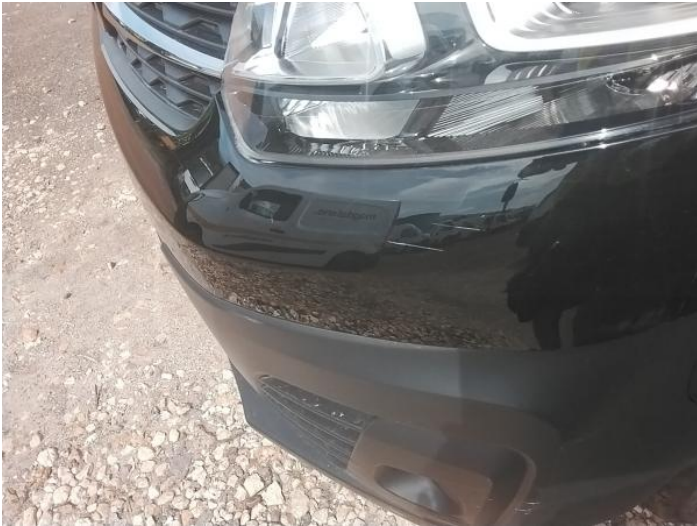
3: Panel Front
Scratched
Over 25mm Thru Paint

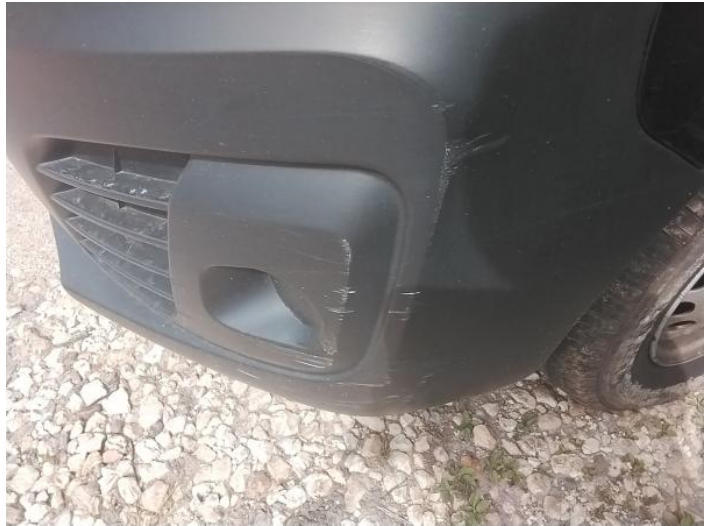
4: Bumper Front
Scratched
Over 100mm Thru Paint

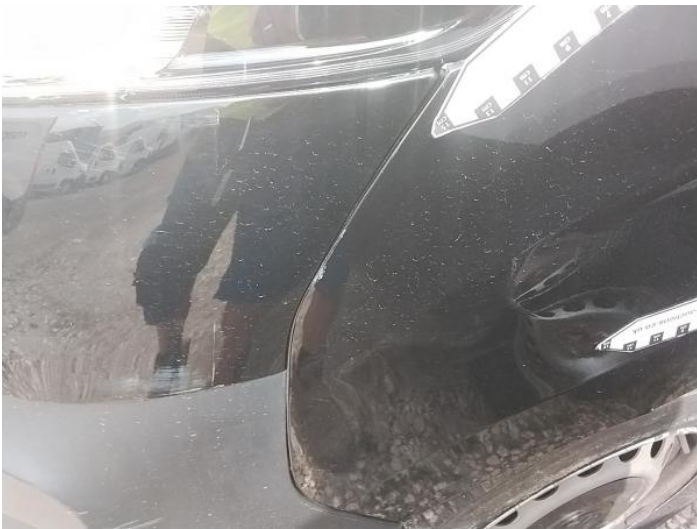
5: Wing nsf
Dented
Over 30mm

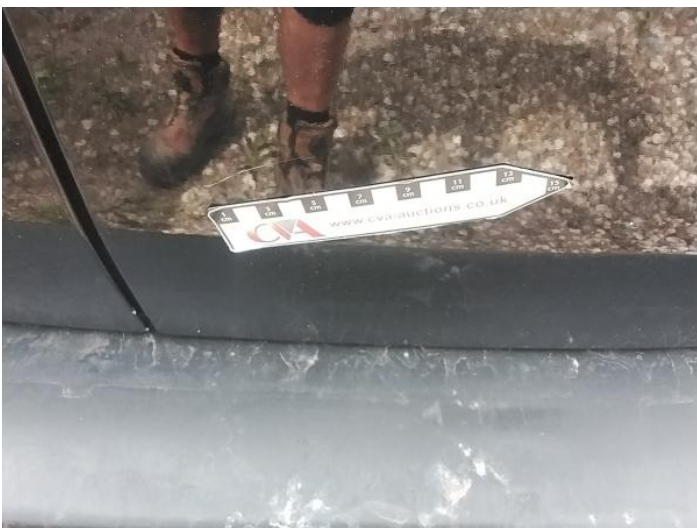
7: Door osr
Scratched
Over 25mm Thru Paint

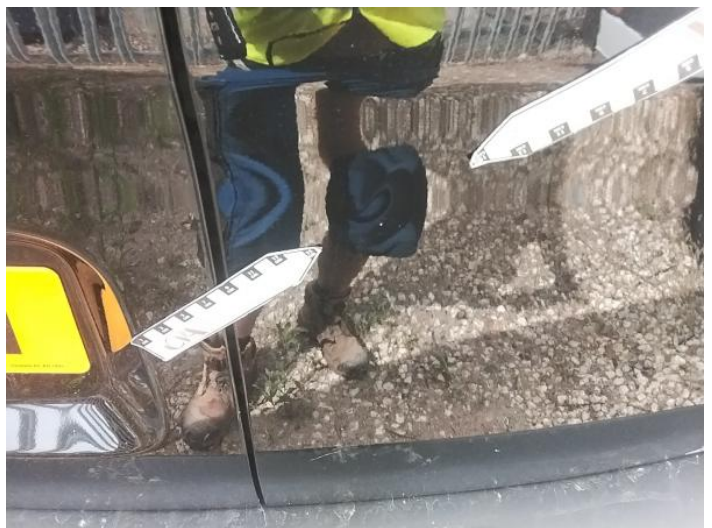
8: Door osr
Dented
Over 30mm

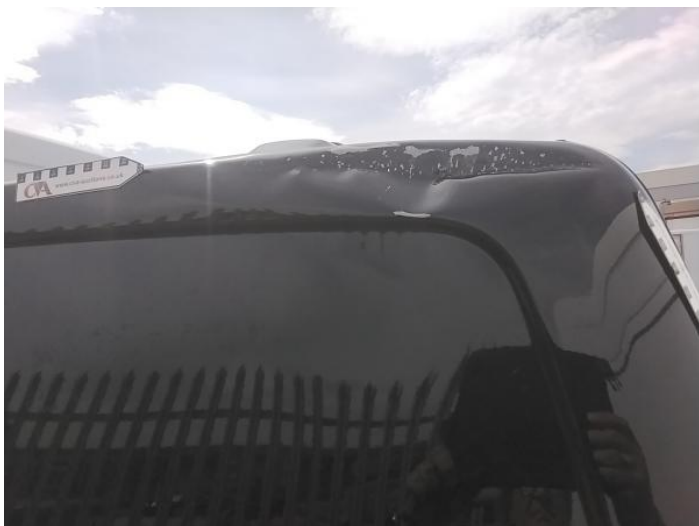
9: Door osr
Dented
With Paint Damage

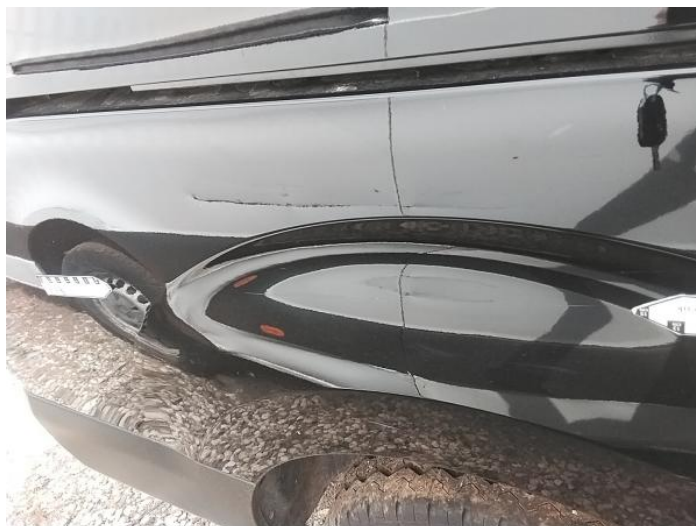
10: Qtr Panel osr
Scratched
Over 25mm Thru Paint

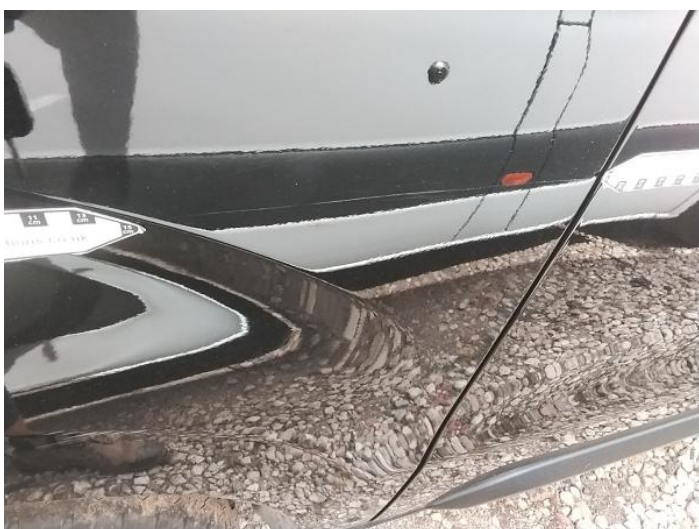
11: Qtr Panel osr
Scratched
Over 25mm Thru Paint

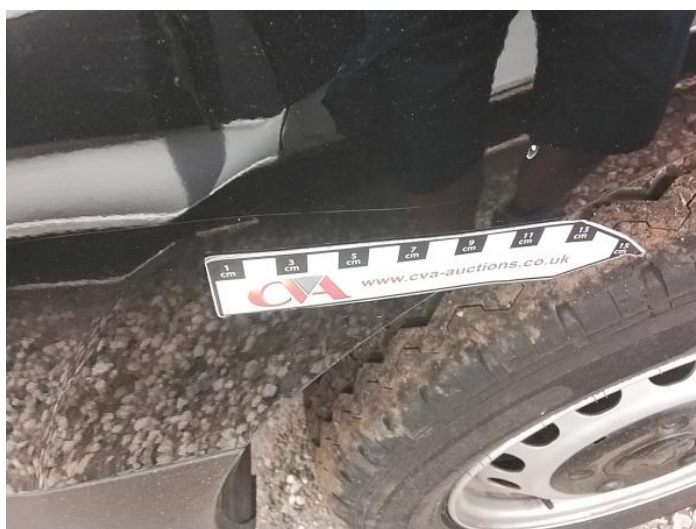
12: Qtr Panel osr
Scratched
Over 25mm Thru Paint

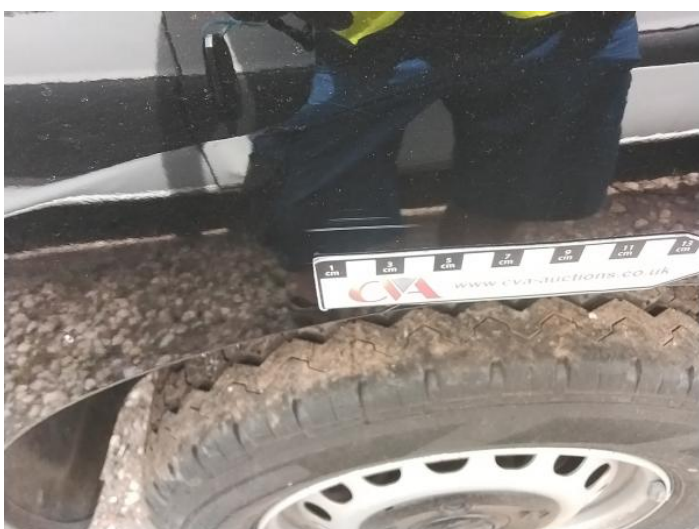
13: Qtr Panel osr
Scratched
Over 25mm Thru Paint

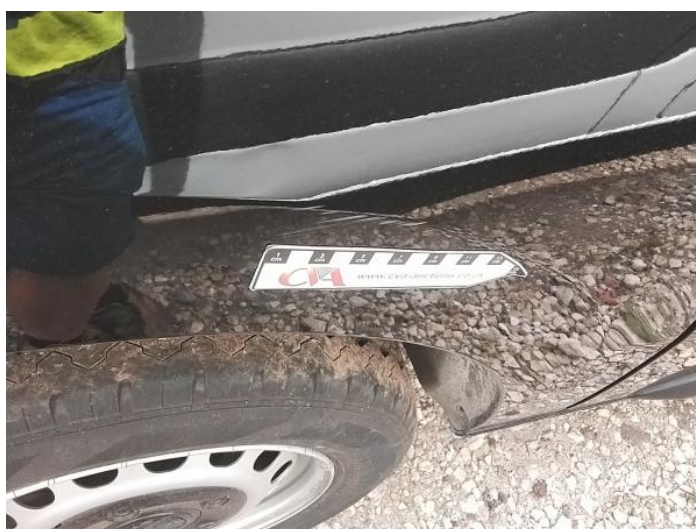
14: Qtr Panel osr
Scratched
Over 25mm Thru Paint

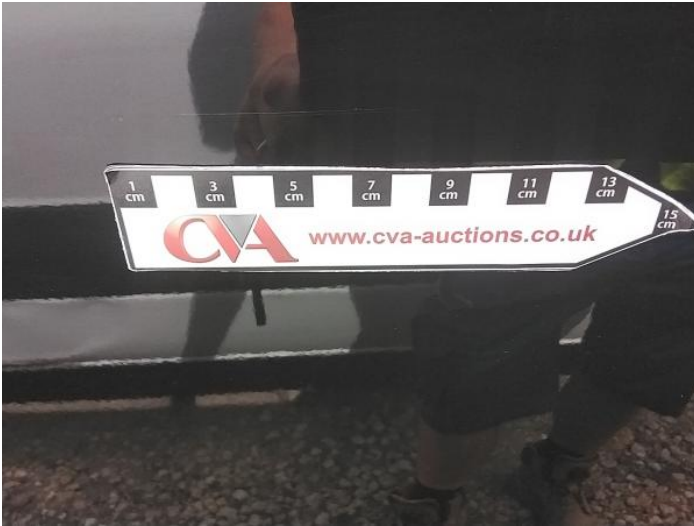
15: Qtr Panel osr
Scratched
Over 25mm Thru Paint

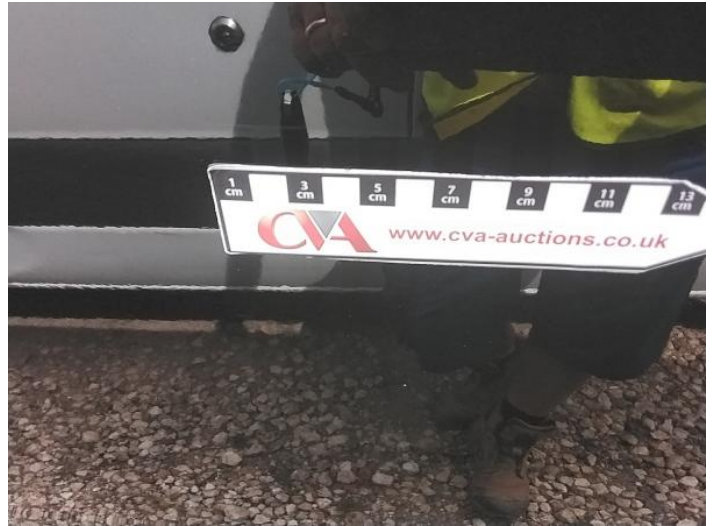
16: Qtr Panel osr
Scratched
Over 25mm Thru Paint

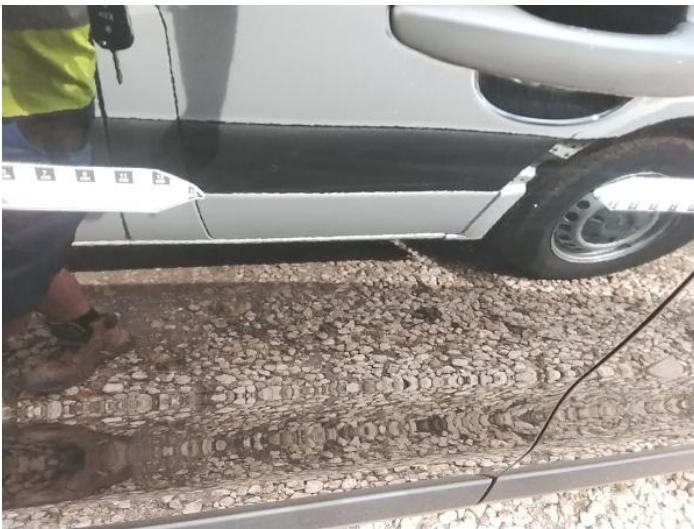
17: Qtr Panel osr
Scratched
Over 25mm Thru Paint

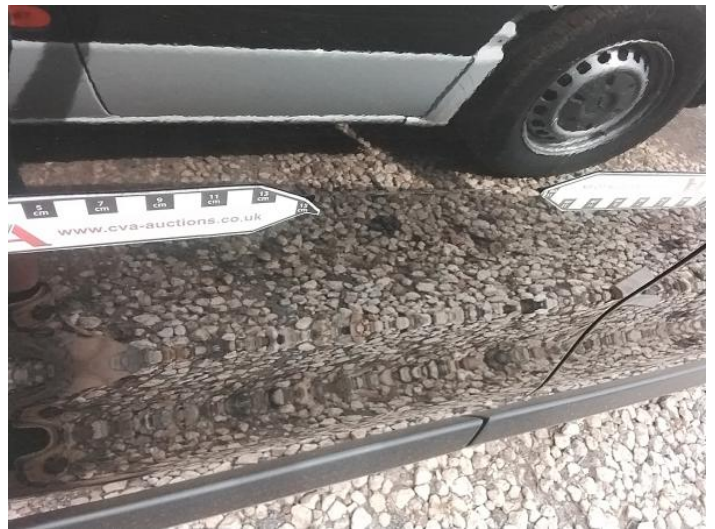
18: Qtr Panel osr
Scratched
Over 25mm Thru Paint

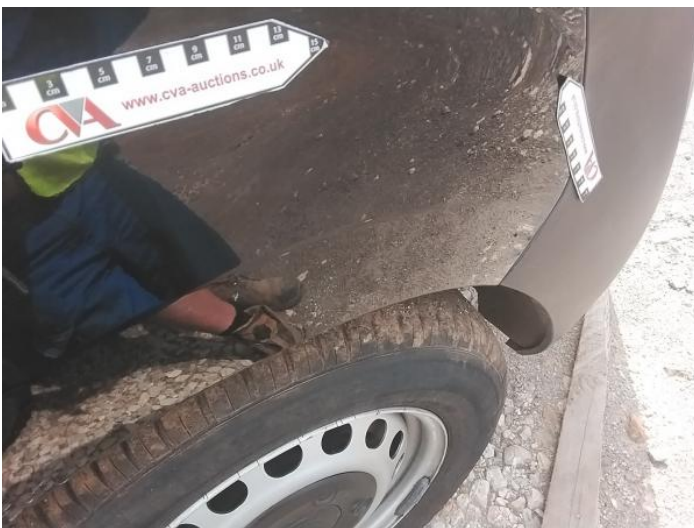
19: Wing osf
Dented
Over 30mm

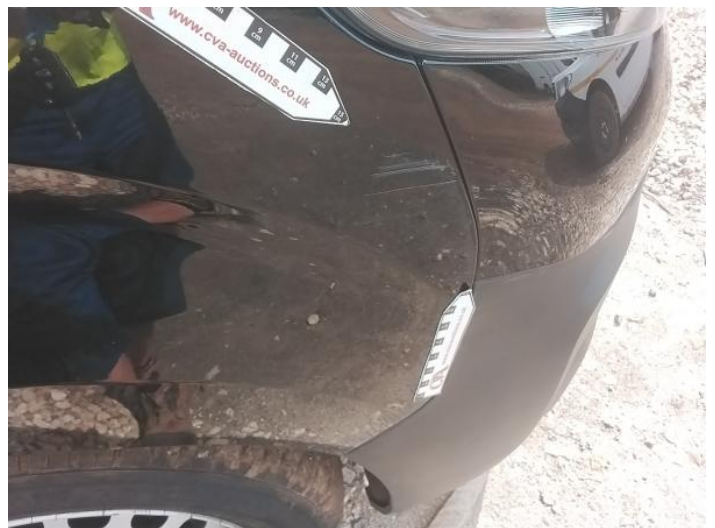
20: Wing osf
Scratched
Over 25mm Thru Paint

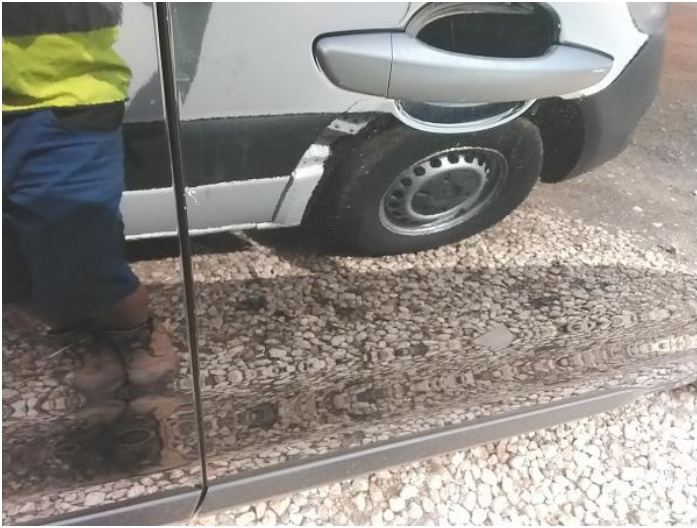
21: Door osf
Chipped
Edge Chip

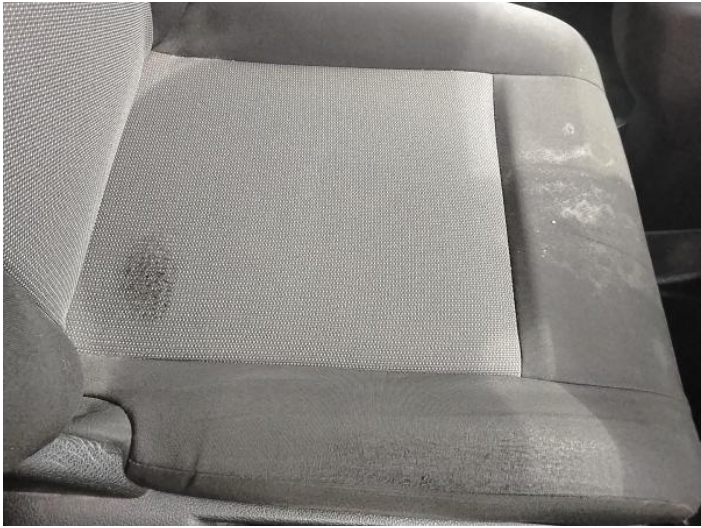
22: Seat Base Cover osf
Soiled
Heavy

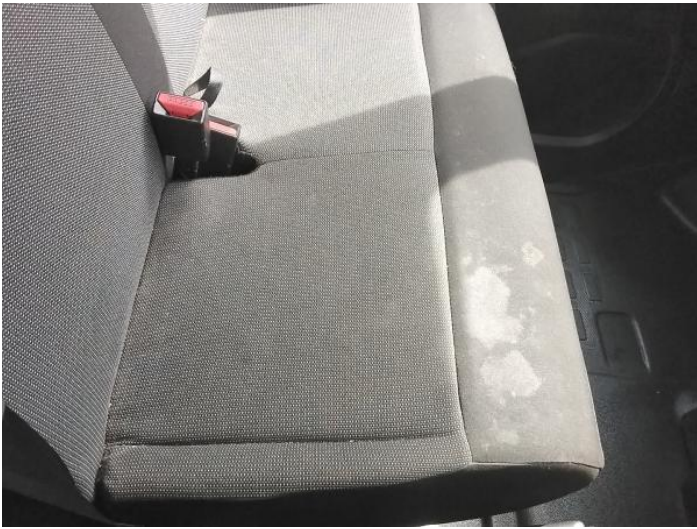
23: Seat Base Cover nsf
Soiled
Heavy

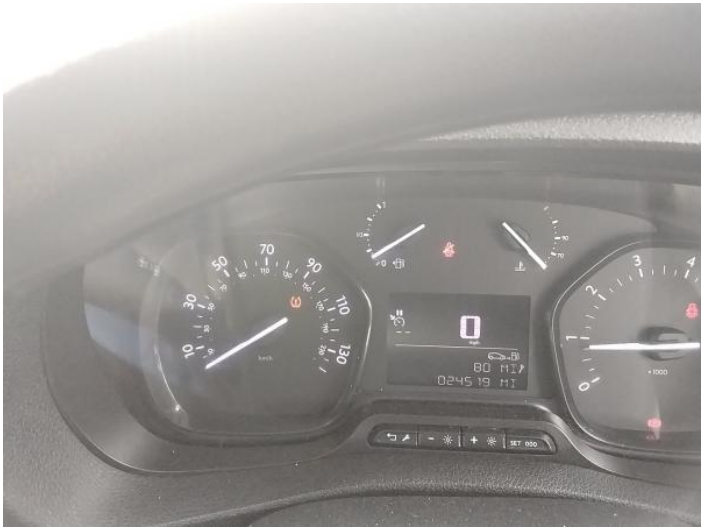
24: Dash Warning Lights
Displayed
No Action
