VEHICLE INSPECTION REPORT

DV73PYA

Vauxhall Vivaro 3100 2.0 145PS PRIME

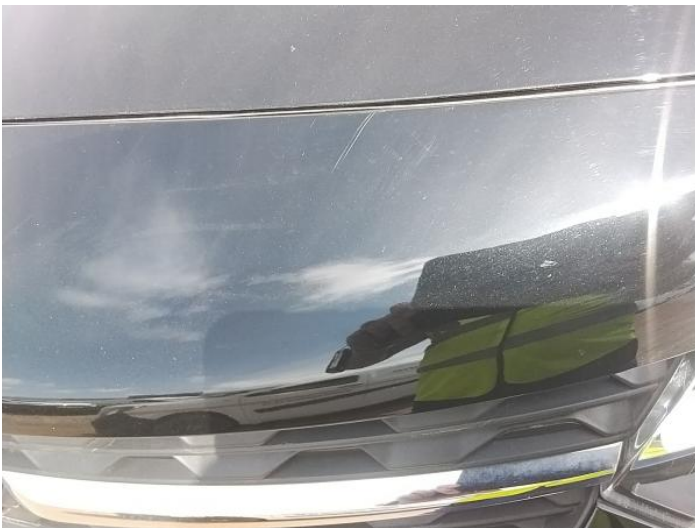
1: Panel Front
Scratched
Over 25mm Thru Paint

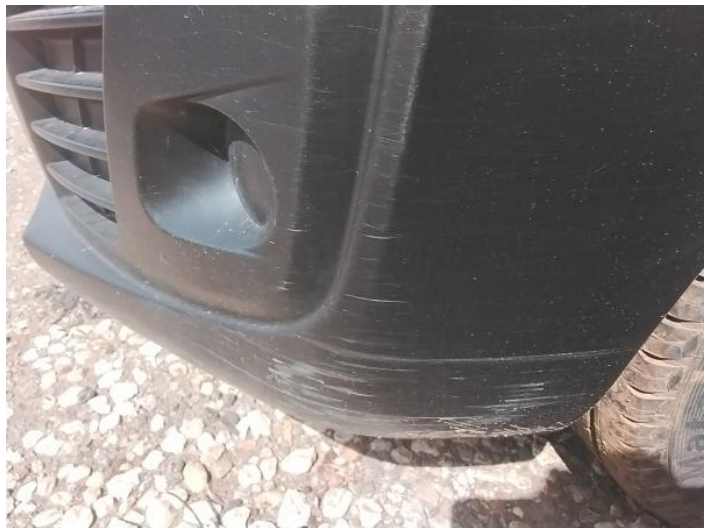
2: Bumper Front
Scratched
Over 100mm Thru Paint

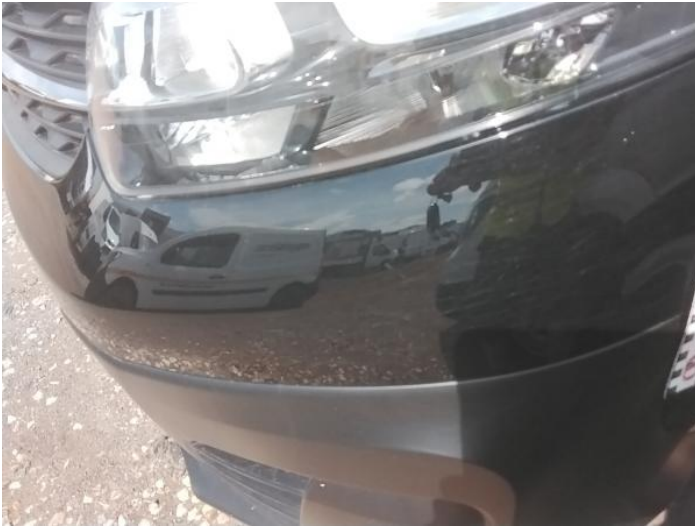
3: Panel Front
Scratched
Over 25mm Not Thru Paint

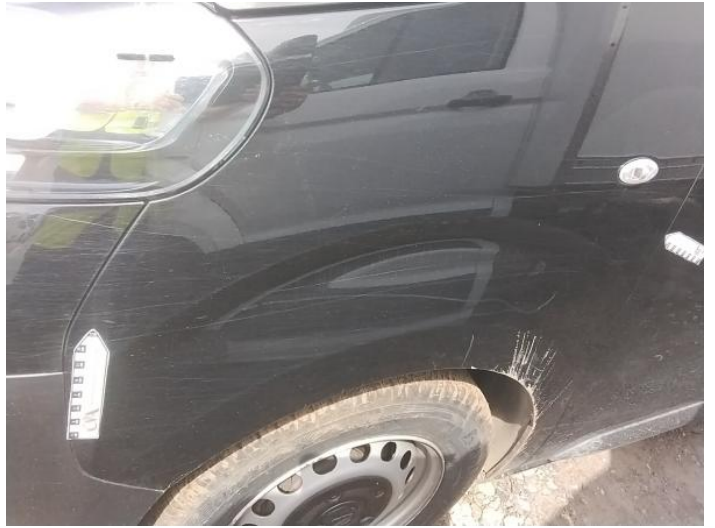
4: Wing nsf
Scratched
Over 25mm Thru Paint

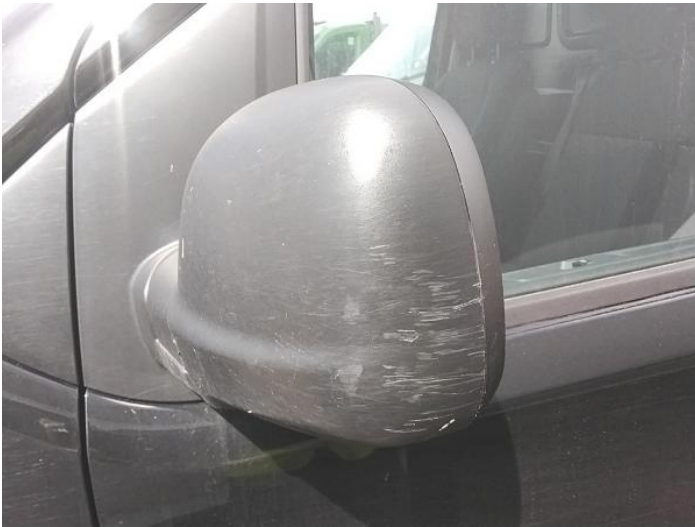
5: Door Mirror Assy nsf
Scuffed (Unpainted)
Over 100mm

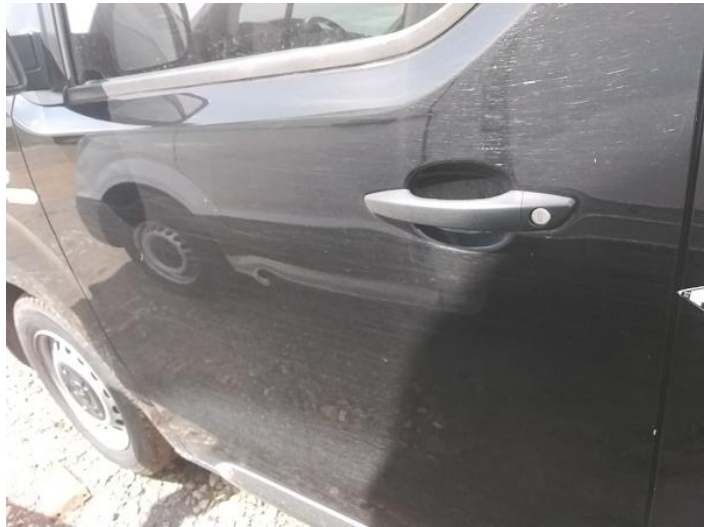
6: Door nsf
Scratched
Over 25mm Thru Paint

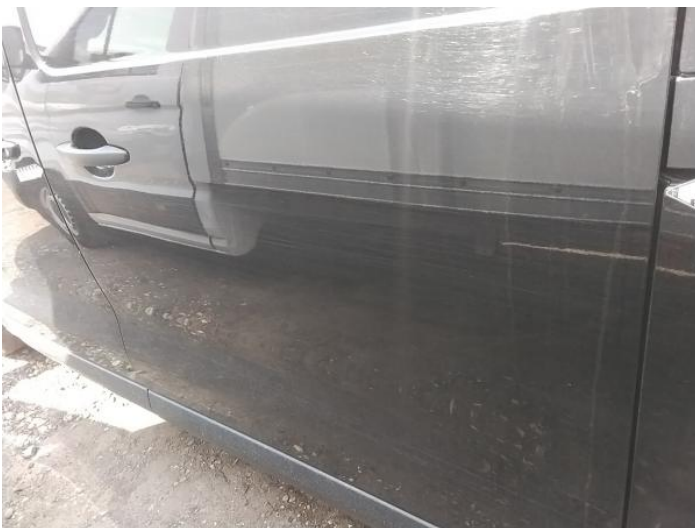
7: Qtr Panel nsr
Scratched
Over 25mm Thru Paint

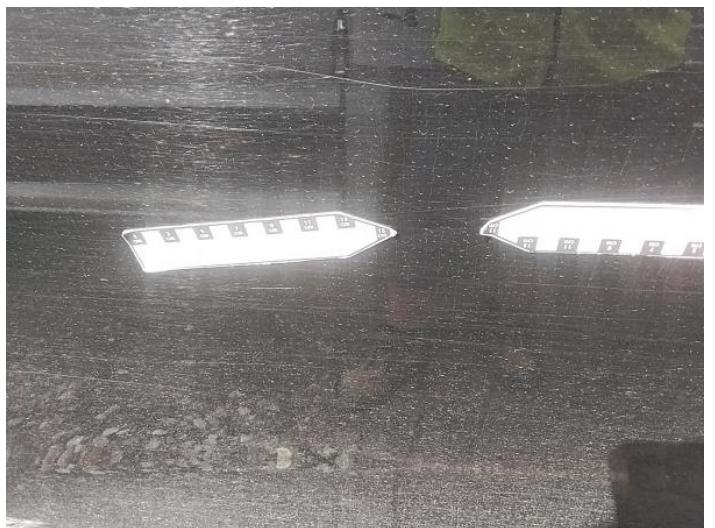
8: Door nsf
Dented
Over 30mm

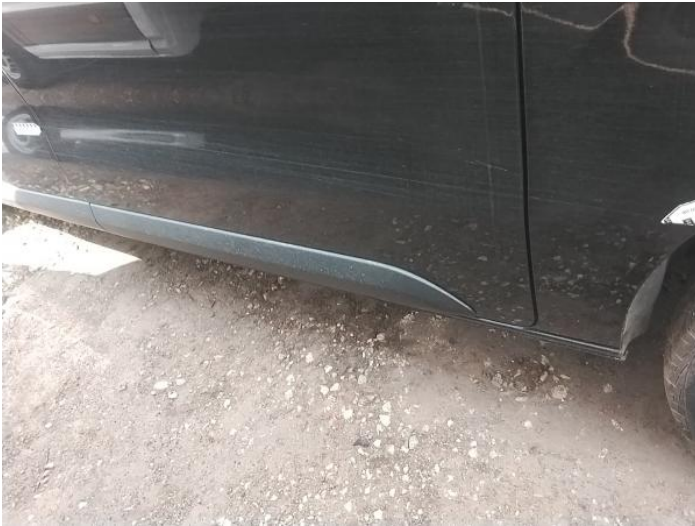
9: Qtr Panel nsr
Scratched
Over 25mm Thru Paint

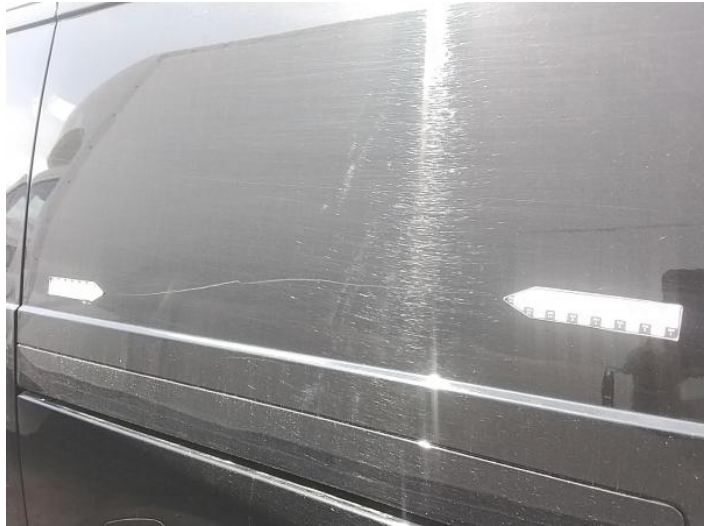
10: Qtr Panel nsr
Scratched
Over 25mm Thru Paint

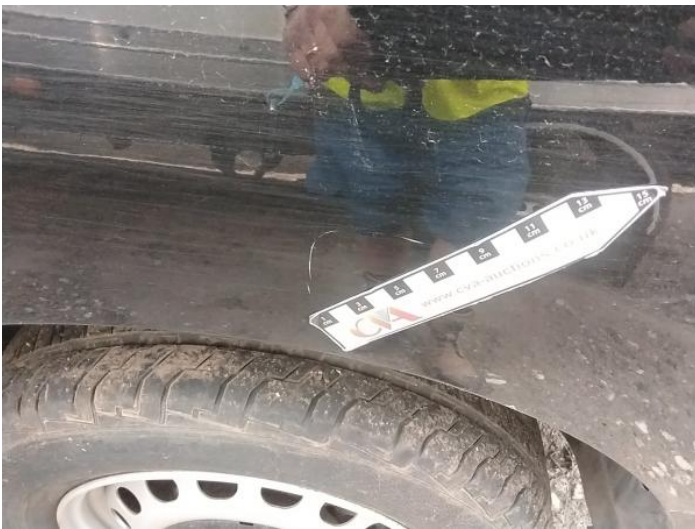
11: Qtr Panel nsr
Scratched
Over 25mm Thru Paint

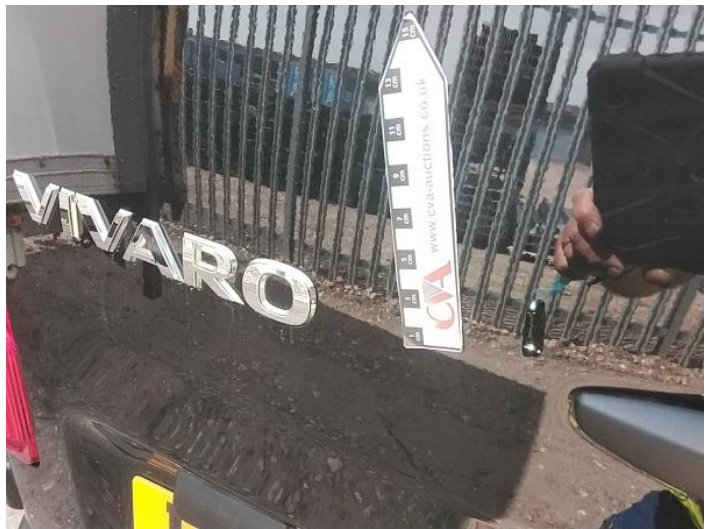
12: Door nsr
Scratched
Over 25mm Thru Paint

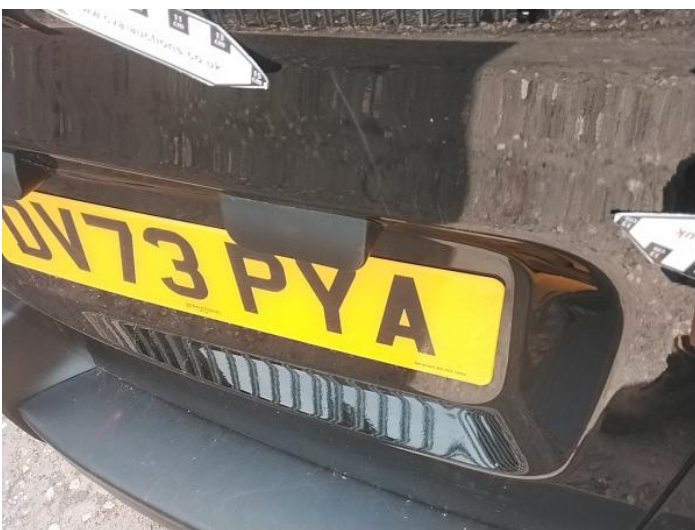
13: Door nsr
Scratched
Over 25mm Thru Paint

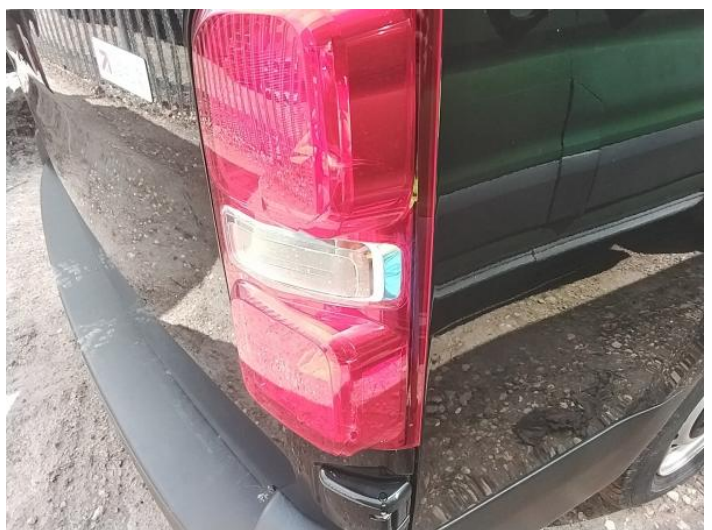
14: Lamp osr
Broken
Replace

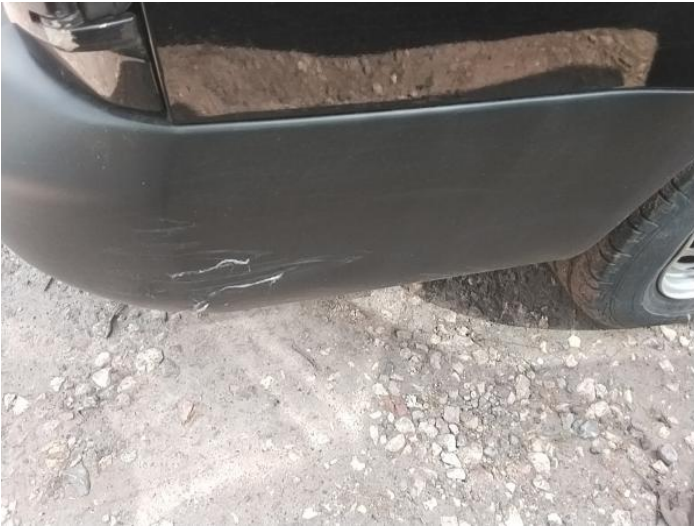
15: Bumper Rear Moulding
Scuffed (Unpainted)
Over 100mm

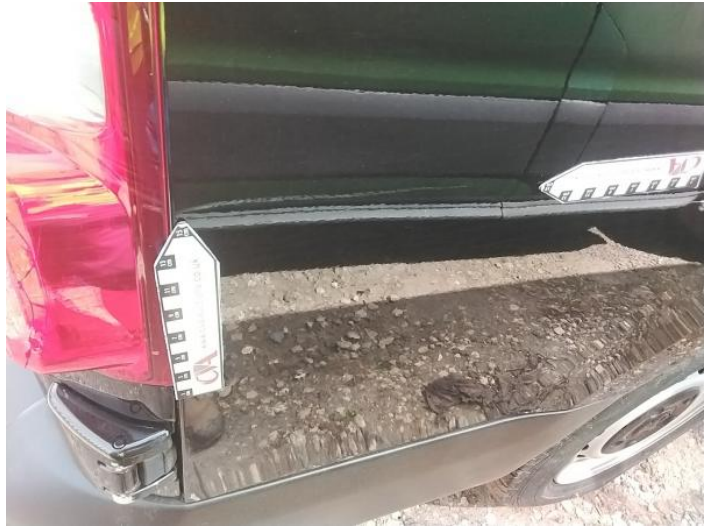
16: Qtr Panel osr
Scratched
Over 25mm Thru Paint

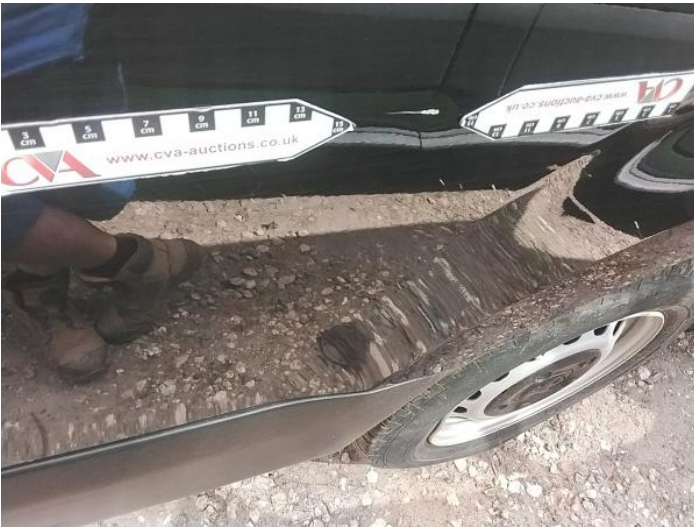
17: Qtr Panel osr
Dented
With Paint Damage

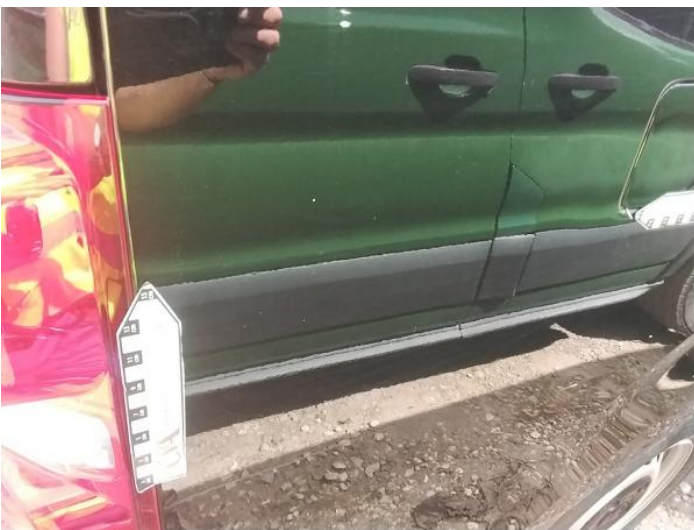
19: Qtr Panel osr
Scratched
Over 25mm Thru Paint

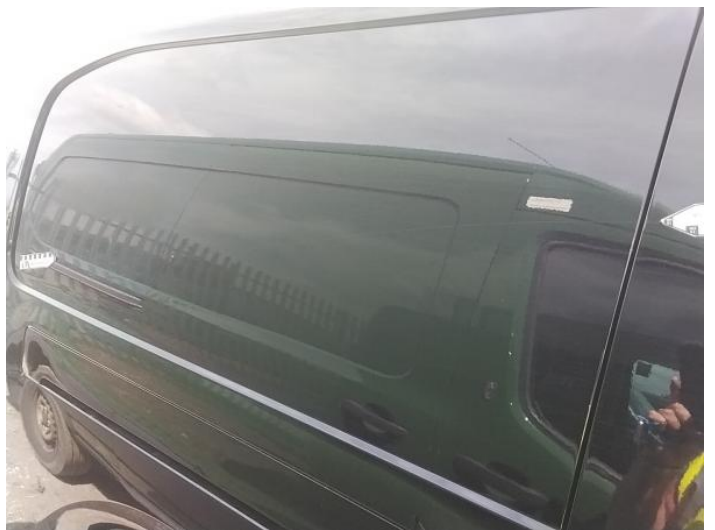
20: Qtr Panel osr
Scratched
Over 25mm Not Thru Paint

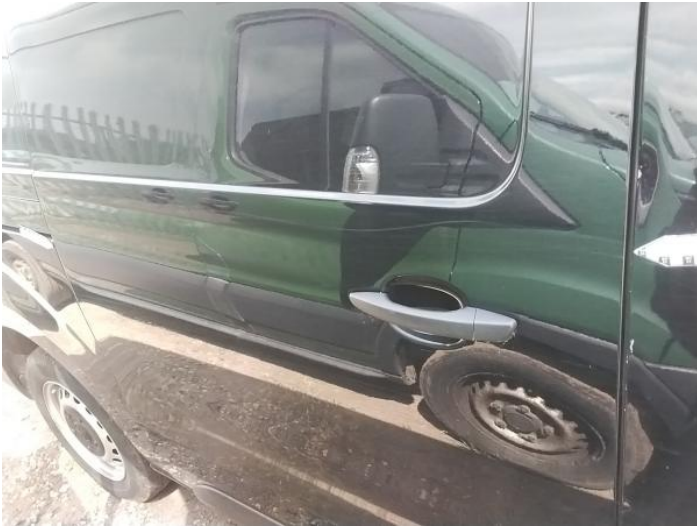
21: Qtr Panel osr
Scratched
Over 25mm Not Thru Paint

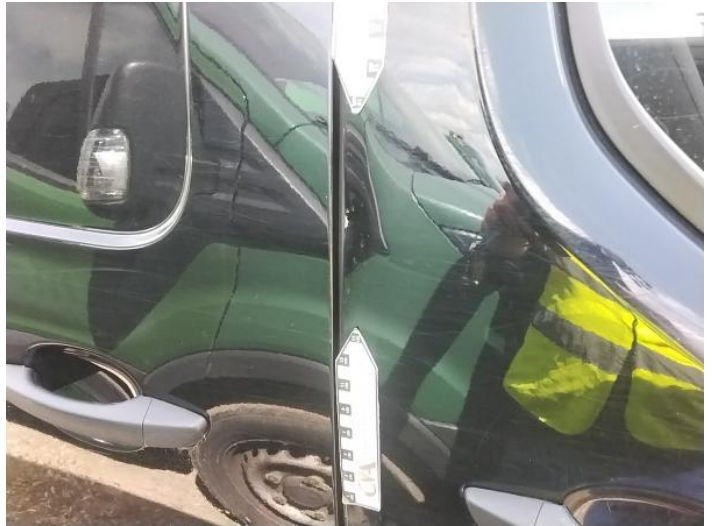
22: Door osf
Dented
With Paint Damage

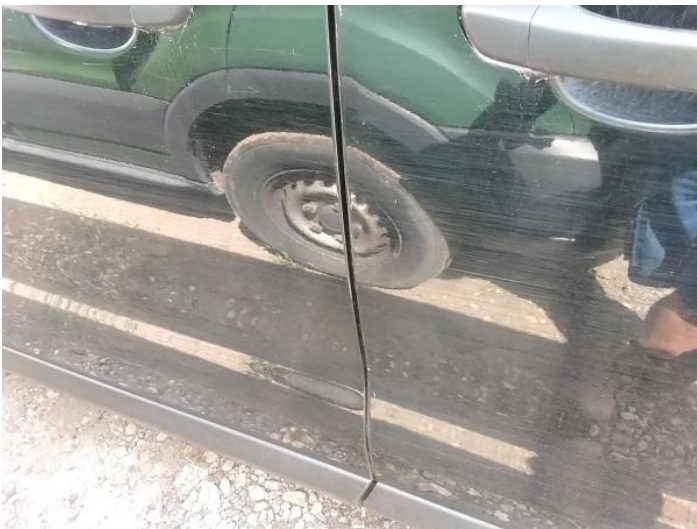
23: Door osf
Chipped
Edge Chip

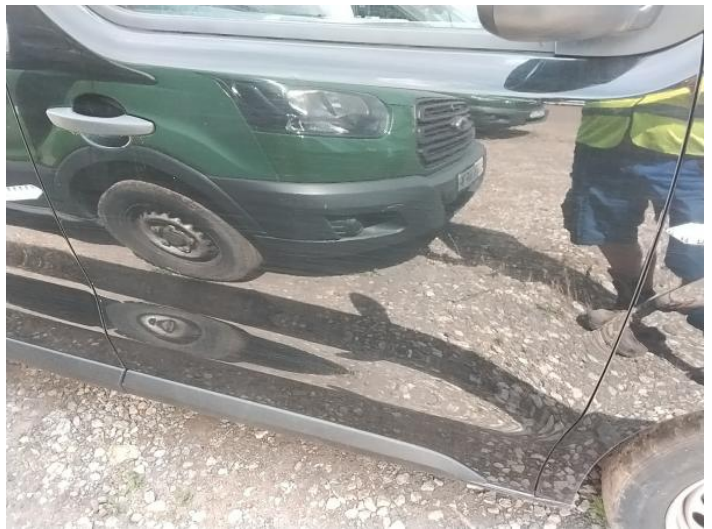
24: Door osf
Scratched
Over 25mm Thru Paint

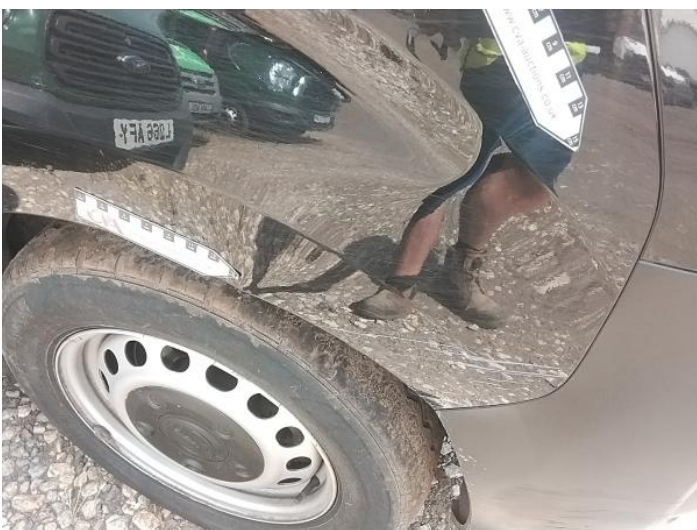
25: Wing osf
Dented
With Paint Damage

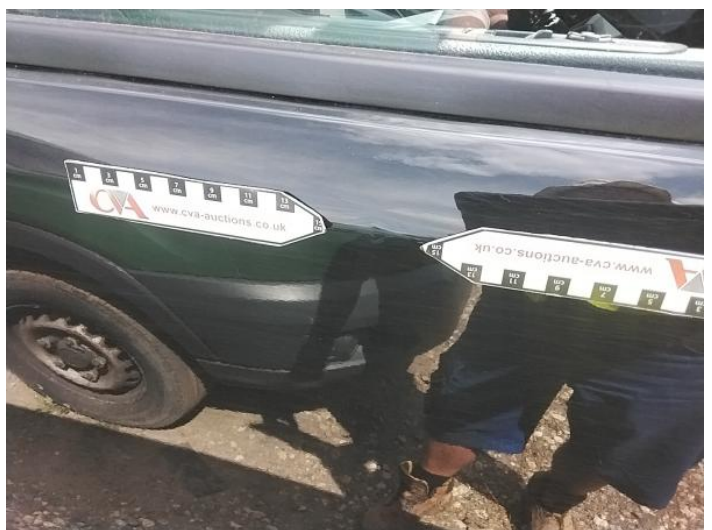
26: Door osf
Dented
Over 30mm

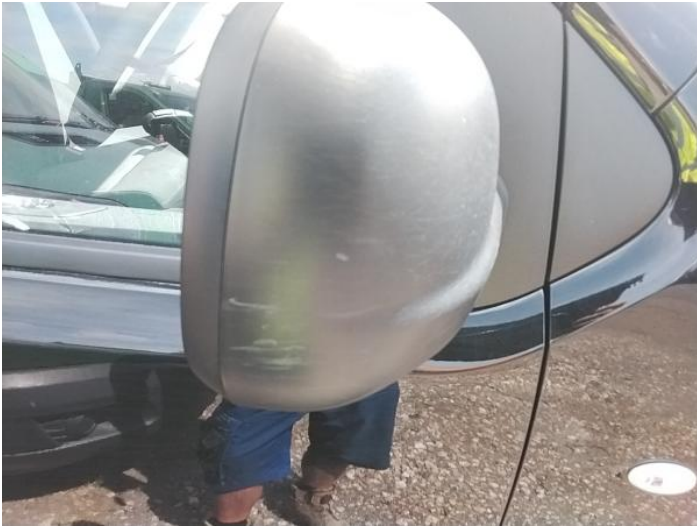
27: Door Mirror Assy osf
Scuffed (Unpainted)
UpTo 100mm

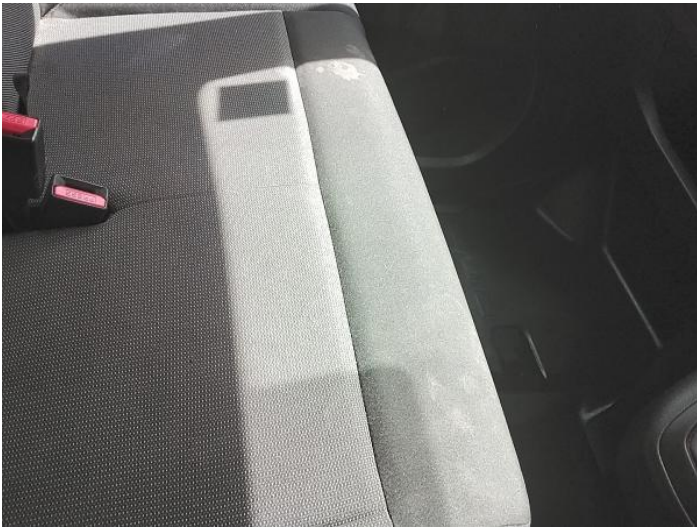
29: Seat Base Cover nsf
Soiled
Heavy

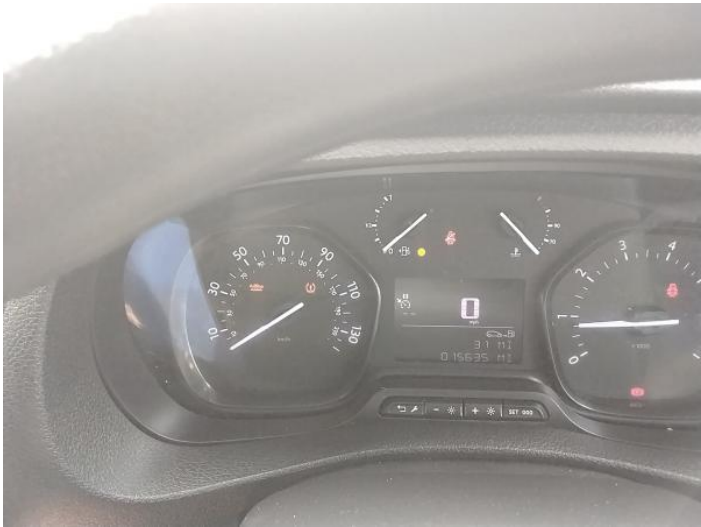
30: Dash Warning Lights
Displayed
No Action
