VEHICLE INSPECTION REPORT

YA70DBZ

Mercedes-Benz Sprinter 315 3.5 PROGRESSIVE

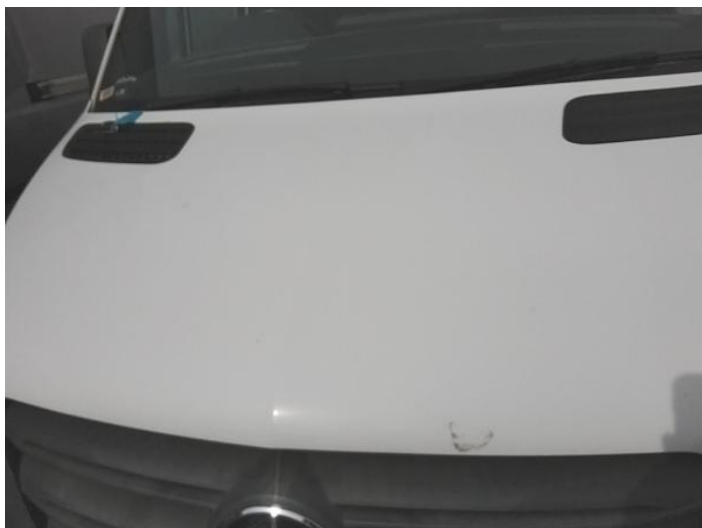
1: Bonnet
Chipped
Multiple Chips

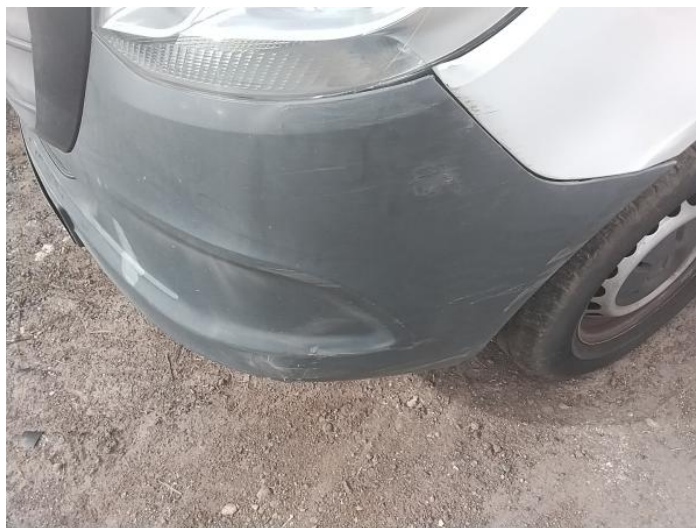
2: Bumper Front
Scratched
Over 100mm Thru Paint

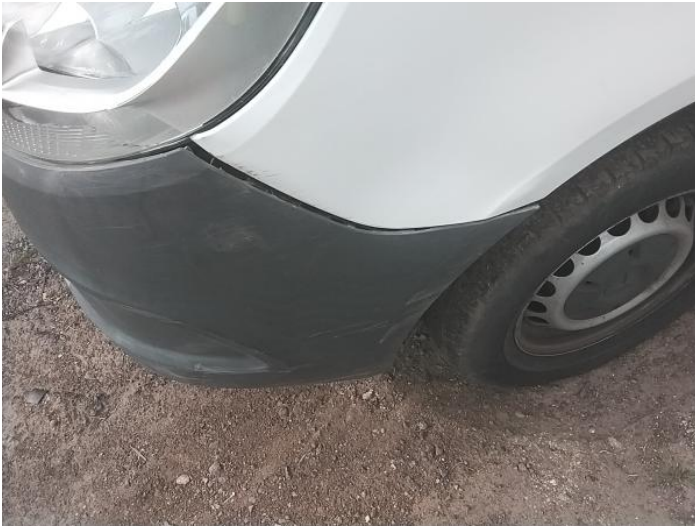
3: Bumper Front
Insecure
Action Required

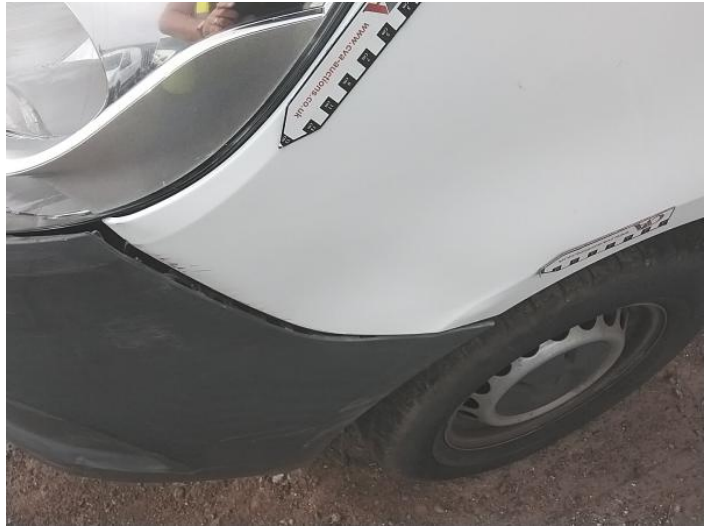
4: Wing nsf
Dented
Over 30mm

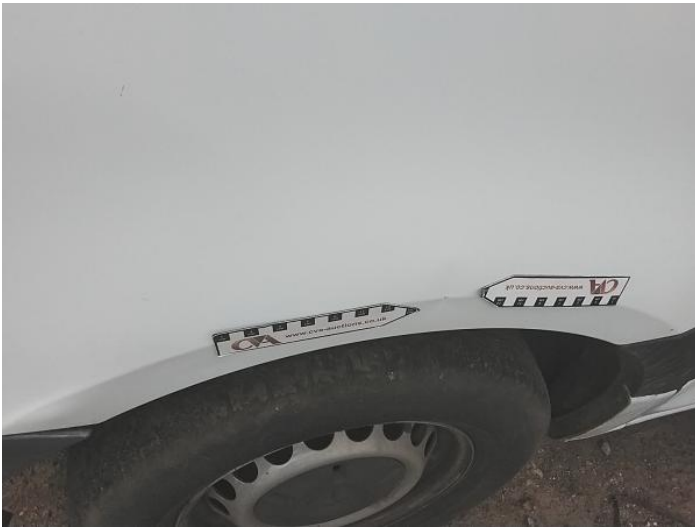
5: Wing nsf
Dented
Over 30mm

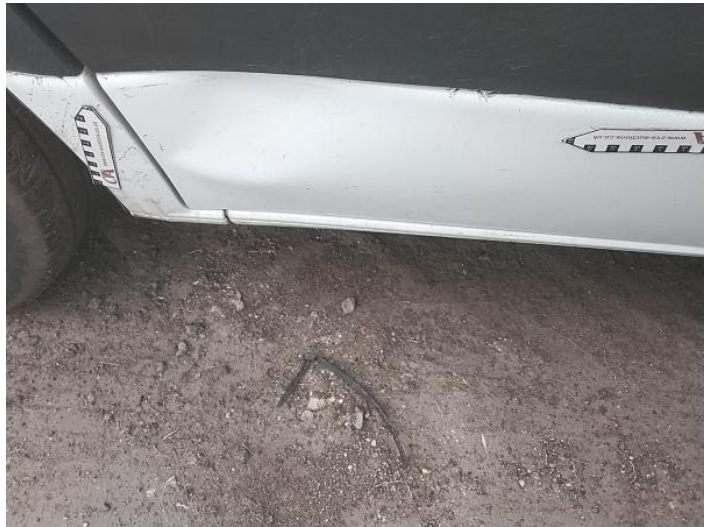
6: Door nsf
Dented
Over 30mm

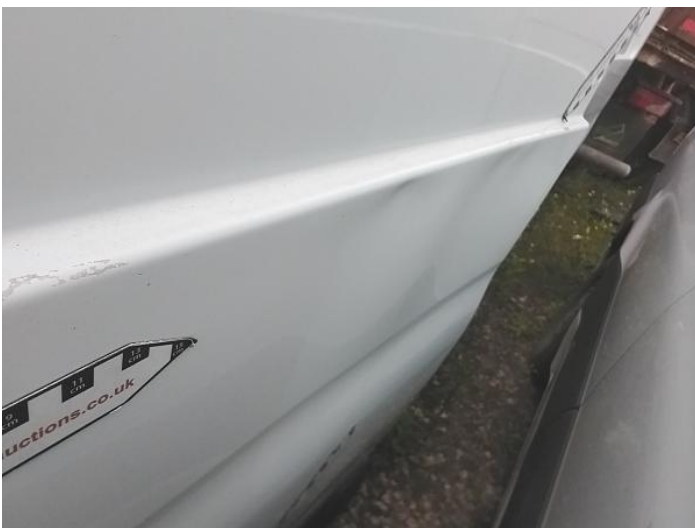
7: Qtr Panel nsr
Dented
Over 30mm

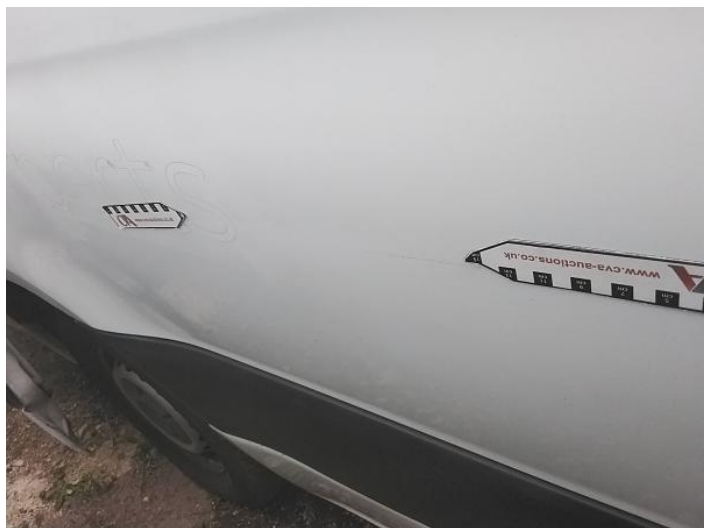
8: Qtr Panel nsr
Dented
Over 30mm

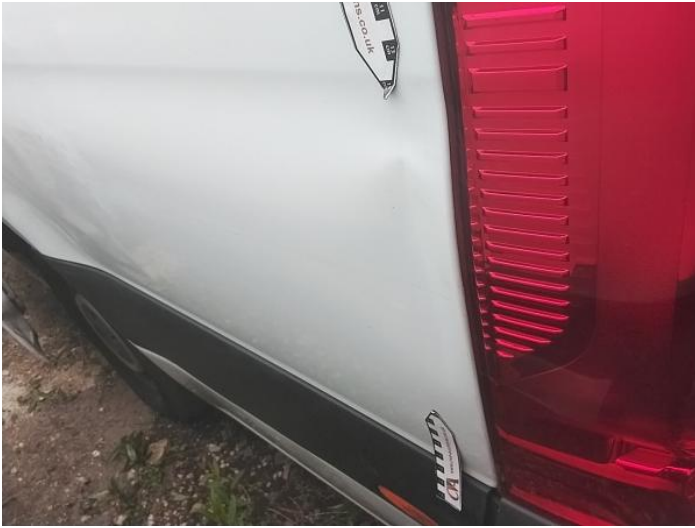
9: Qtr Panel nsr
Dented
Over 30mm

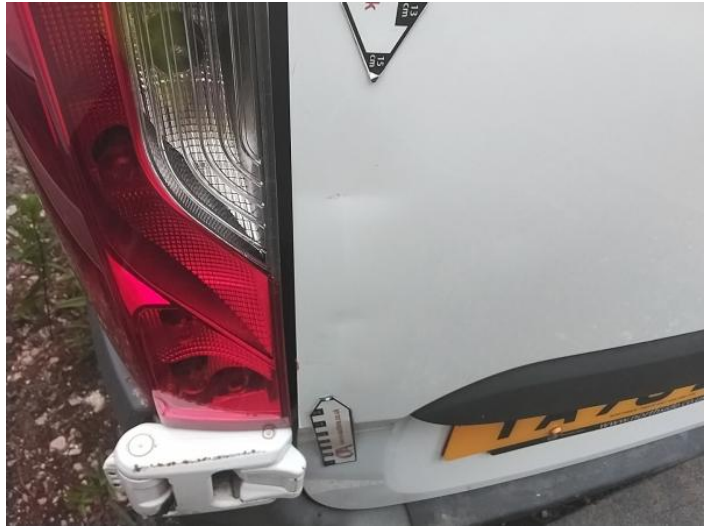
10: Door nsr
Dented
Over 30mm

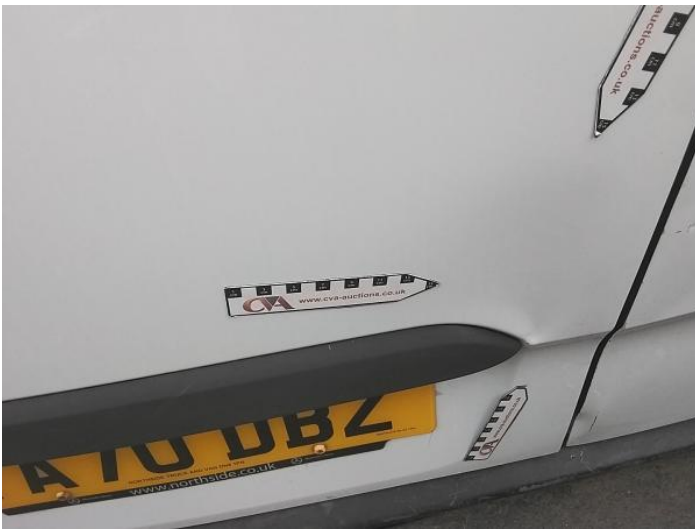
11: Door nsr
Dented
Over 30mm

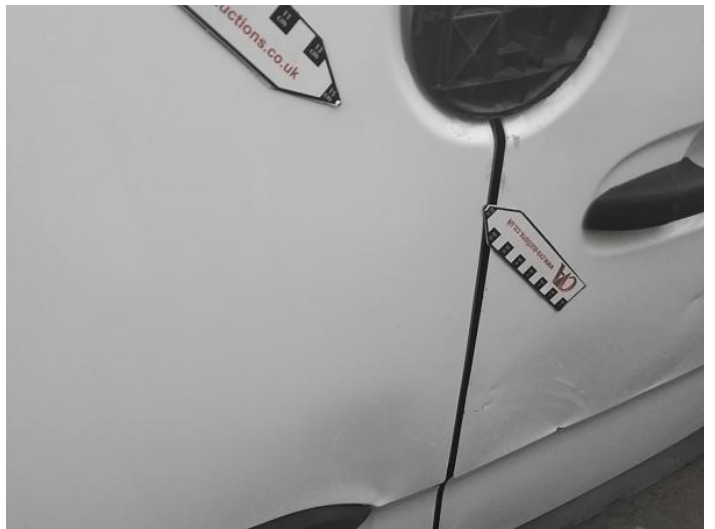
12: Door nsr
Dented
Over 30mm

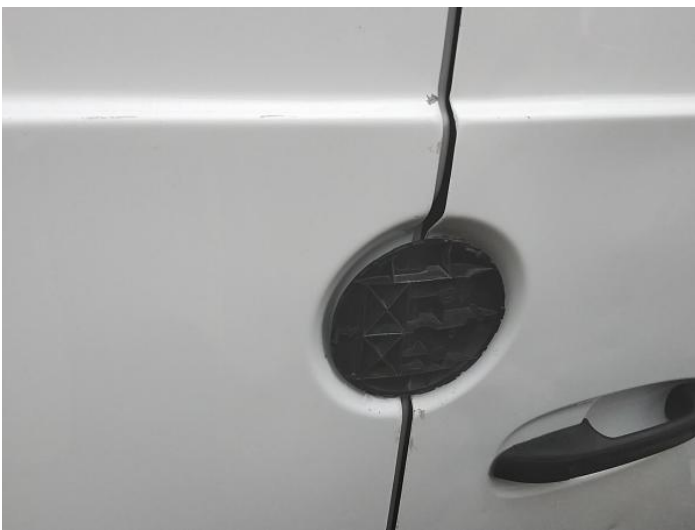
13: Badgedecal Rear
Broken
Replace

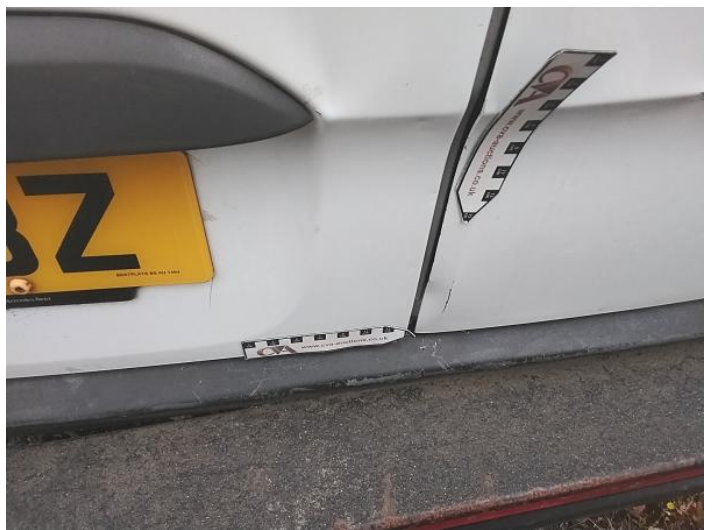
14: Door osr
Dented
With Paint Damage

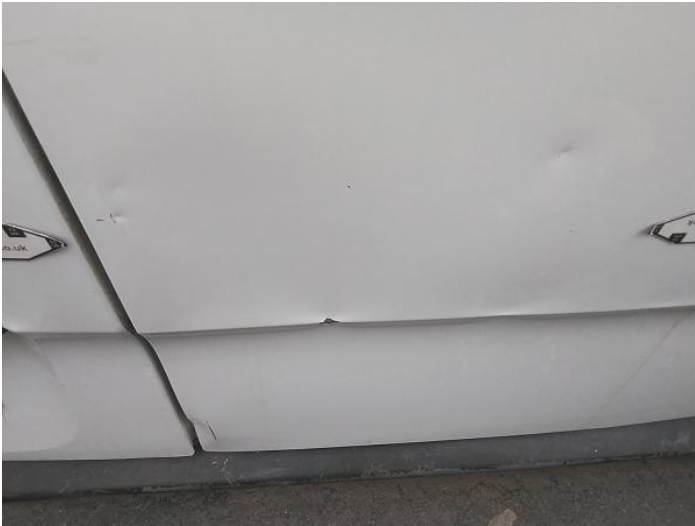
15: Door osr
Dented
With Paint Damage

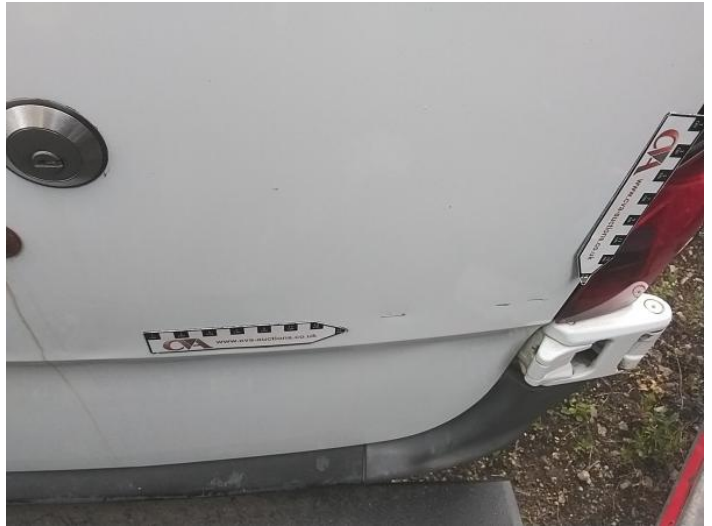
16: Door osr
Dented
With Paint Damage

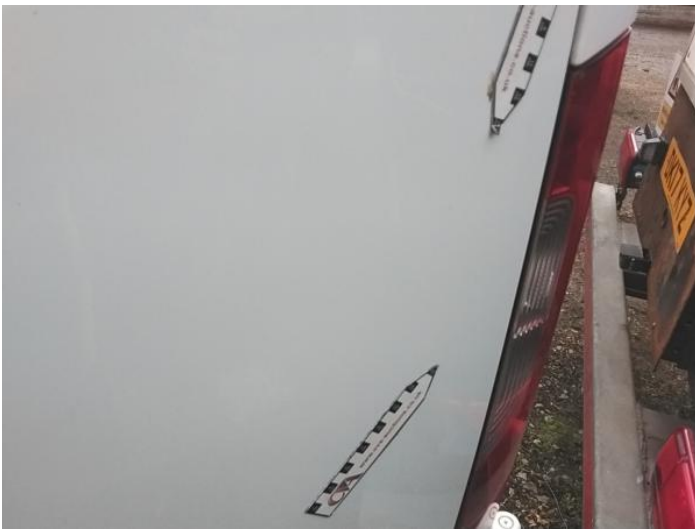
17: Door osr
Dented
Over 30mm

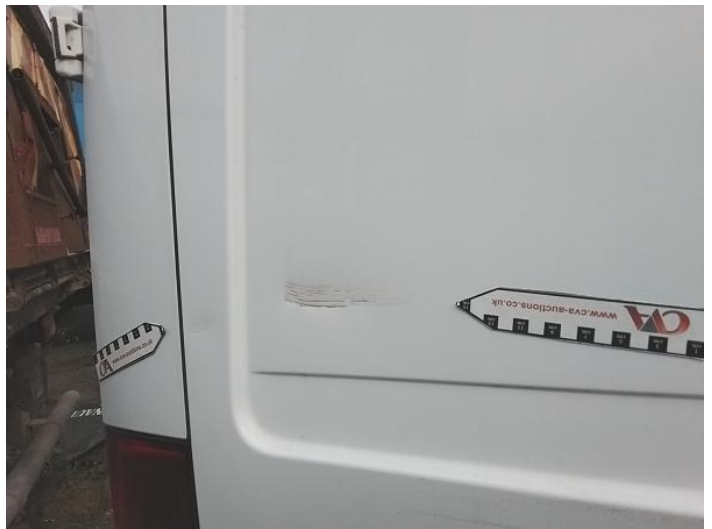
18: Qtr Panel osr
Dented
With Paint Damage

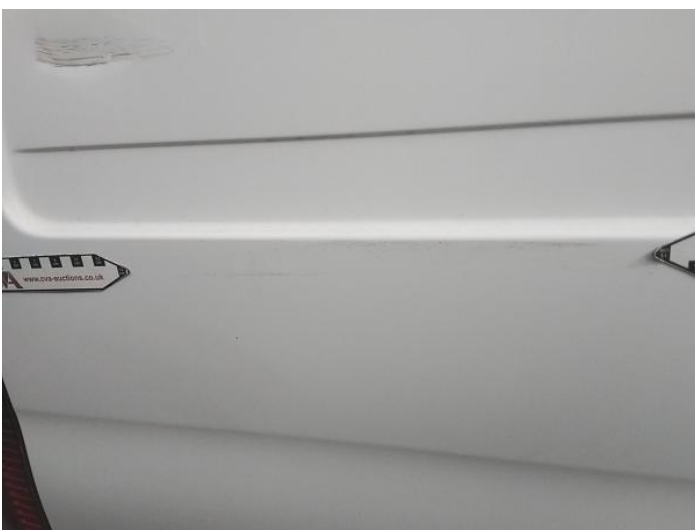
19: Qtr Panel osr
Scratched
Over 25mm Thru Paint

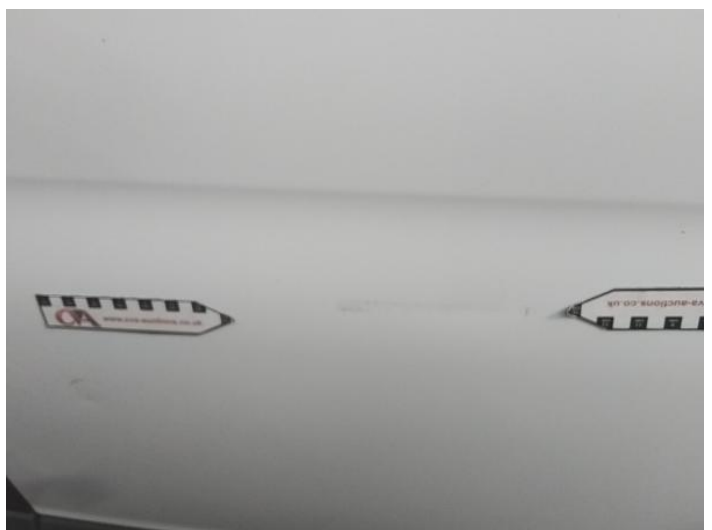
20: Qtr Panel osr
Dented
With Paint Damage

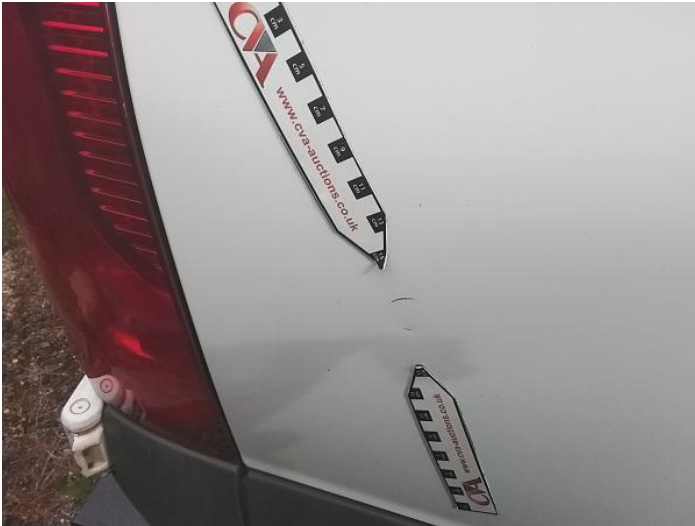
21: Qtr Panel osr
Dented
With Paint Damage

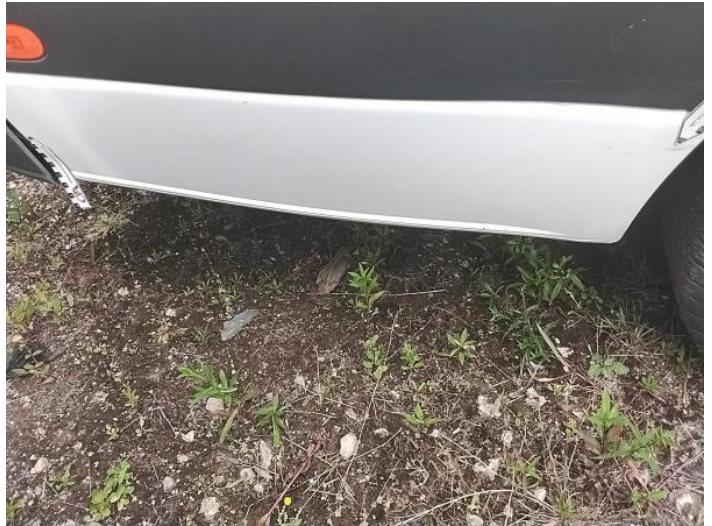
22: Qtr Panel osr
Scratched
Over 25mm Thru Paint

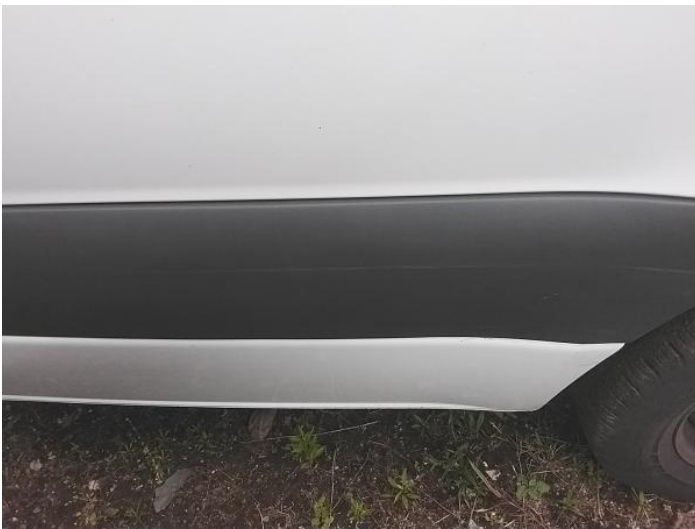
23: Qtr Panel Moulding os
Scuffed (Unpainted)
Over 100mm

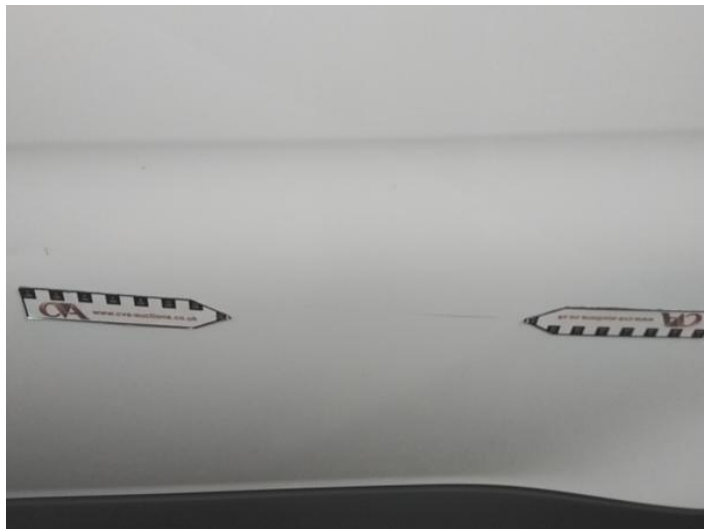
24: Qtr Panel osr
Scratched
Over 25mm Thru Paint

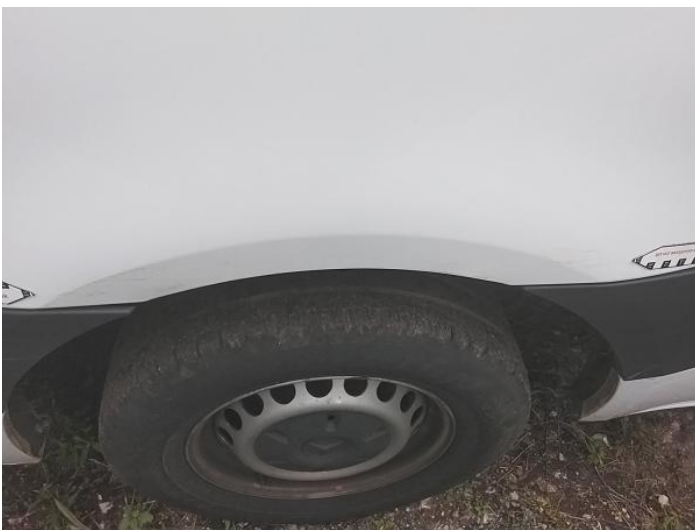
25: Qtr Panel osr
Scratched
Over 25mm Thru Paint

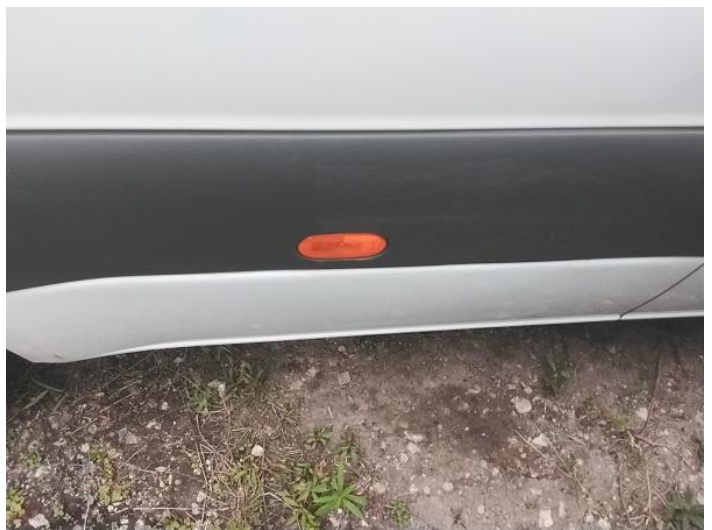
26: Qtr Panel Moulding os
Scuffed (Unpainted)
Over 100mm

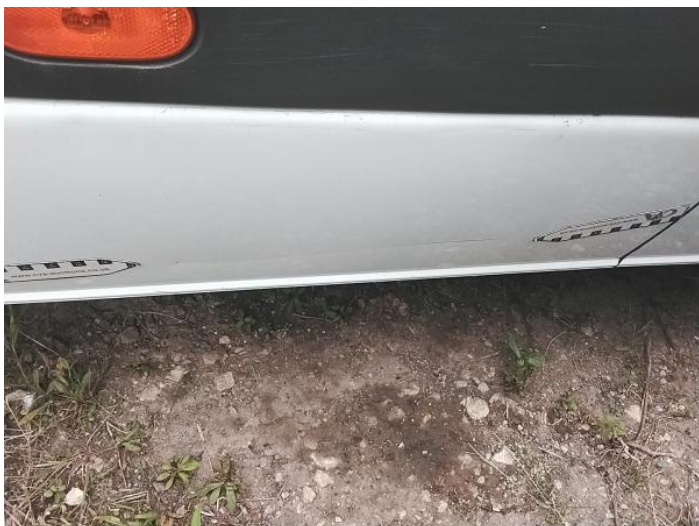
27: Qtr Panel osr
Dented
With Paint Damage

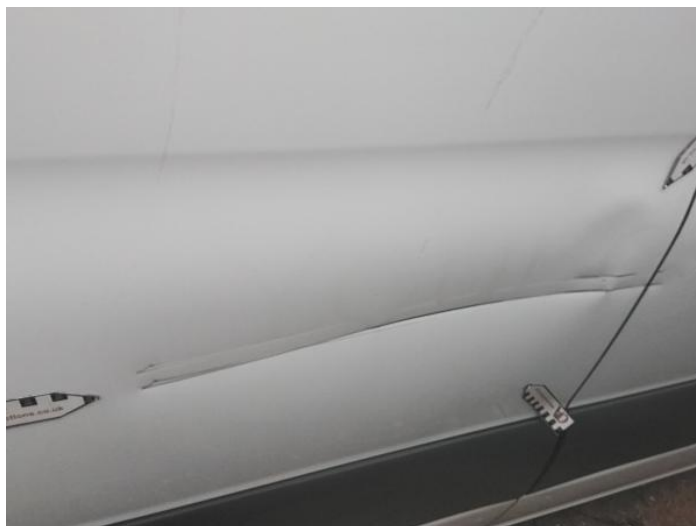
28: Qtr Panel osr
Dented
With Paint Damage

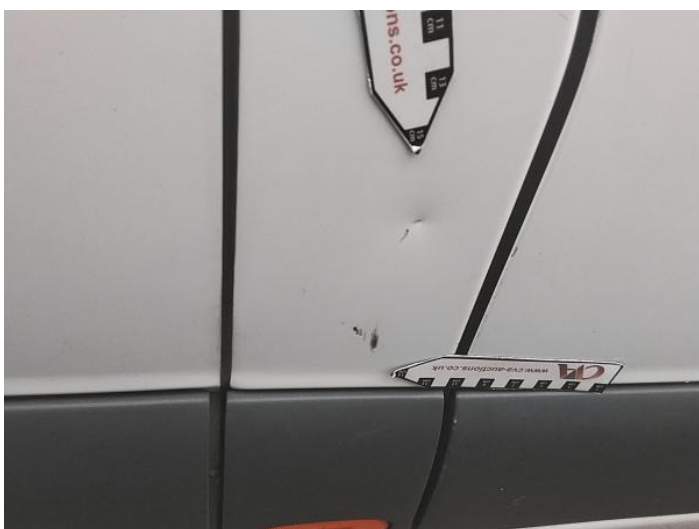
29: C Post os
Dented
With Paint Damage

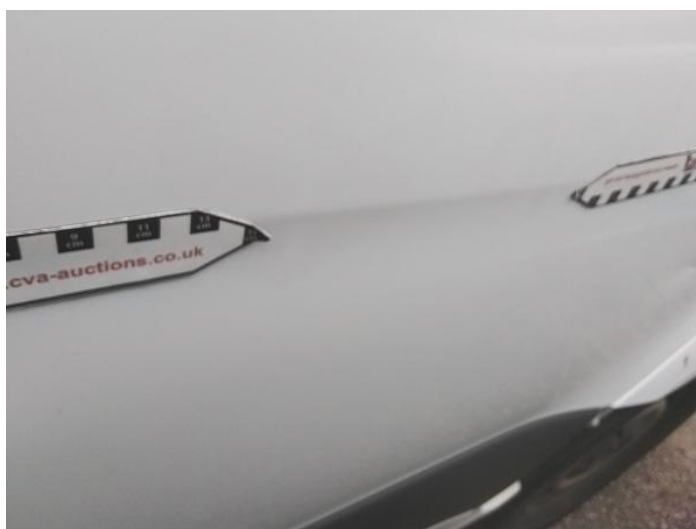
30: Door osf
Dented
Over 30mm

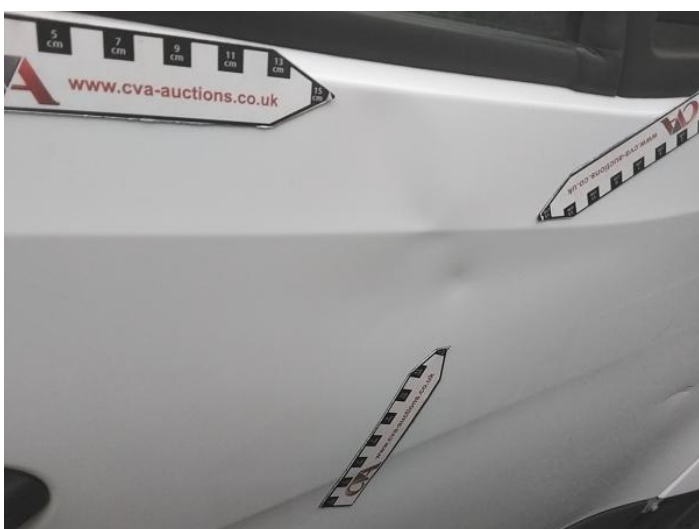
31: Door osf
Dented
Over 30mm

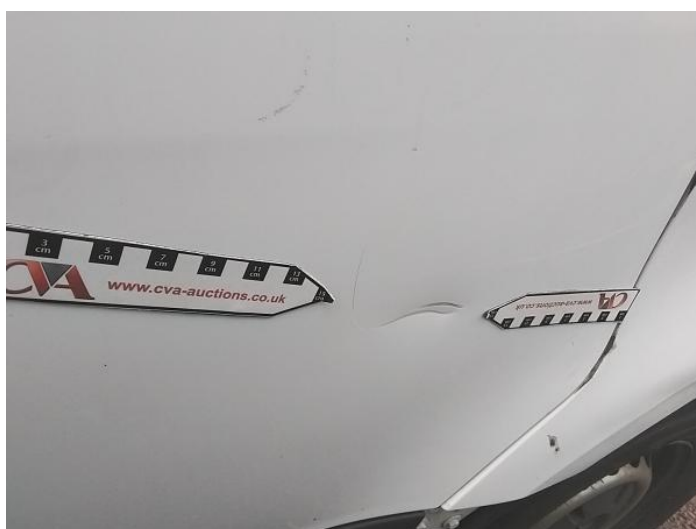
32: Door osf
Dented
With Paint Damage

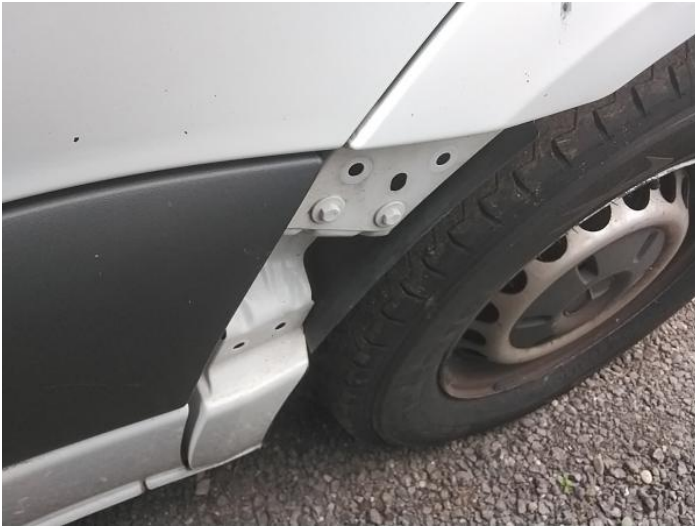
33: Door Moulding osf
Missing
Replace

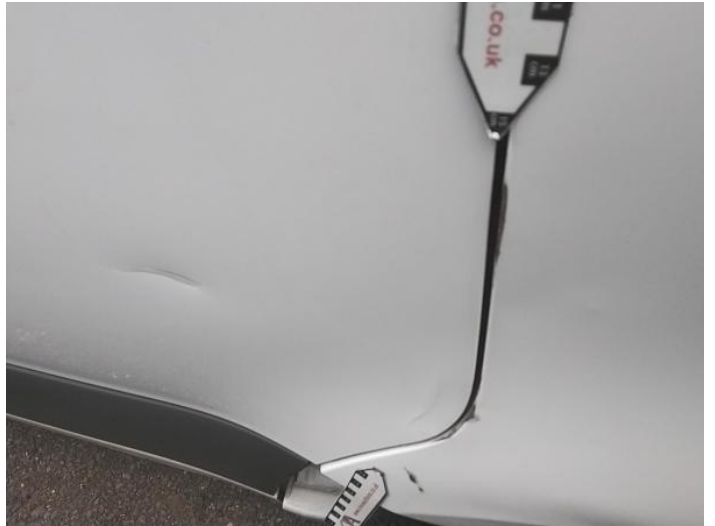
34: Wing osf
Dented
With Paint Damage

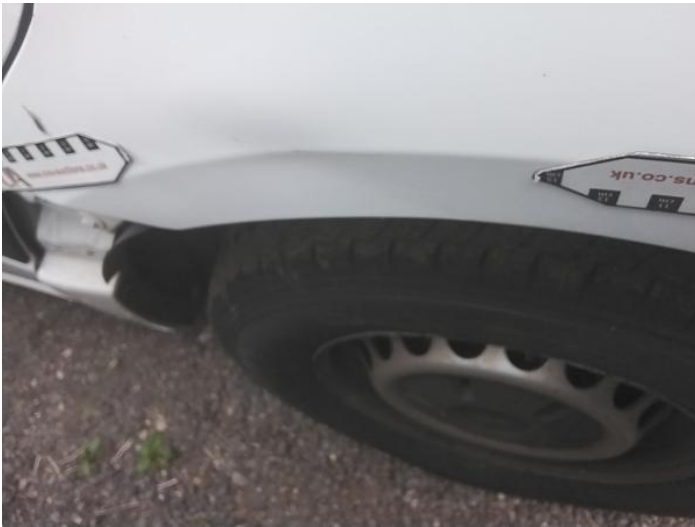
35: Wing osf
Dented
Over 30mm

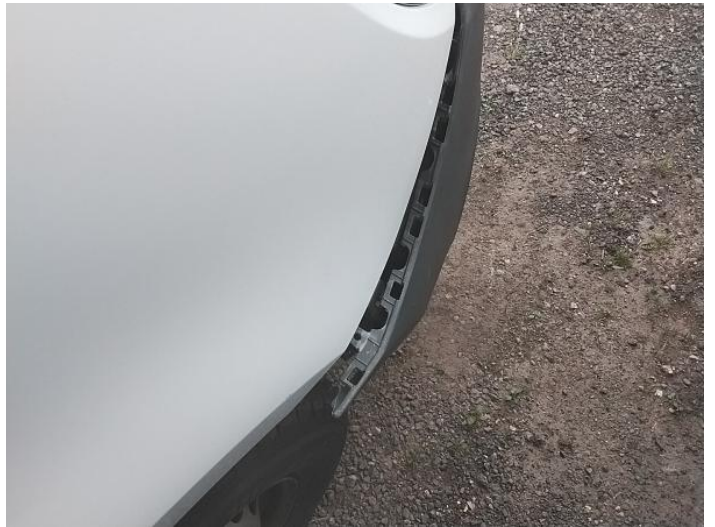
36: Bumper Front
Insecure
Action Required

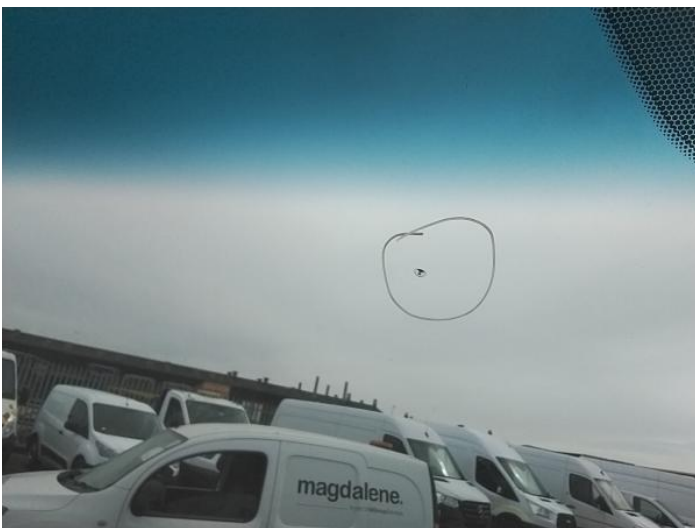
37: Screen Front
Chipped
UpTo 10mm

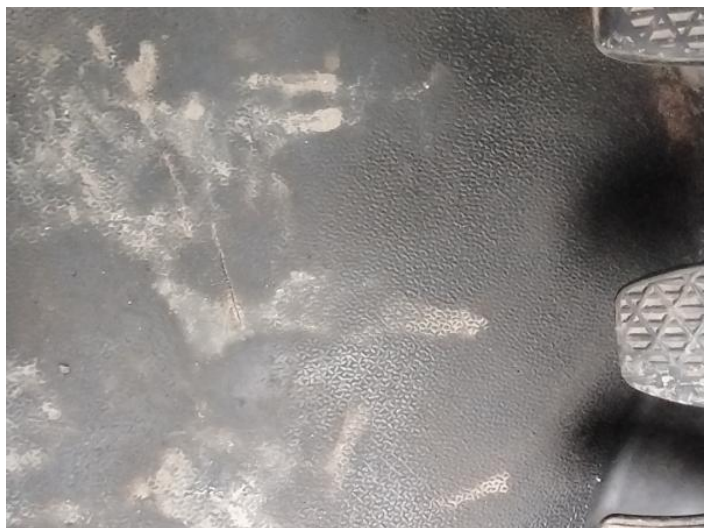
38: Carpets Front
Torn
Over 10mm

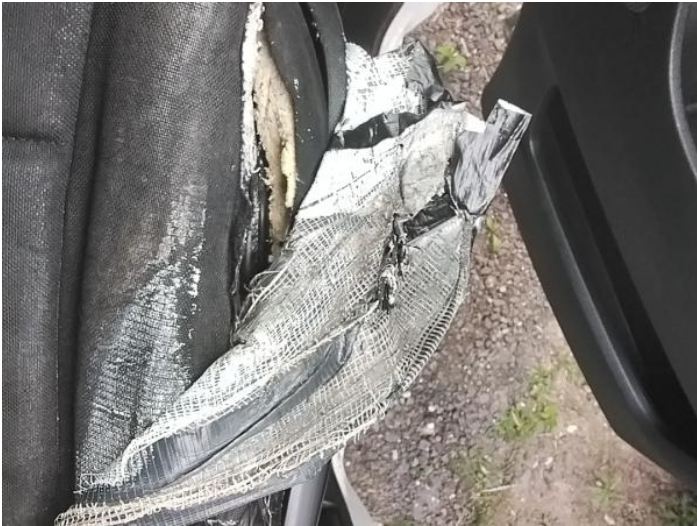
39: Seat Base Cover osf
Holed
Over 3mm

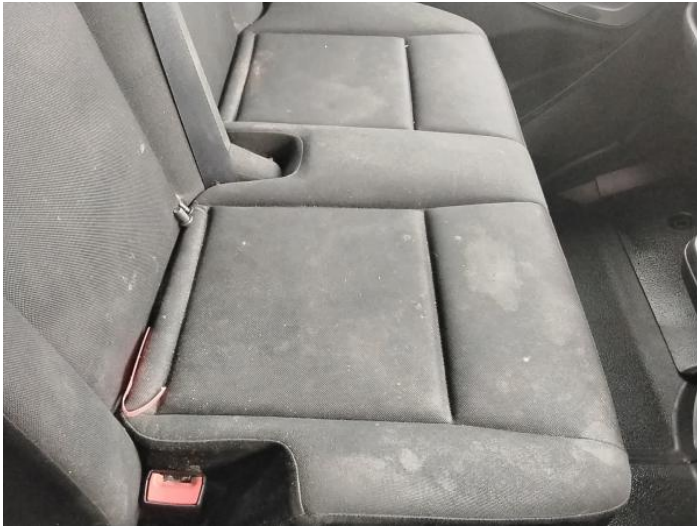
40: Seat Base Cover nsf
Soiled
Heavy

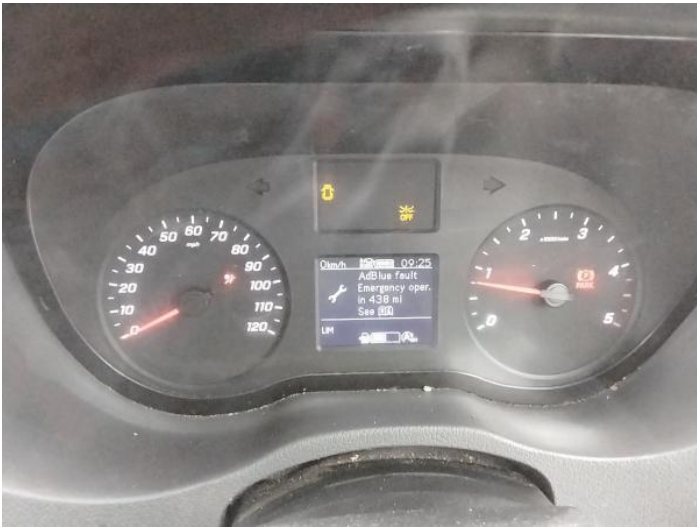
41: Dash Warning Lights
Displayed
No Action

Carpet Condition	Poor	Upholstery Condition	OK
Seat Condition	Poor	Odour	Yes
Engine Runs	OK	No Excessive Smoking	OK
EML light illuminated	OK	DPF light illuminated	Fault
Airbag light illuminated	Fault		
ABS light illuminated	OK

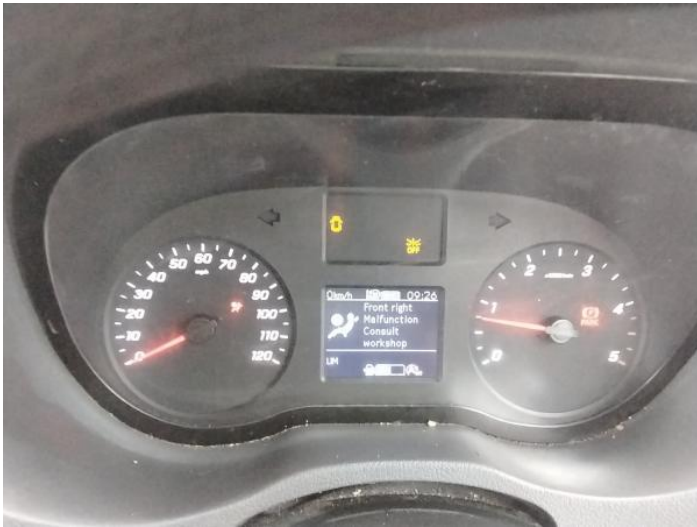
42: Dash Warning Lights
Displayed
No Action
