VEHICLE INSPECTION REPORT

YH20UES

Mercedes-Benz Sprinter 314CDI 3.5t H2 Van

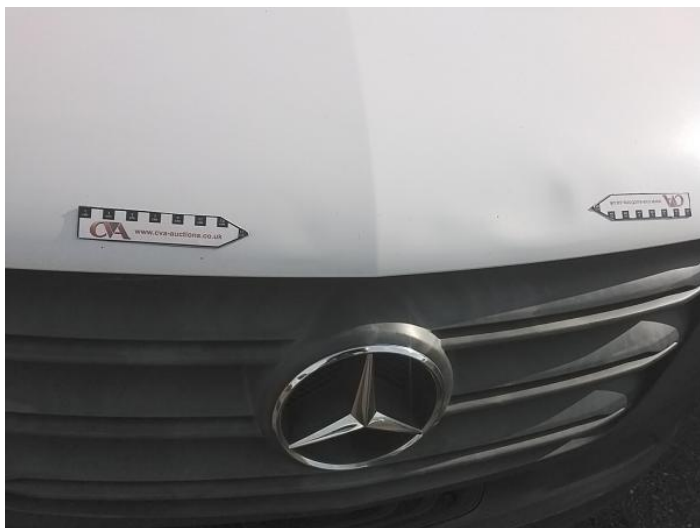
1: Bonnet
Dented
Over 30mm

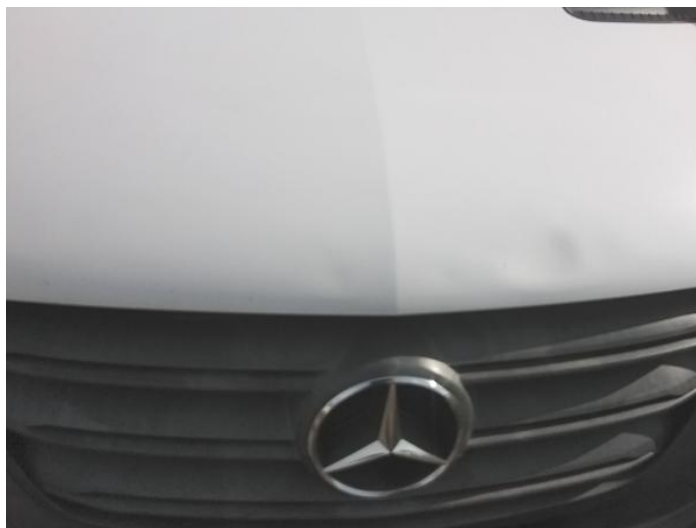
2: Bonnet
Chipped
Multiple Chips

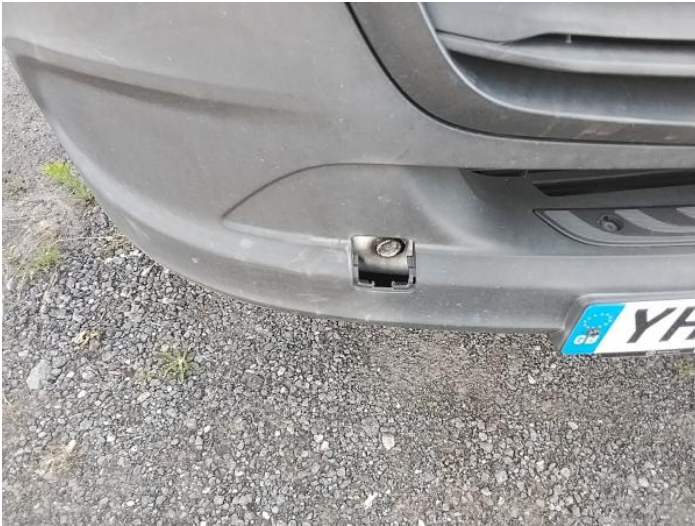
3: Bumper Front Moulding
Missing
Replace

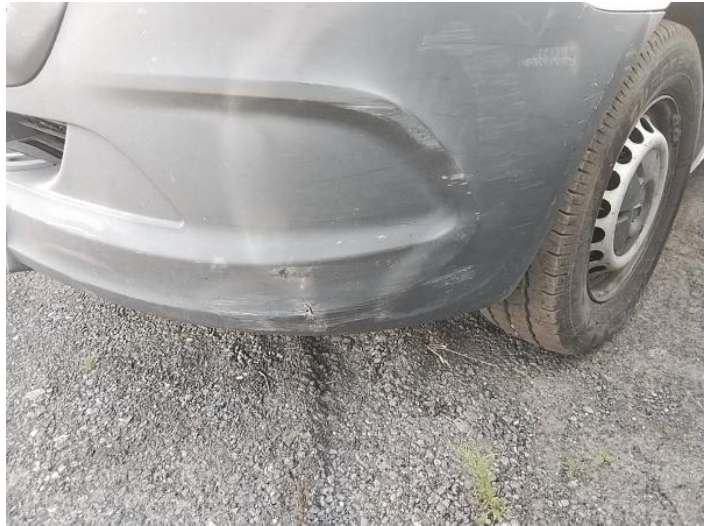
4: Bumper Front
Scratched
Over 100mm Thru Paint

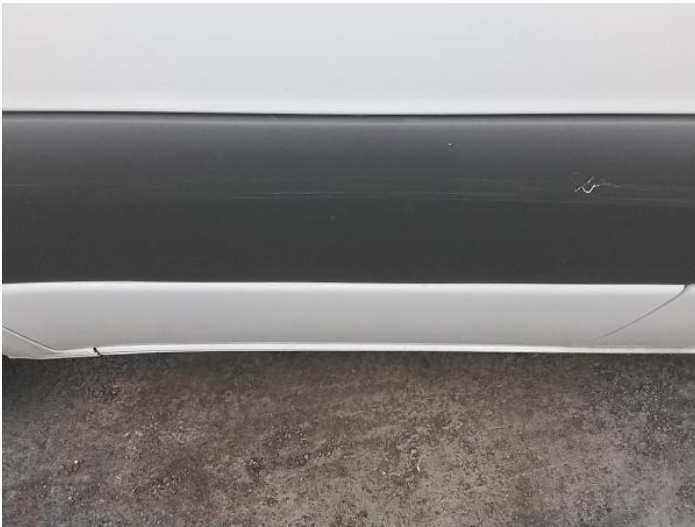
5: Door Moulding nsf
Scuffed (Unpainted)
Over 100mm

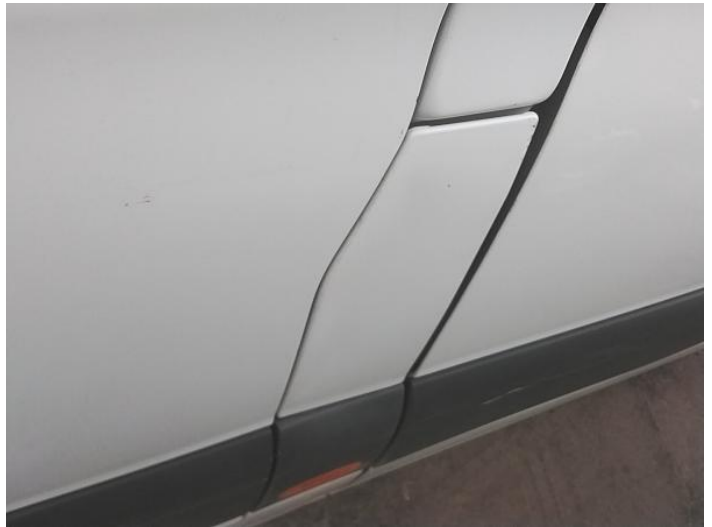
6: Fuel Flap
Dented
Over 30mm

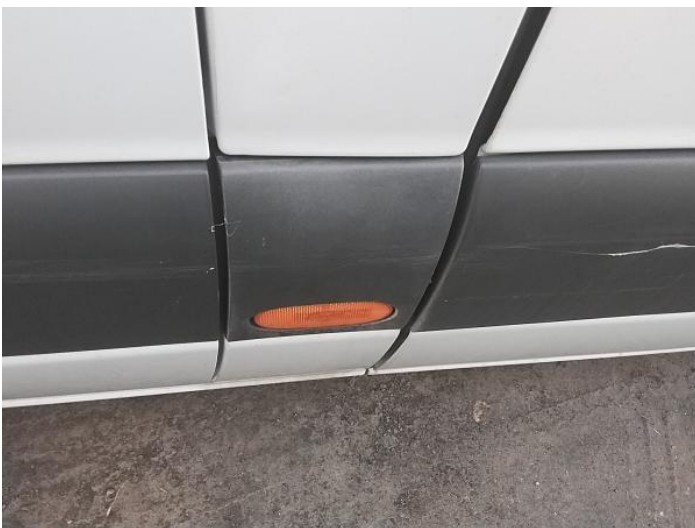
7: Door Moulding nsf
Scuffed (Unpainted)
UpTo 100mm

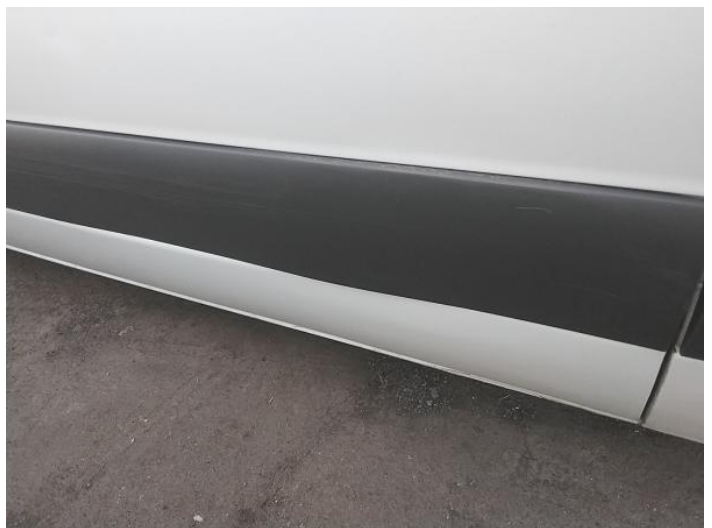
8: Qtr Panel Moulding ns
Scuffed (Unpainted)
Over 100mm

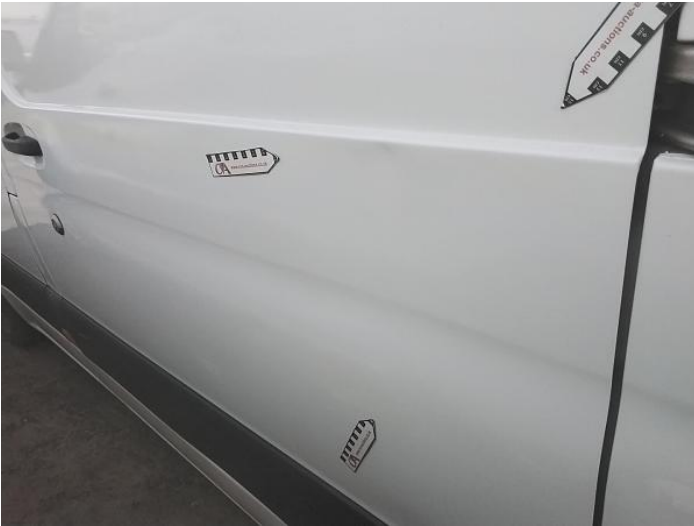
9: Qtr Panel nsr
Dented
Over 30mm

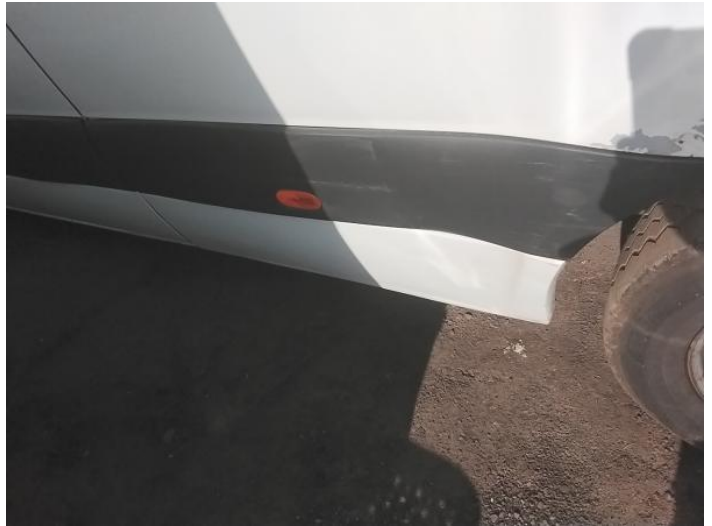
10: Qtr Panel Moulding ns
Broken
Replace

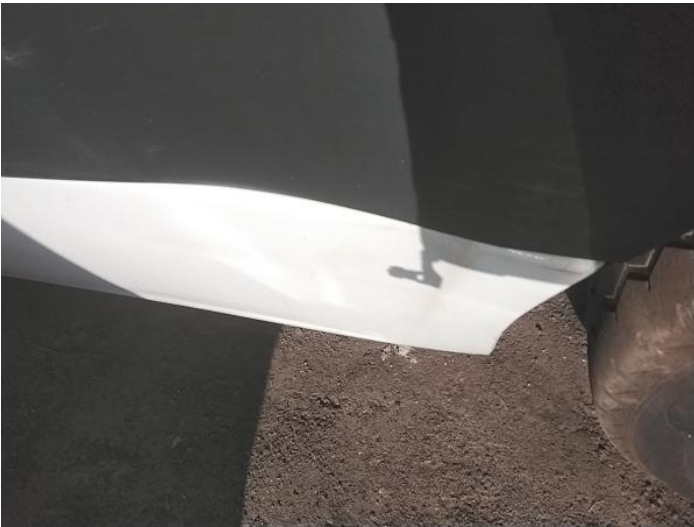
11: Qtr Panel nsr
Dented
Over 30mm

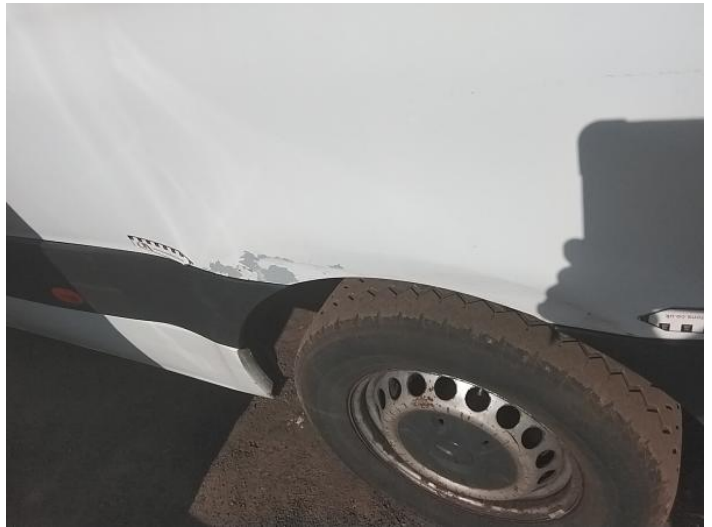
12: Qtr Panel nsr
Dented
With Paint Damage

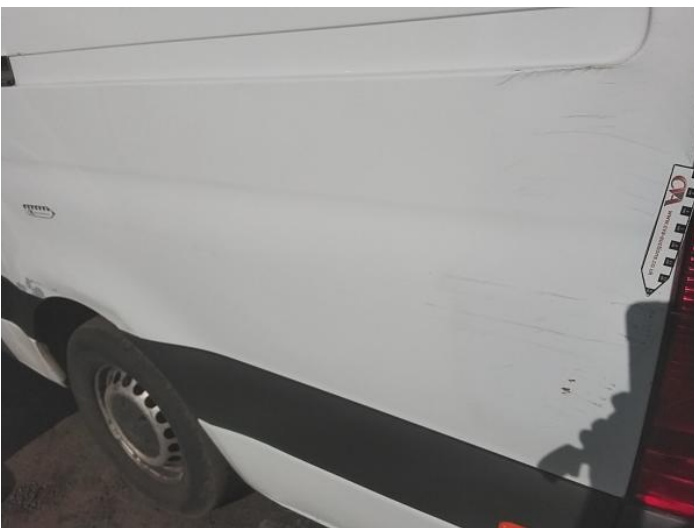
13: Qtr Panel nsr
Scratched
Over 25mm Thru Paint

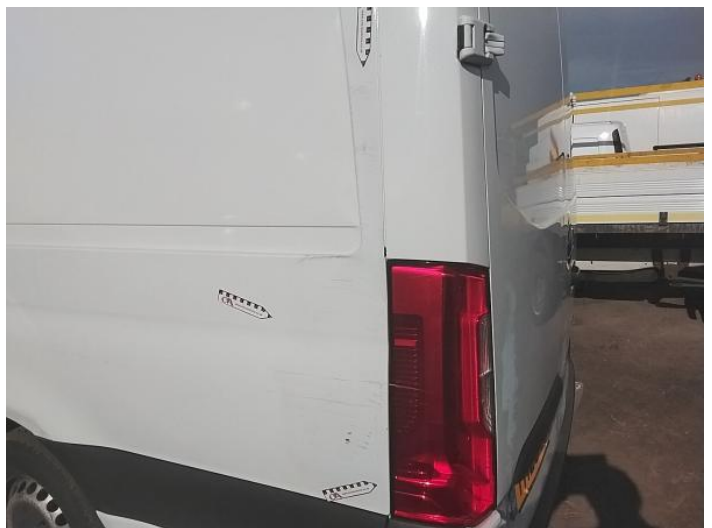
14: Qtr Panel nsr
Dented
With Paint Damage

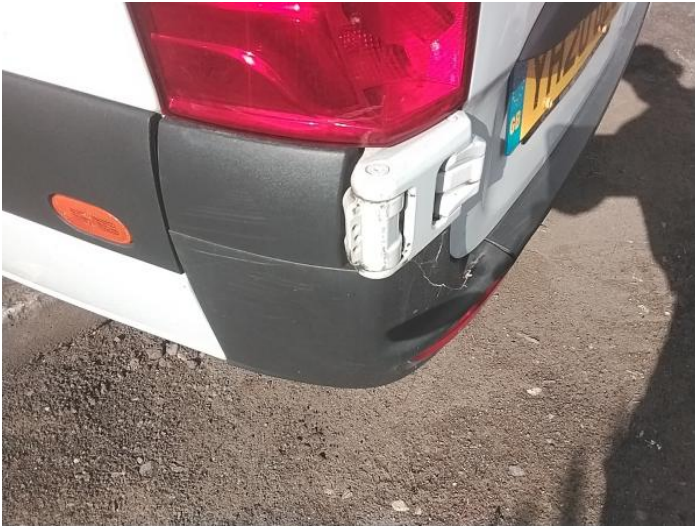
15: Bumper Rear Moulding
Scuffed (Unpainted)
Over 100mm

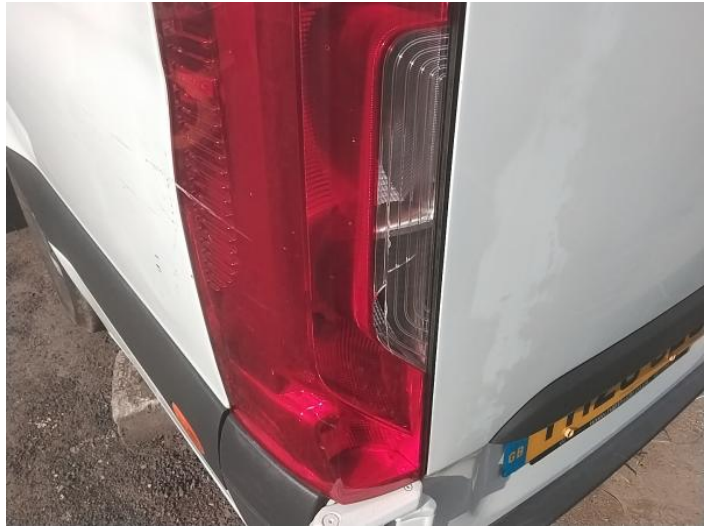
16: Lamp nsr
Broken
Replace

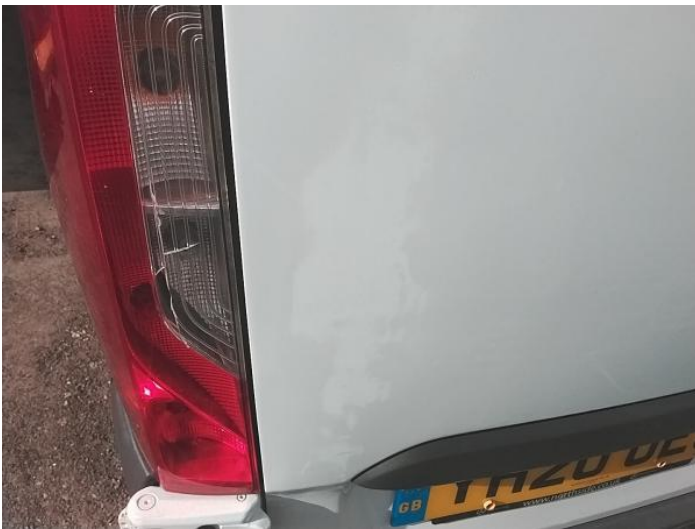
17: Door nsr
Poor Previous Repair
Poor Paint

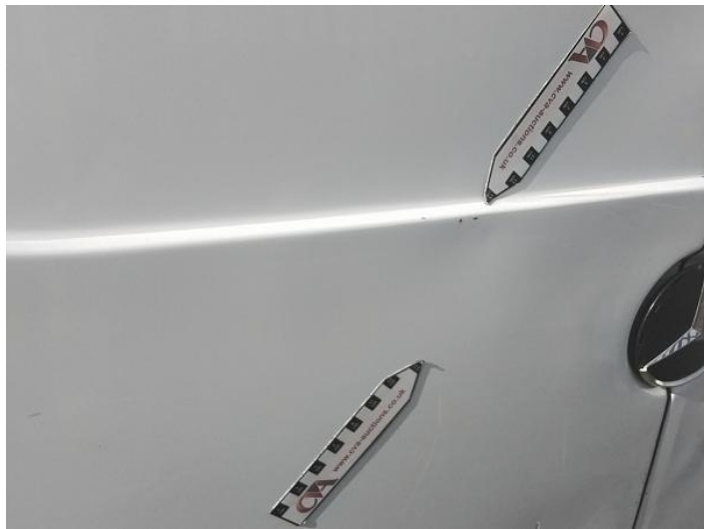
18: Door nsr
Dented
Over 30mm

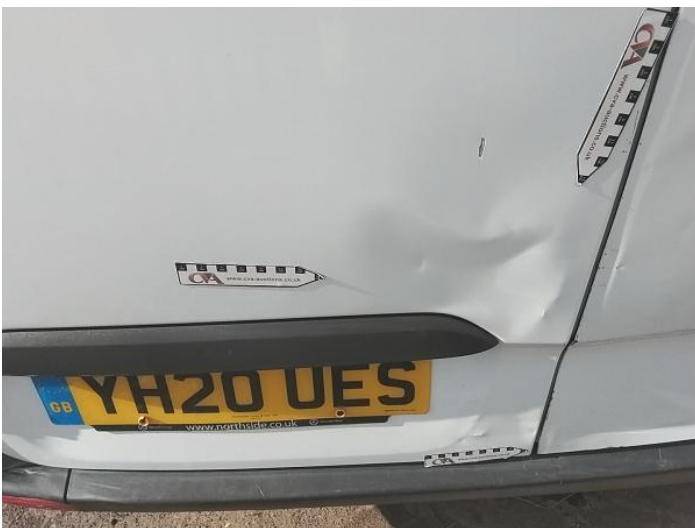
19: Door nsr
Dented
With Paint Damage

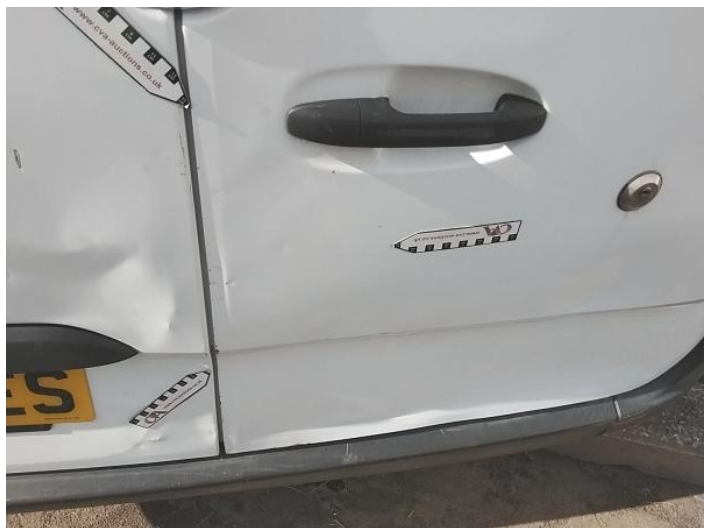
20: Door osr
Dented
With Paint Damage

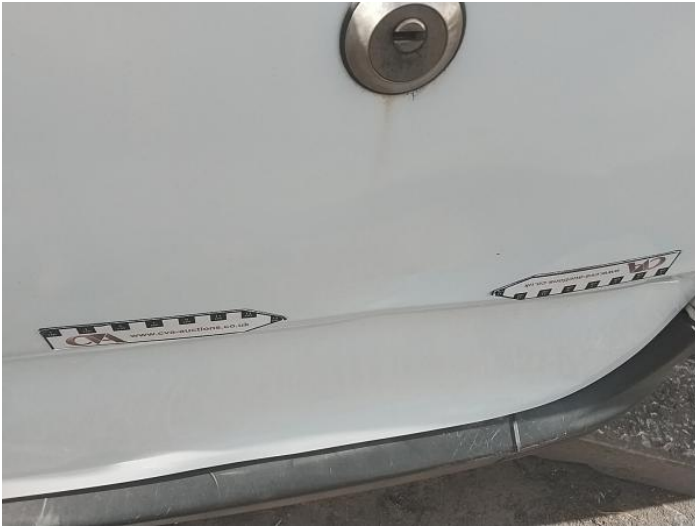
21: Door osr
Dented
Over 30mm

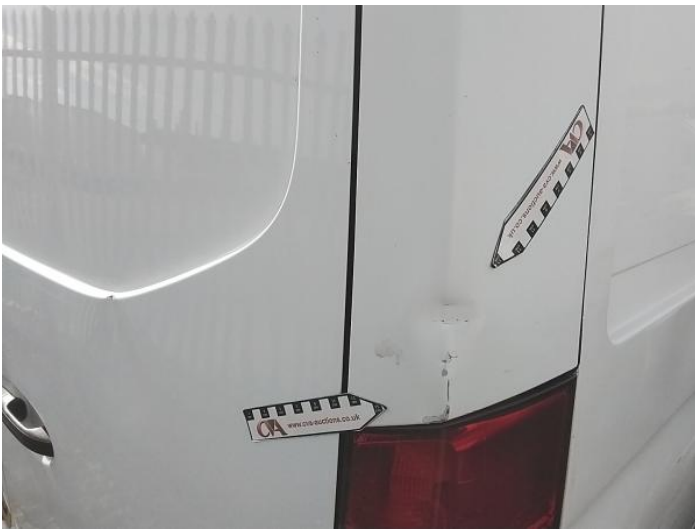
23: C Post ns
Dented
With Paint Damage

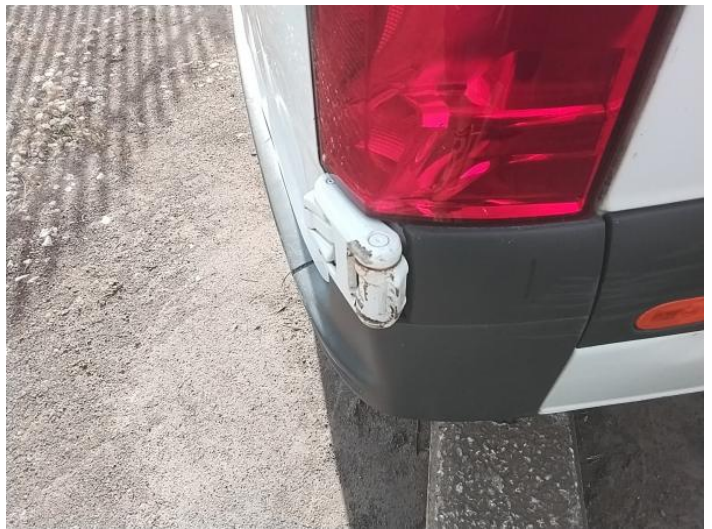
24: Bumper Rear Moulding
Scuffed (Unpainted)
UpTo 100mm

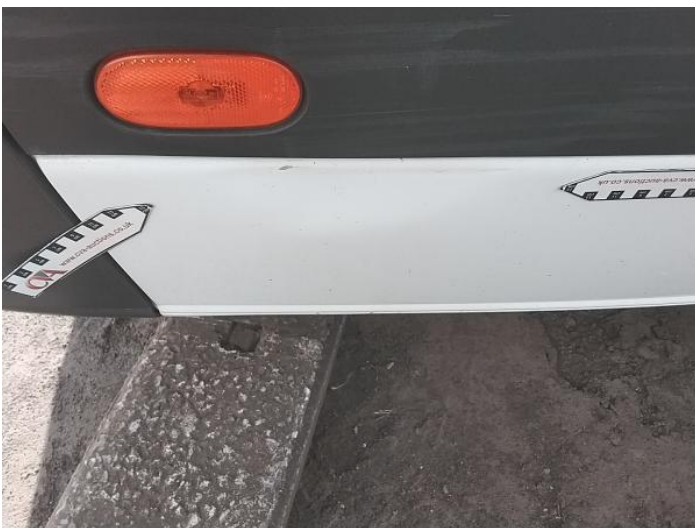
25: Qtr Panel osr
Dented
With Paint Damage

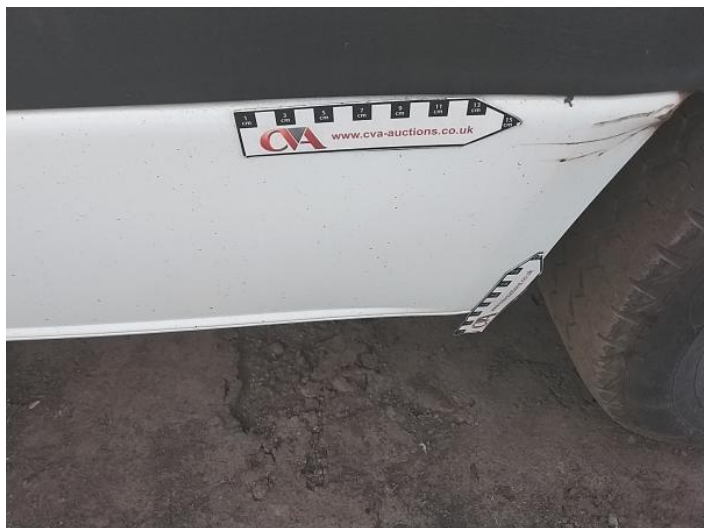
26: Qtr Panel osr
Dented
With Paint Damage

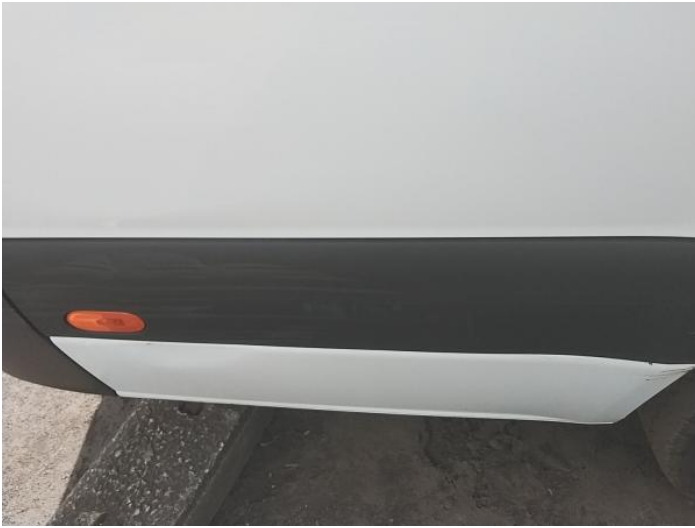
27: Qtr Panel Moulding os
Scuffed (Unpainted)
Over 100mm

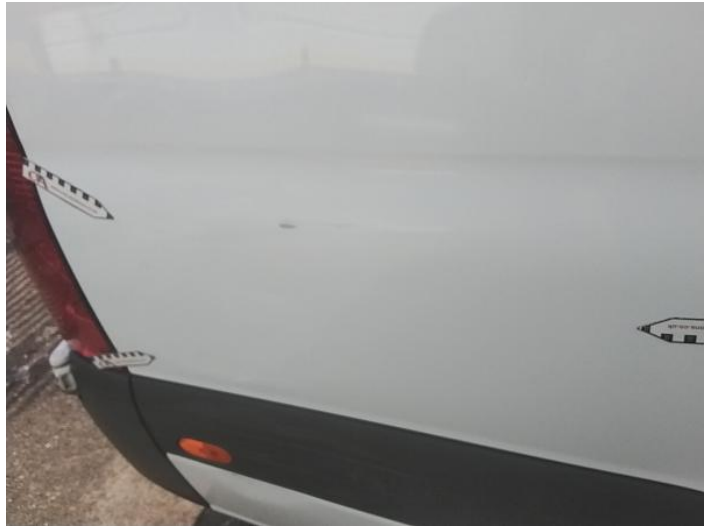
28: Qtr Panel osr
Dented
With Paint Damage

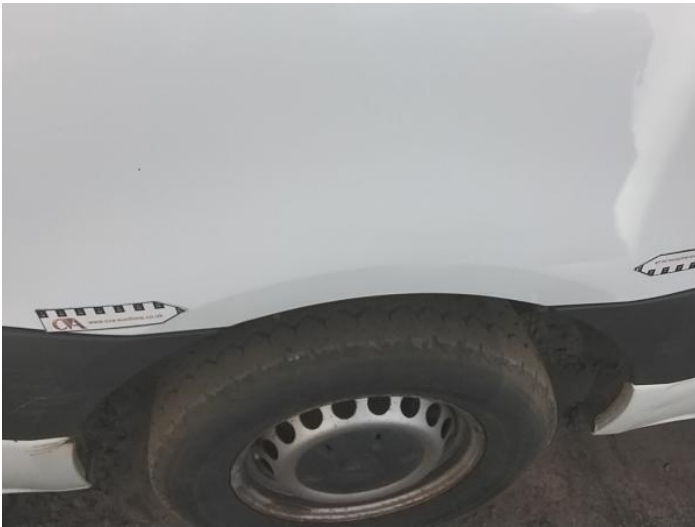
29: Qtr Panel osr
Dented
Over 30mm

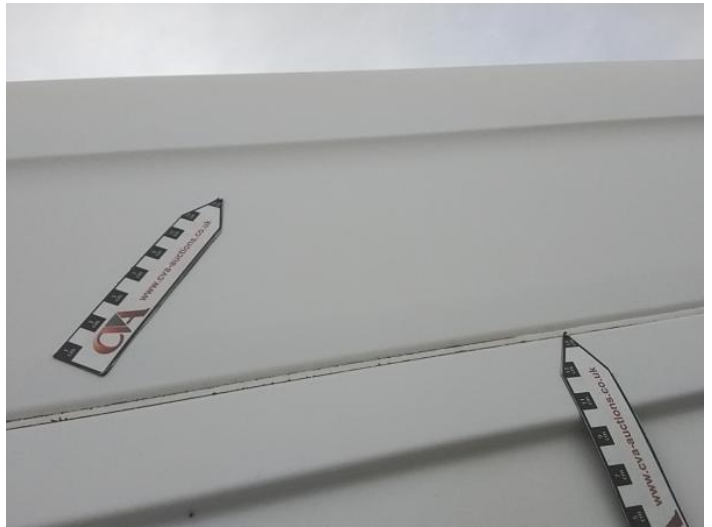
30: Qtr Panel osr
Dented
Over 30mm

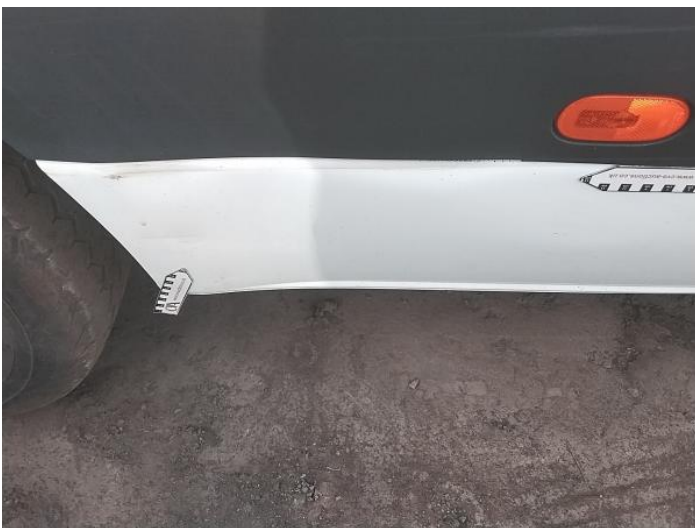
31: Qtr Panel osr
Dented
With Paint Damage

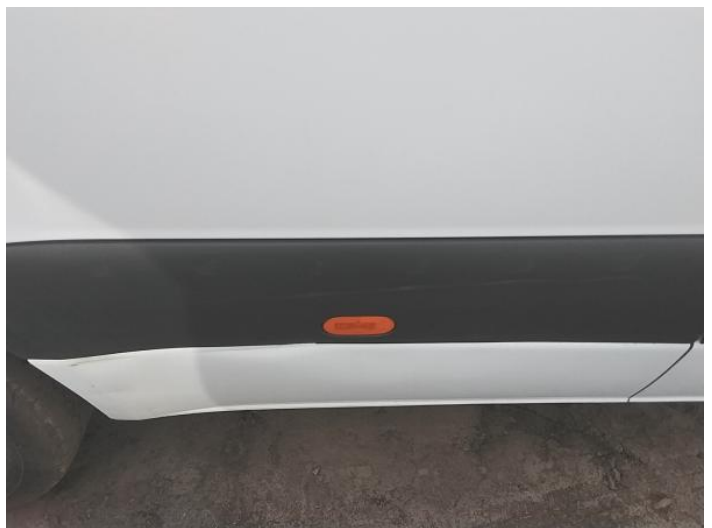
32: Qtr Panel Moulding os
Scuffed (Unpainted)
Over 100mm

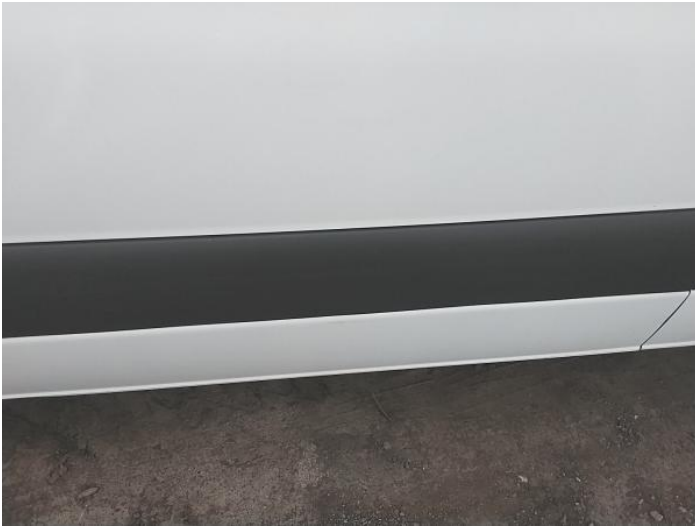
33: Qtr Panel Moulding os
Scuffed (Unpainted)
Over 100mm

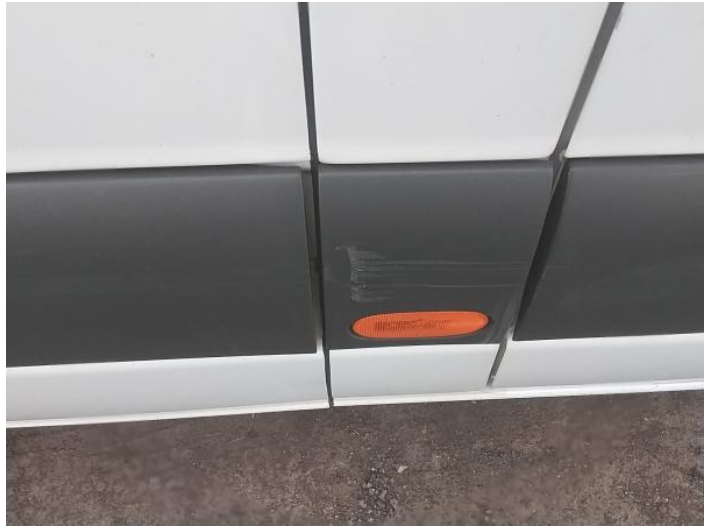
34: Door Moulding osf
Scuffed (Unpainted)
Up To 100mm

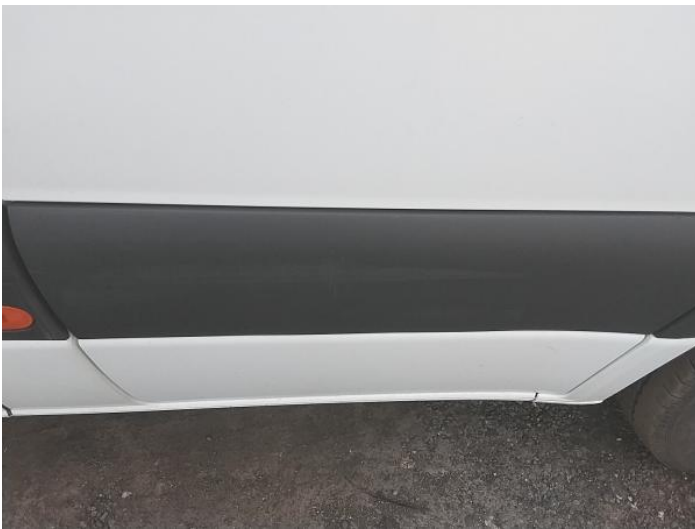
35: Door Moulding osf
Scuffed (Unpainted)
Over 100mm

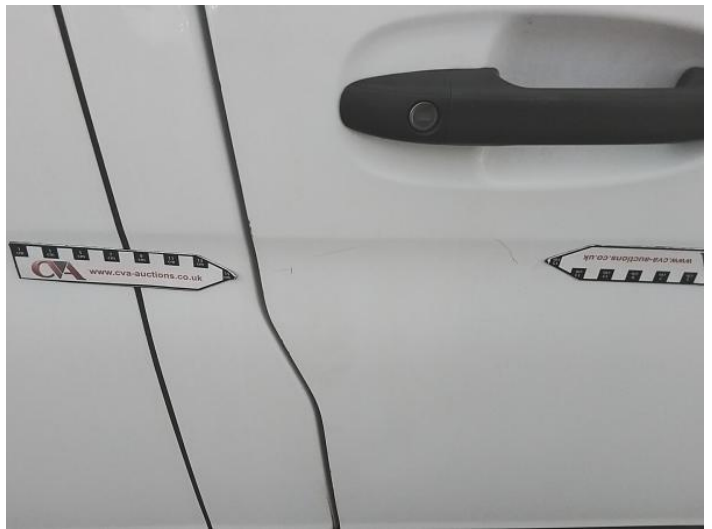
36: Door osf
Scratched
Over 25mm Thru Paint

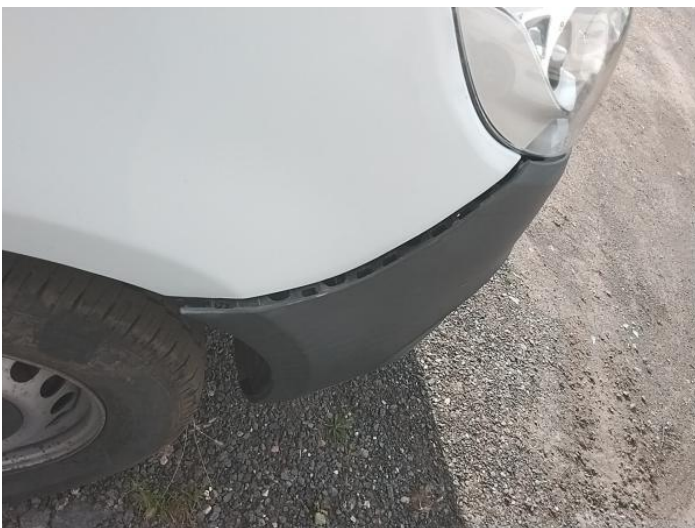
37: Bumper Front
Insecure
Action Required

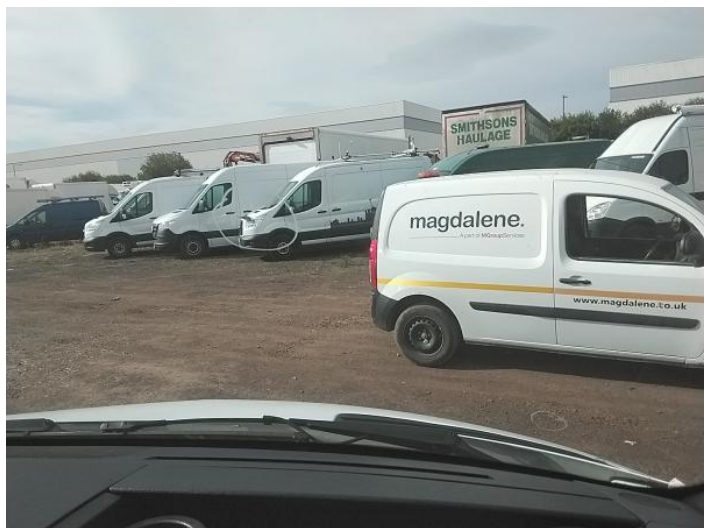
38: Screen Front
Chipped
Over 10mm

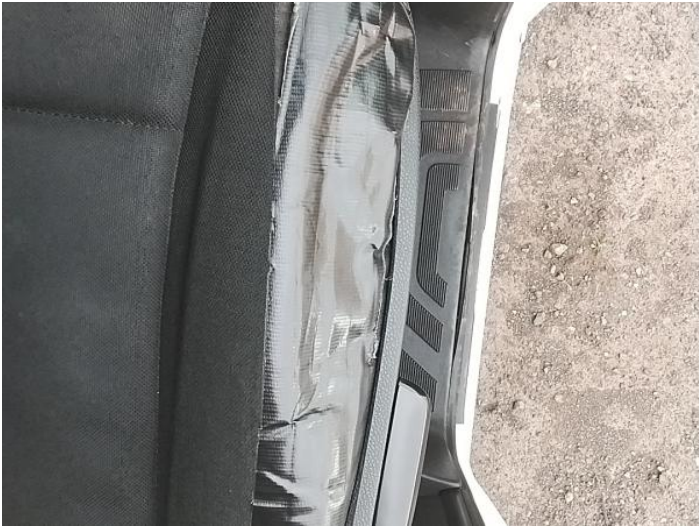
39: Seat Base Cover osf
Torn
Over 3mm

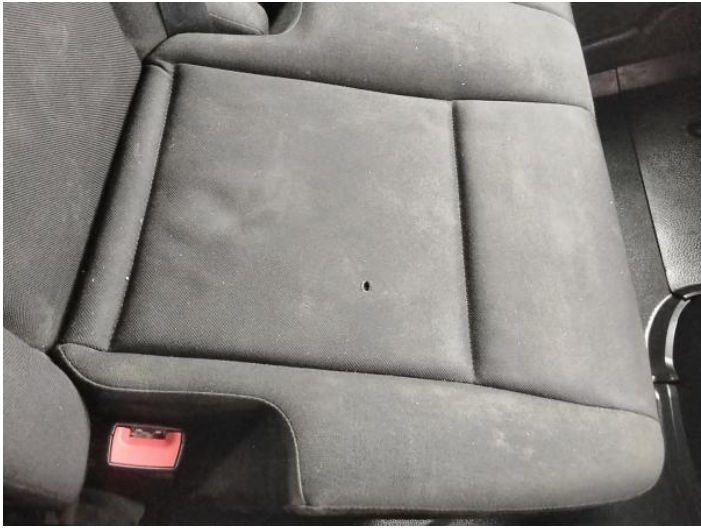
40: Seat Base Cover nsf
Burn
Over 3mm
