VEHICLE INSPECTION REPORT

YH20UET

Mercedes-Benz Sprinter 314 CDI

Inspection

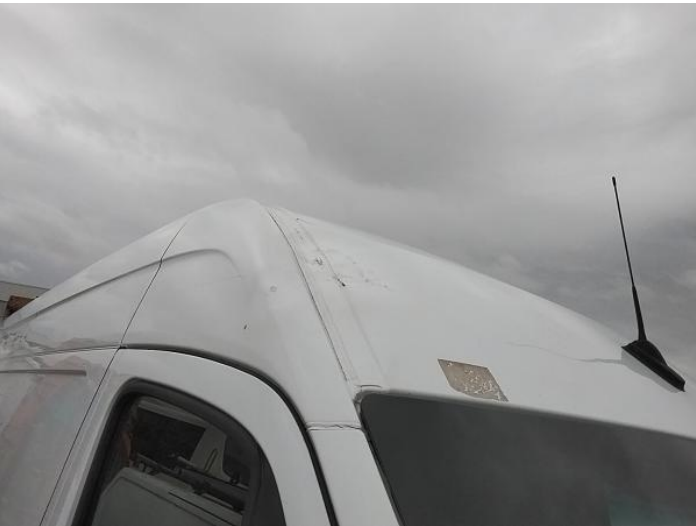
1: Roof
Dented
With Paint Damage

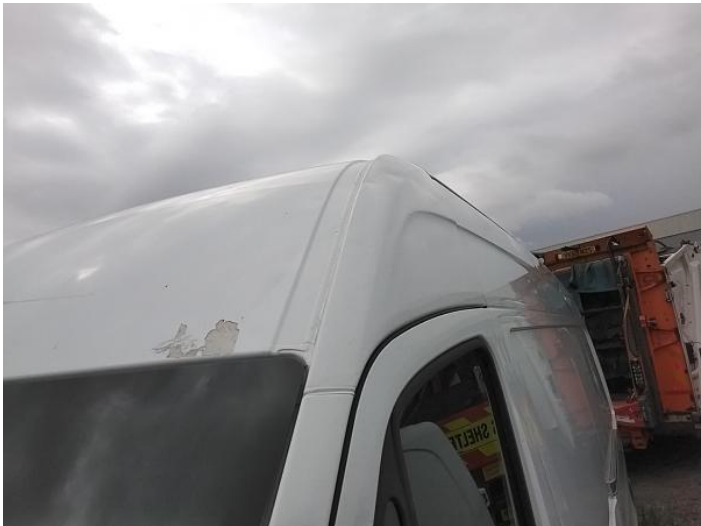
2: Roof
Dented
With Paint Damage

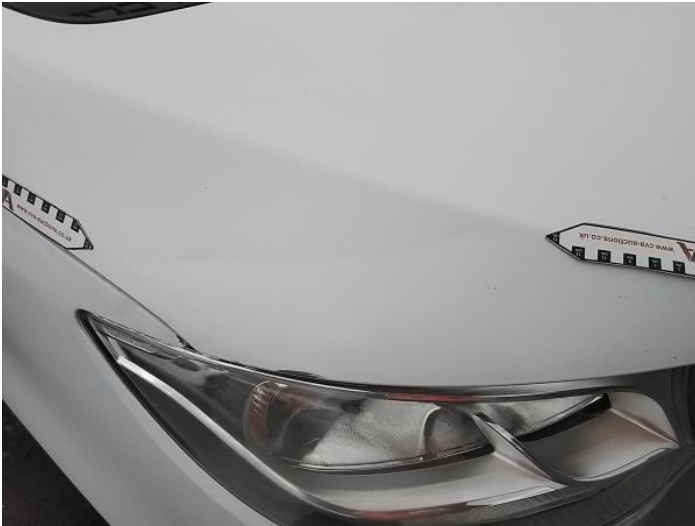
3: Bonnet
Dented
Over 30mm

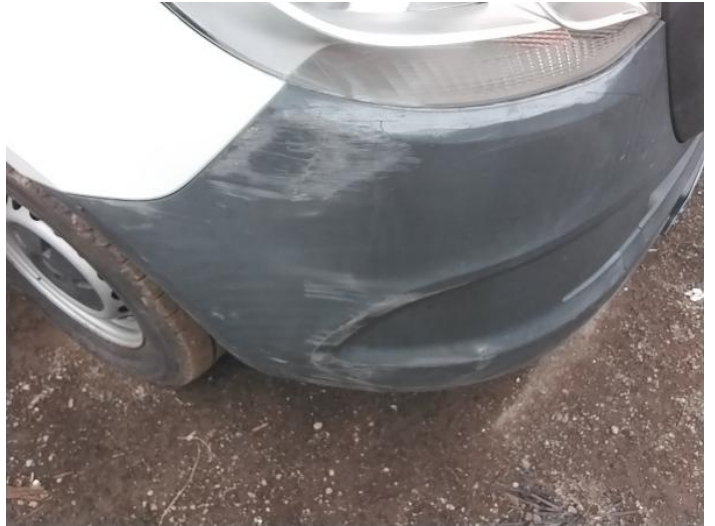
4: Bumper Front
Scratched
Over 100mm Thru Paint

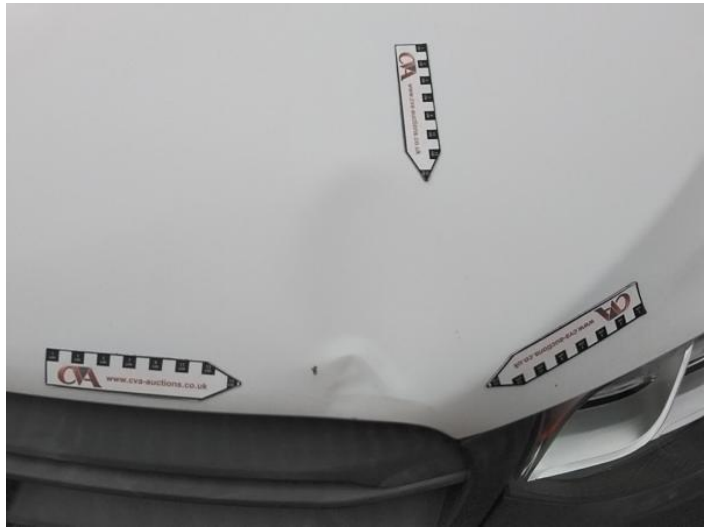
6: Bonnet
Dented
With Paint Damage

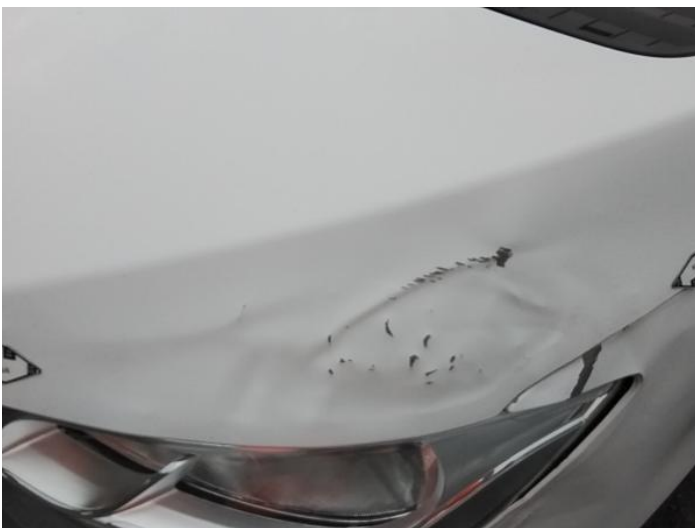
7: Bonnet
Dented
With Paint Damage

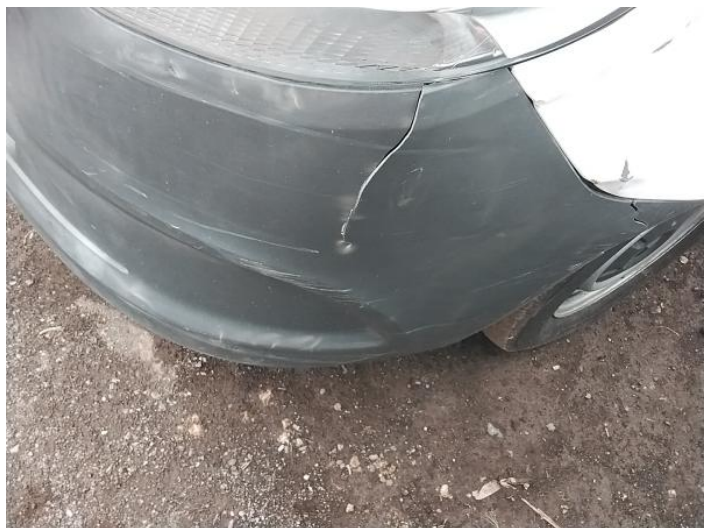
8: Bumper Front
Cracked
Over 25mm

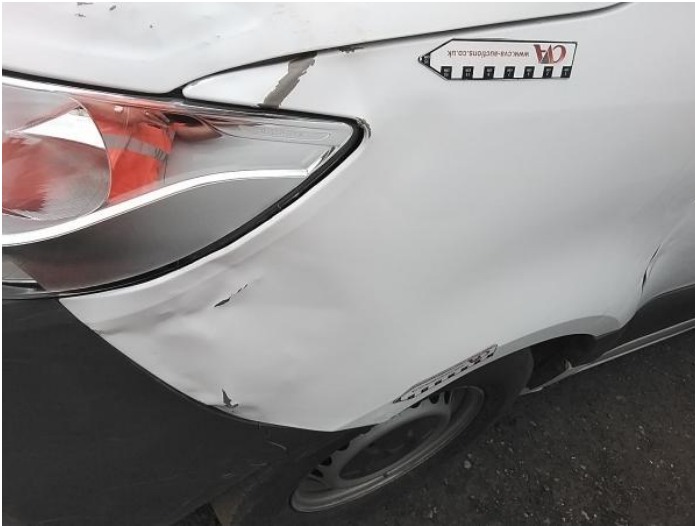
9: Wing nsf
Dented
With Paint Damage

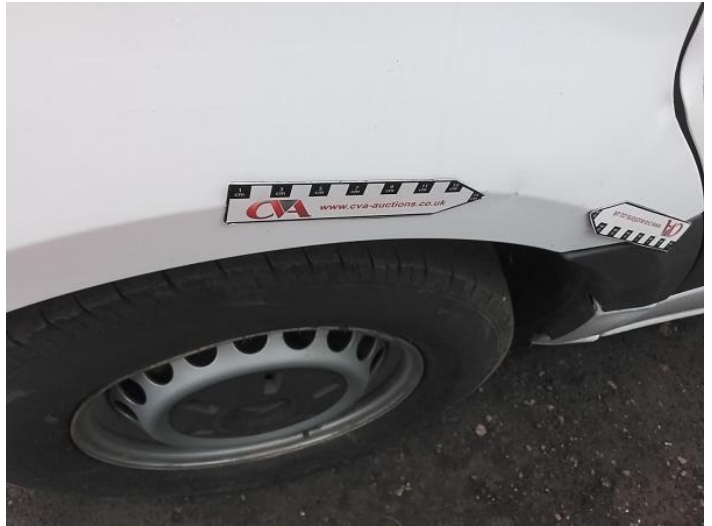
10: Wing nsf
Dented
Over 30mm

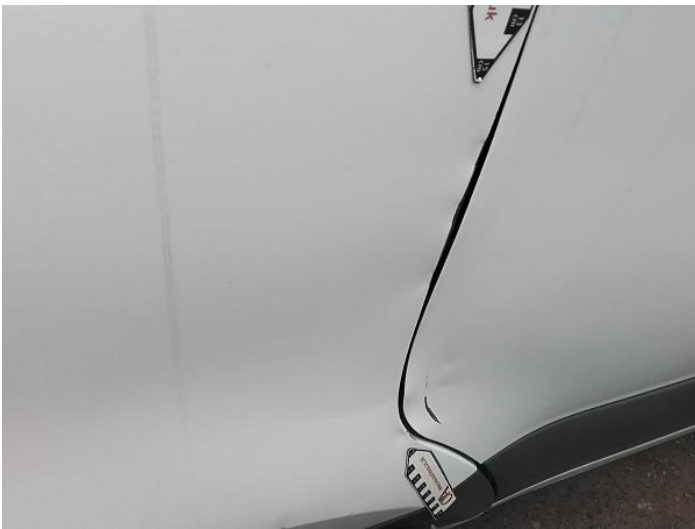
11: Wing nsf
Dented
With Paint Damage

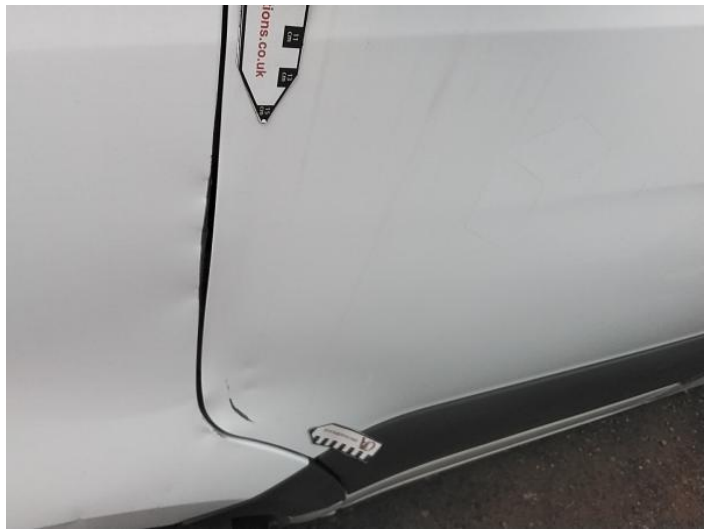
12: Door nsf
Dented
With Paint Damage

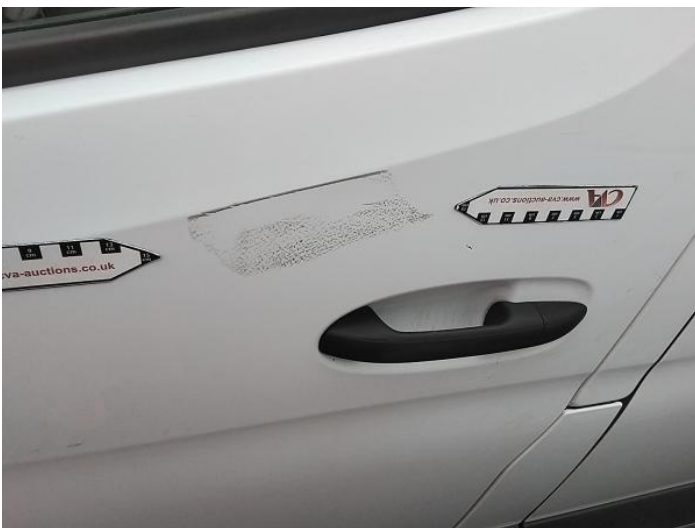
13: Door nsf
Dented
With Paint Damage

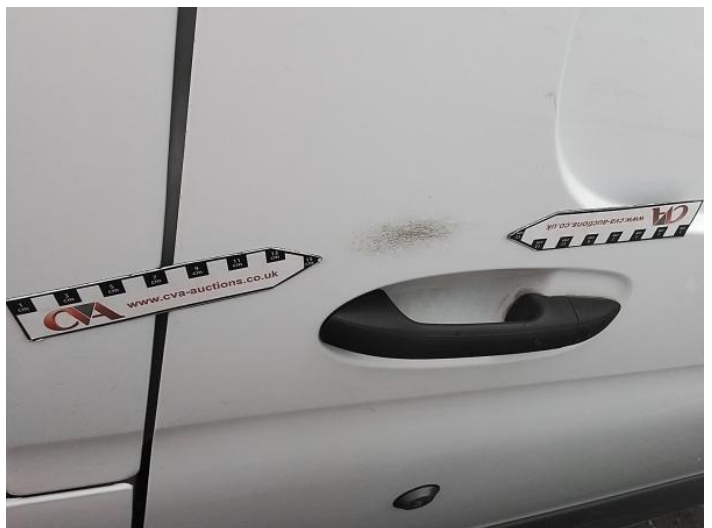
14: Qtr Panel nsr
Scratched
Over 25mm Thru Paint

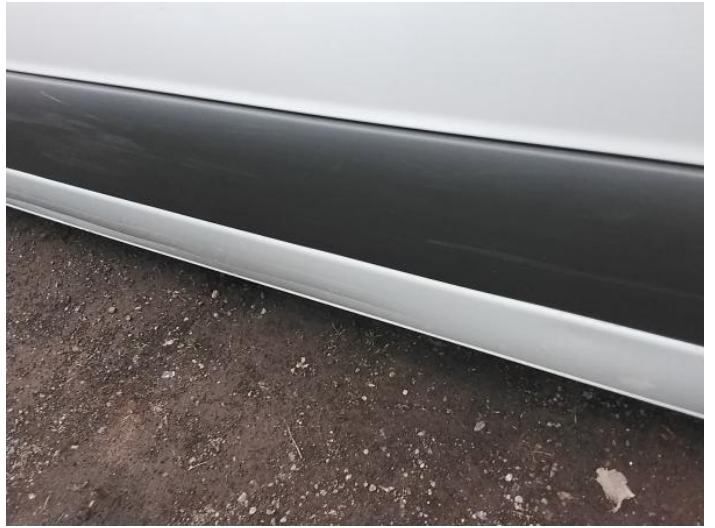
16: Qtr Panel Moulding ns
Scuffed (Unpainted)
Over 100mm

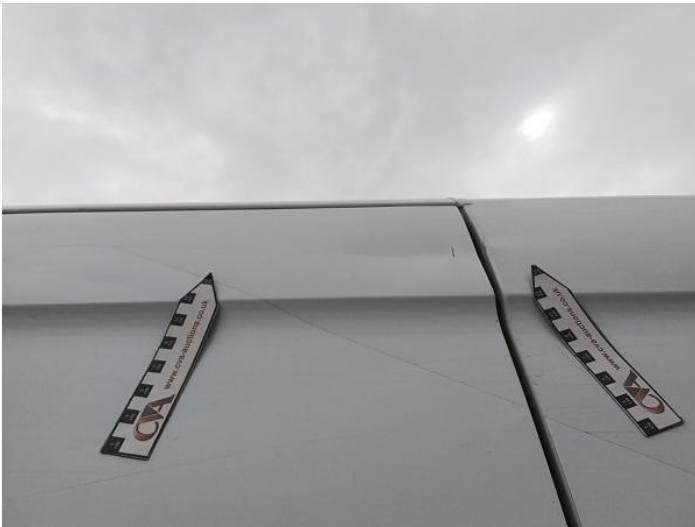
17: Qtr Panel nsr
Dented
With Paint Damage

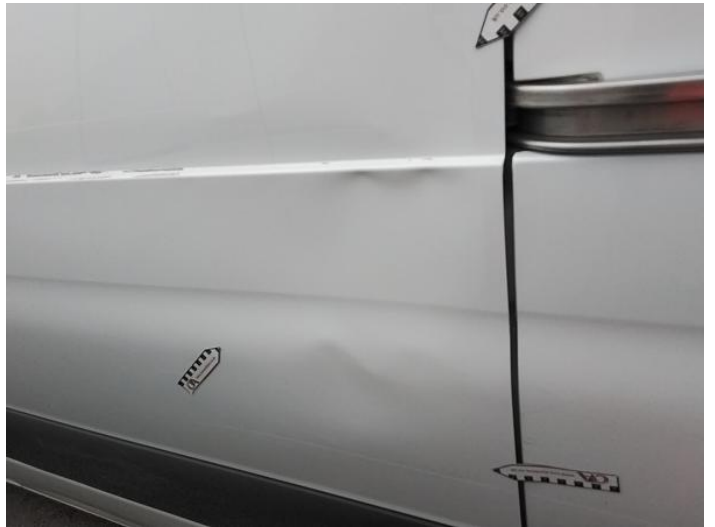
18: Qtr Panel nsr
Dented
Over 30mm

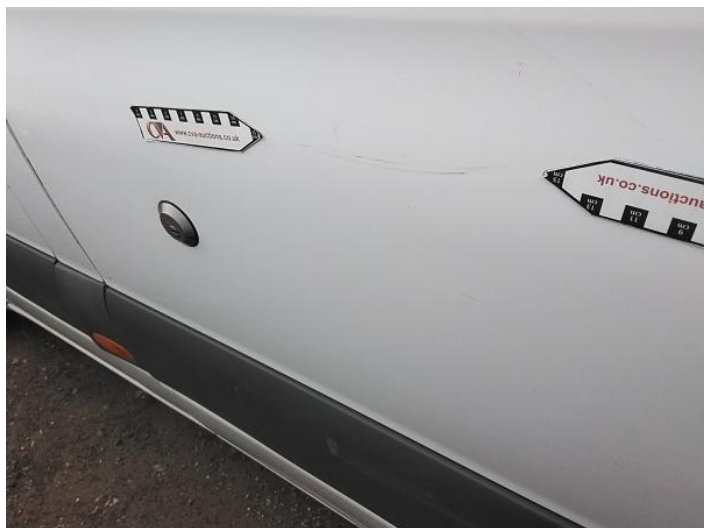
20: Qtr Panel nsr
Dented
With Paint Damage

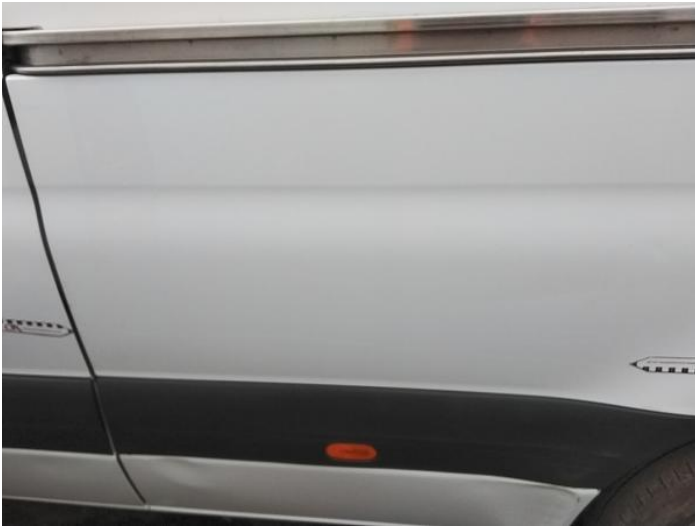
21: Qtr Panel nsr
Scratched
Over 25mm Thru Paint

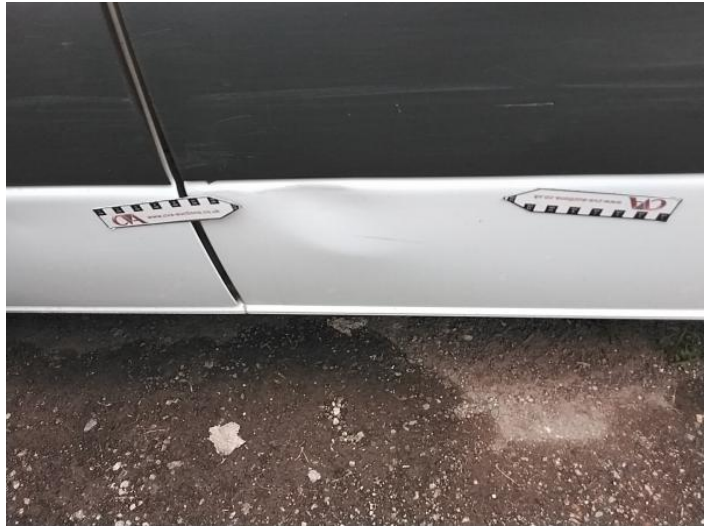
22: Qtr Panel nsr
Dented
Over 30mm

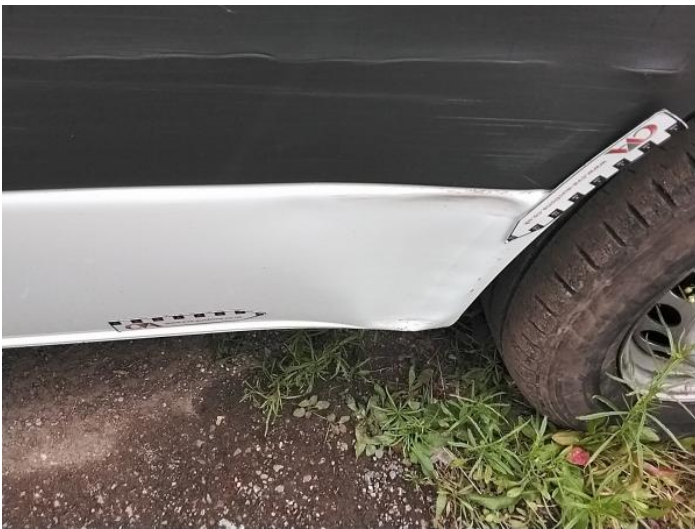
23: Qtr Panel nsr
Dented
With Paint Damage

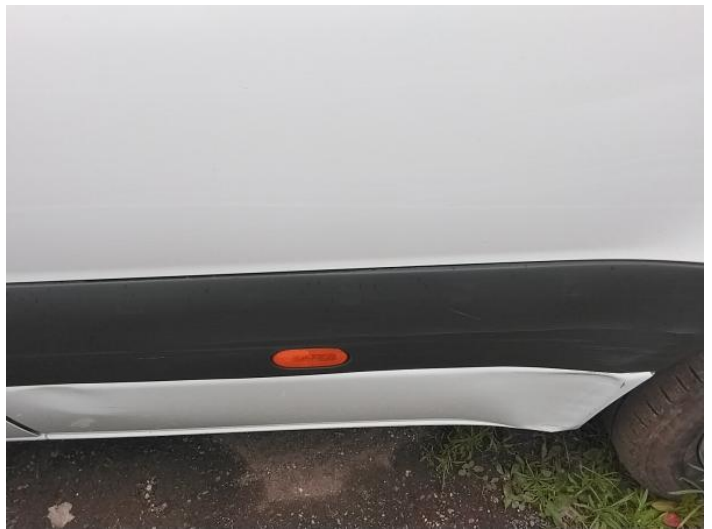
24: Qtr Panel Moulding ns
Scuffed (Unpainted)
Over 100mm

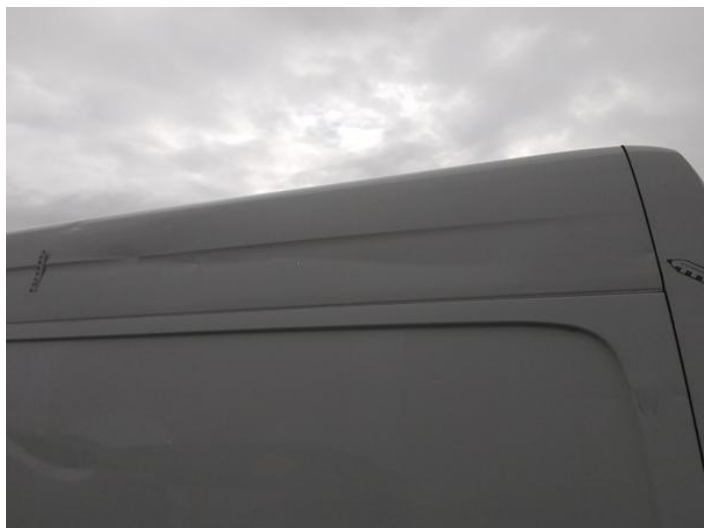
26: Qtr Panel nsr
Dented
With Paint Damage

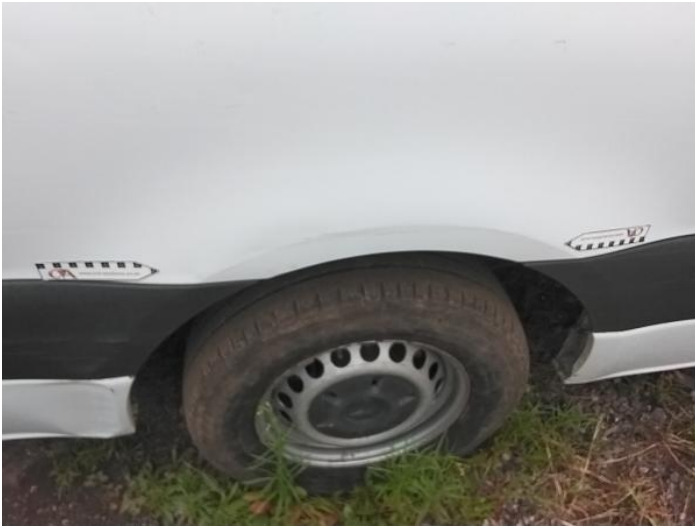
27: Qtr Panel nsr
Dented
With Paint Damage

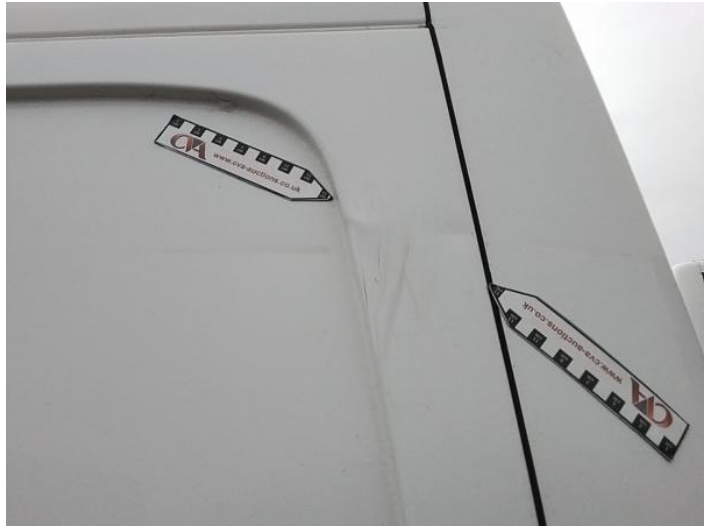
28: Qtr Panel nsr
Dented
Over 30mm

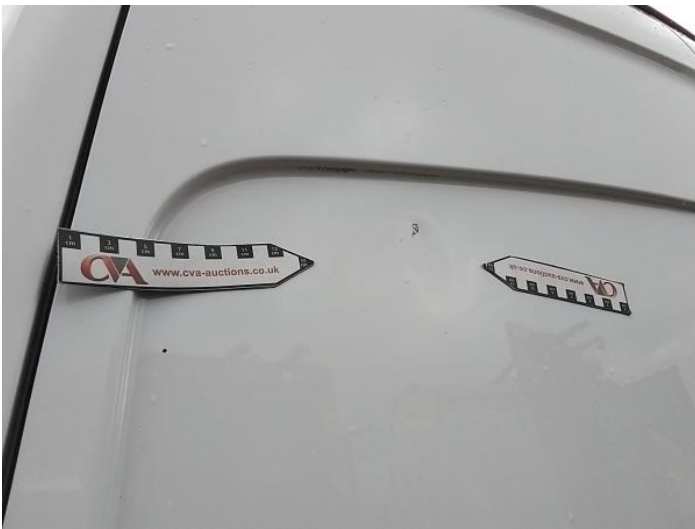
29: Door nsr
Dented
With Paint Damage

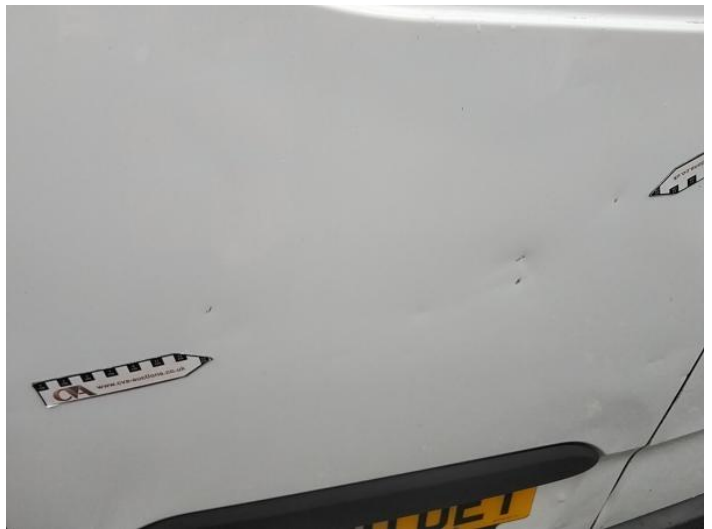
30: Door nsr
Dented
With Paint Damage

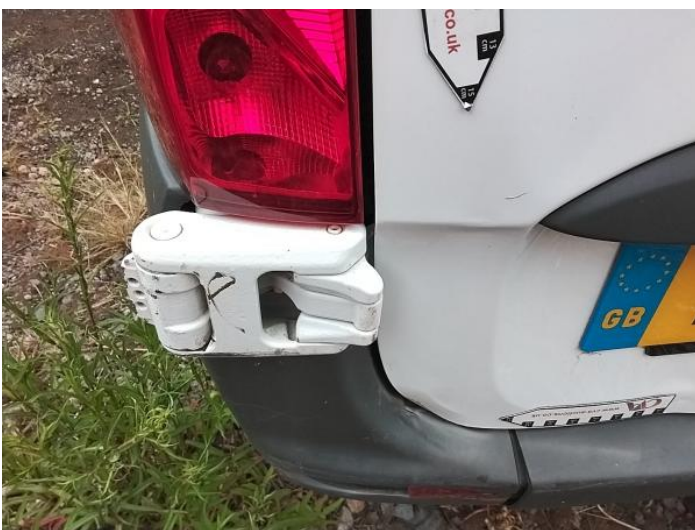
31: Door nsr
Dented
Over 30mm

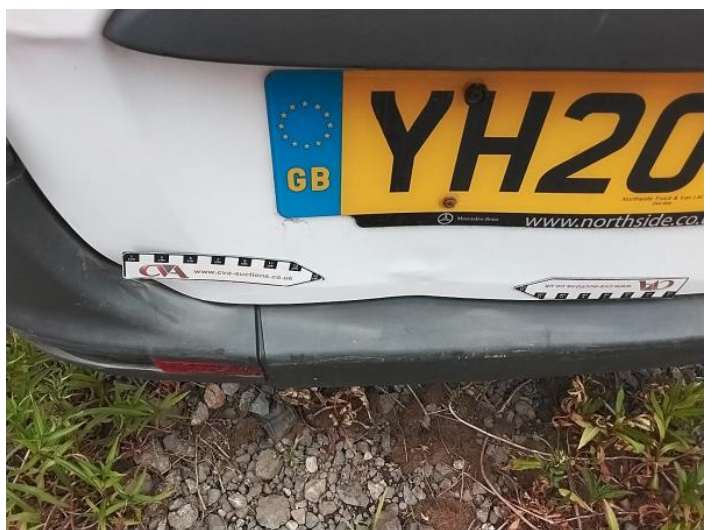
32: Door nsr
Dented
Over 30mm

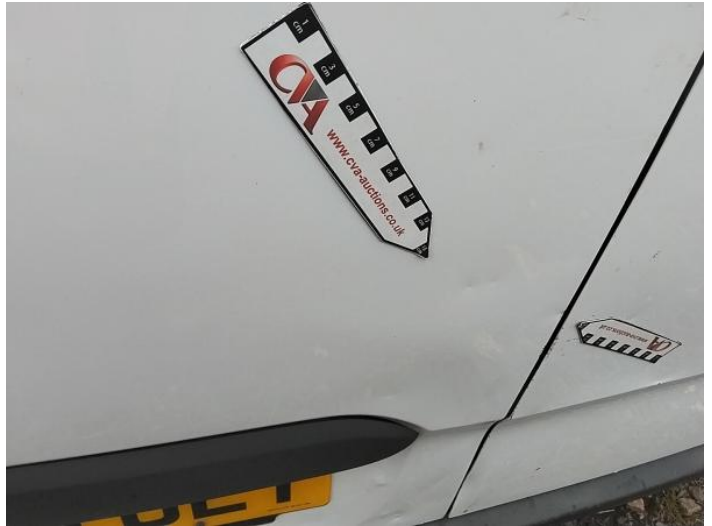
34: Door nsr
Dented
Over 30mm

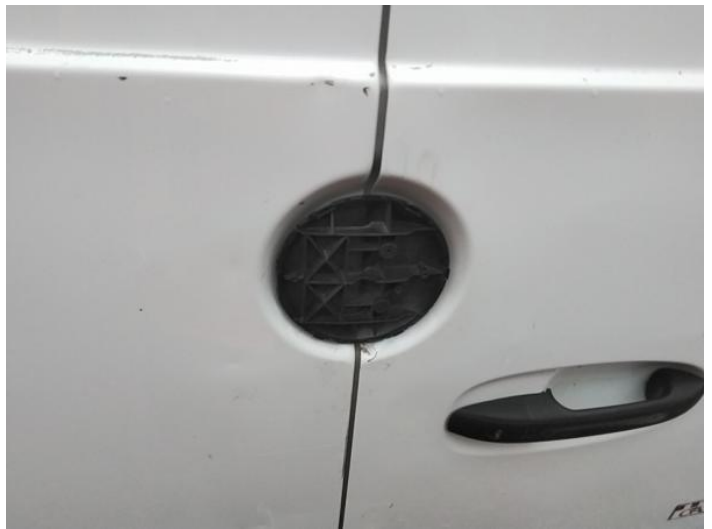
36: Badgedecal Rear
Broken
Replace

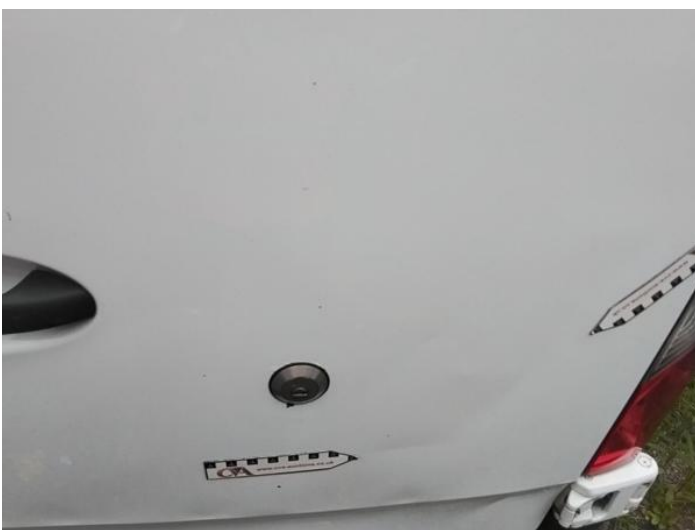
37: Door osr
Dented
Over 30mm

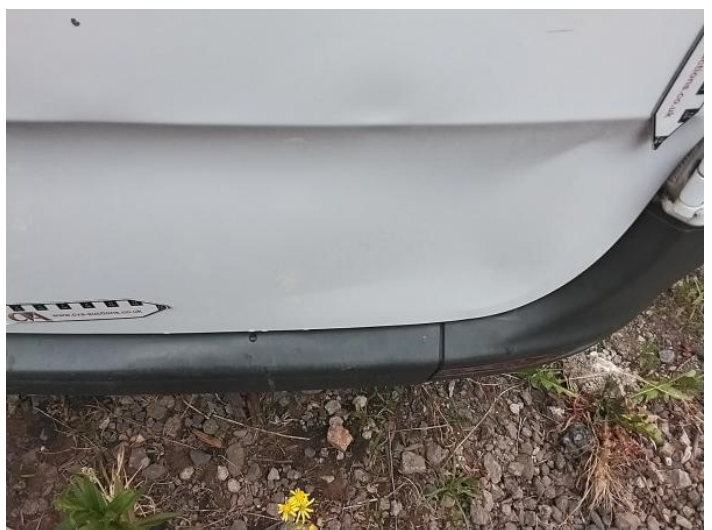
38: Door osr
Dented
Over 30mm

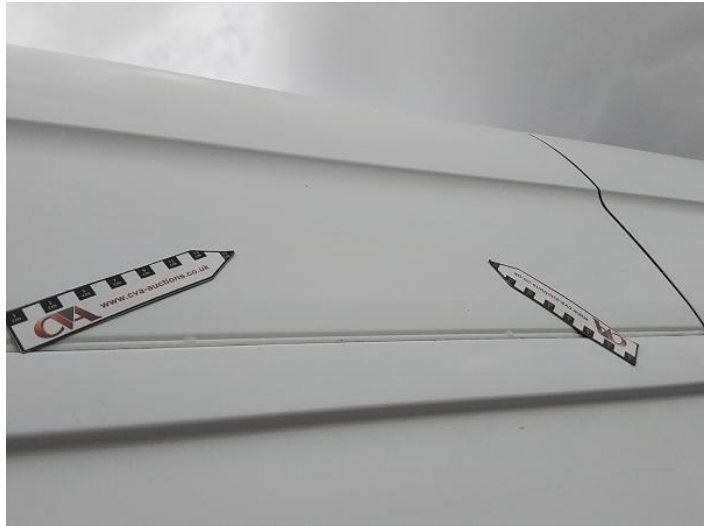
40: Qtr Panel osr
Dented
Over 30mm

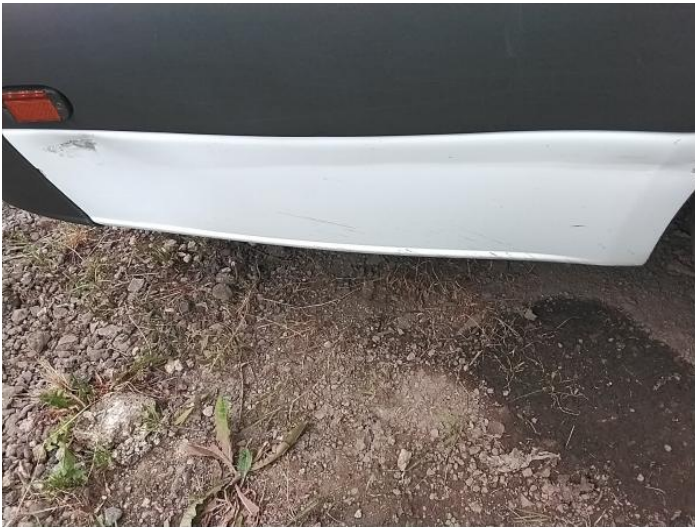
41: Qtr Panel osr
Dented
With Paint Damage

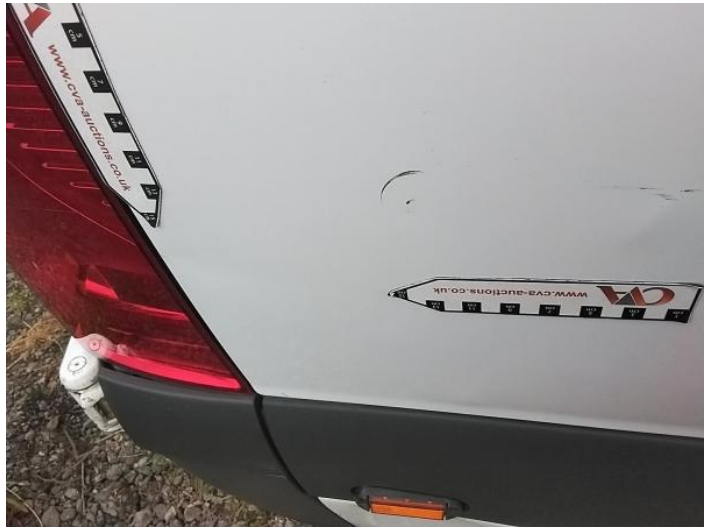
42: Qtr Panel osr
Dented
Over 30mm

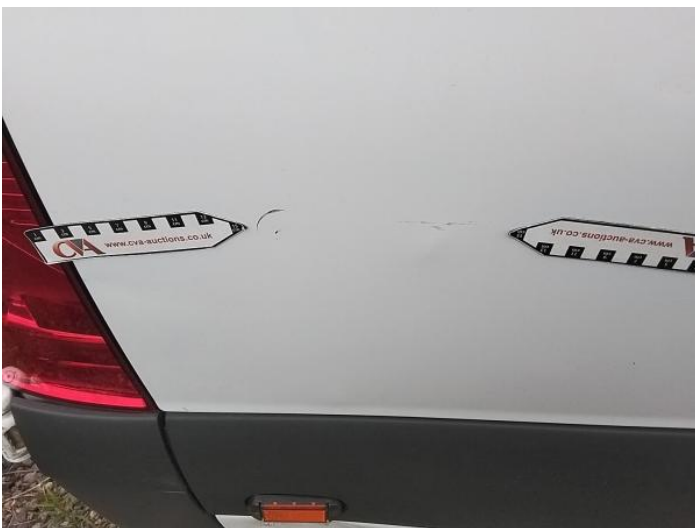
43: Qtr Panel osr
Dented
With Paint Damage

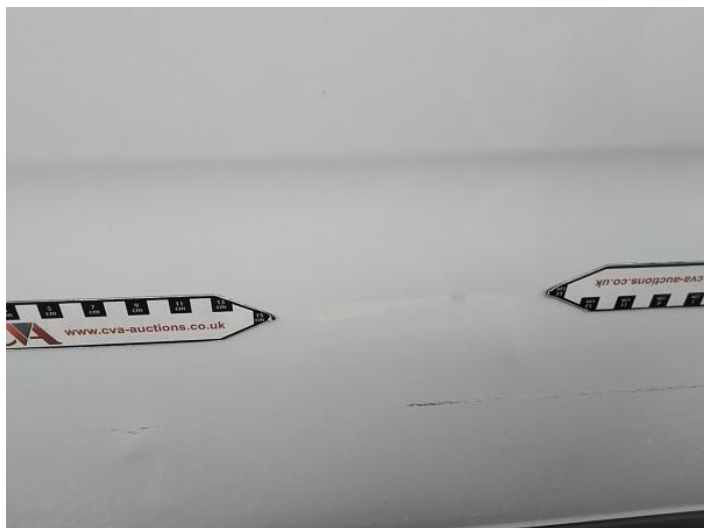
44: Qtr Panel osr
Dented
With Paint Damage

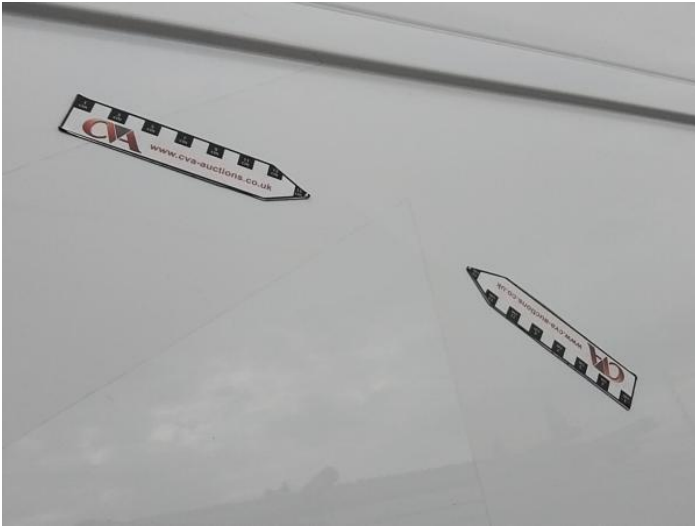
45: Qtr Panel osr
Dented
Over 30mm

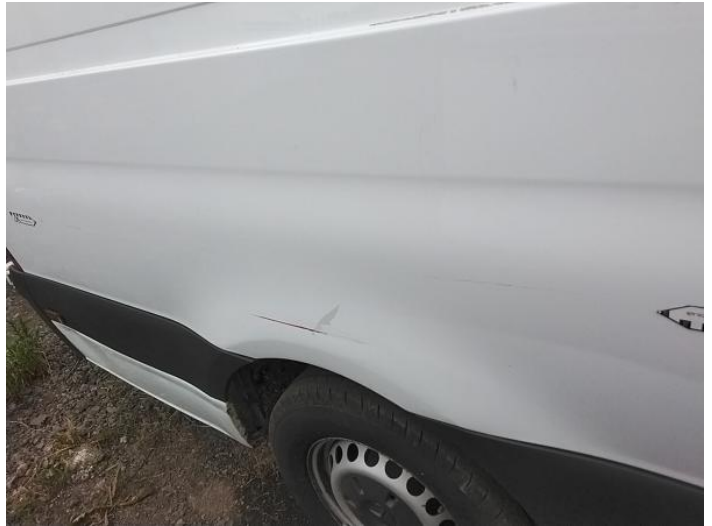
46: Qtr Panel osr
Scratched
Over 25mm Thru Paint

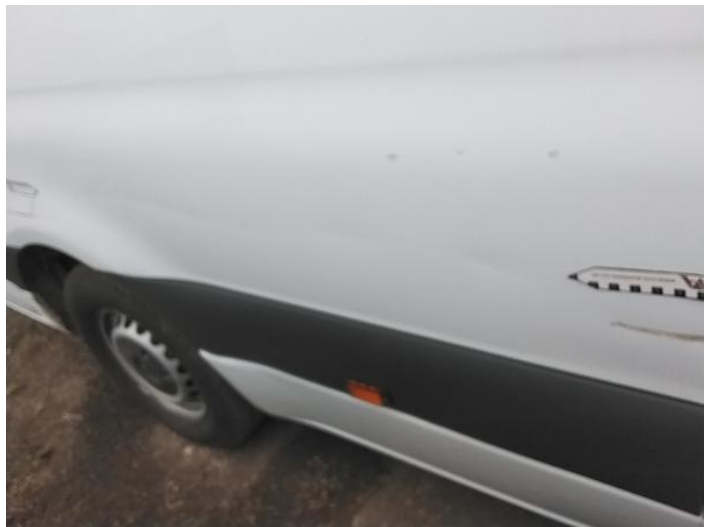
48: Qtr Panel osr
Dented
Over 30mm

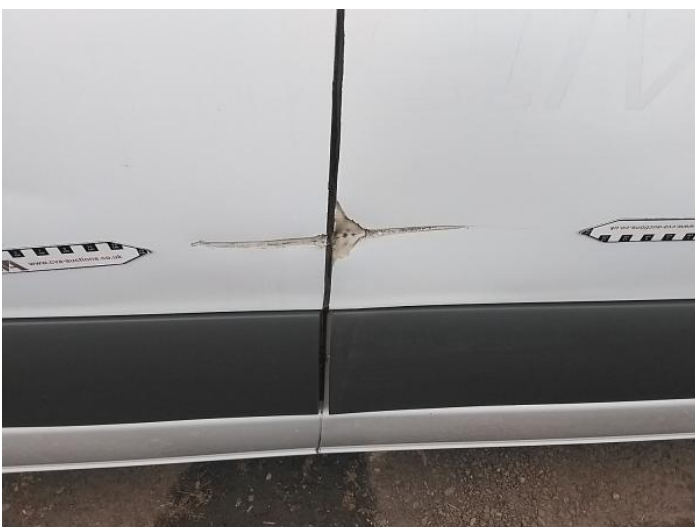
49: Qtr Panel osr
Dented
With Paint Damage

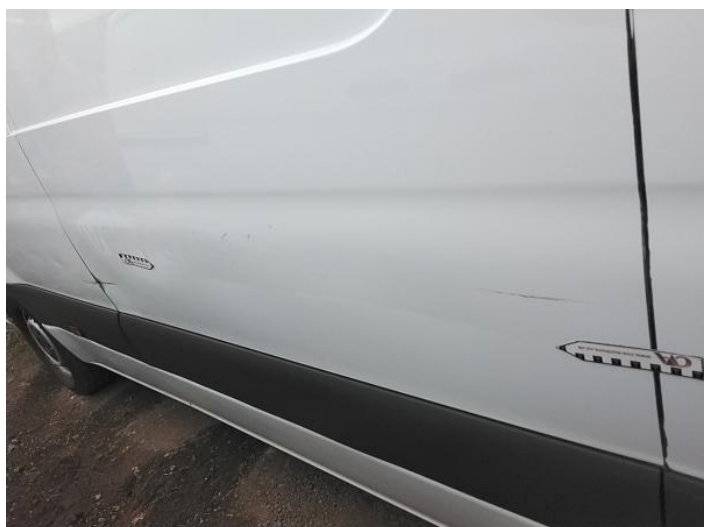
50: Qtr Panel osr
Dented
Over 30mm

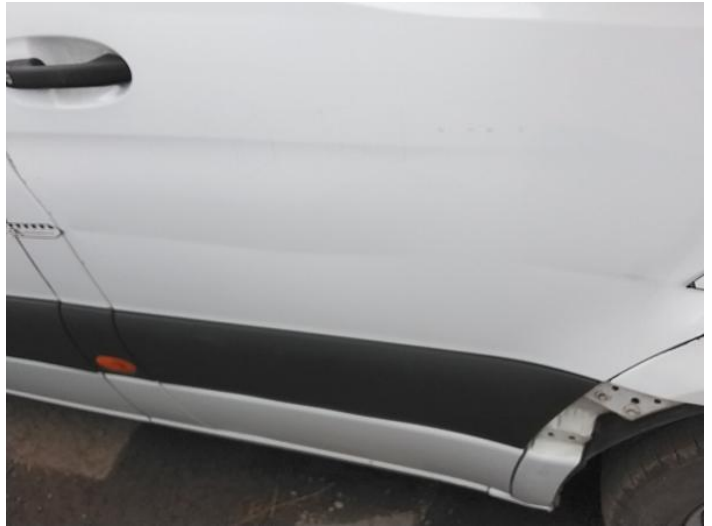
52: Door osf
Dented
Over 30mm

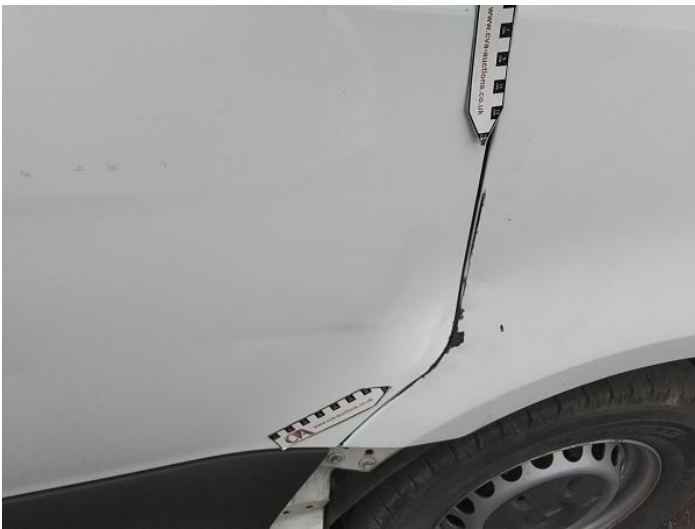
53: Door osf
Dented
With Paint Damage

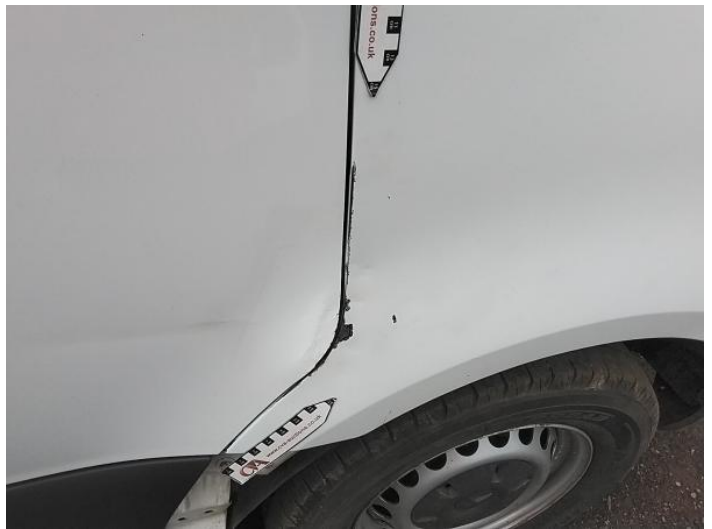
54: Wing osf
Dented
With Paint Damage

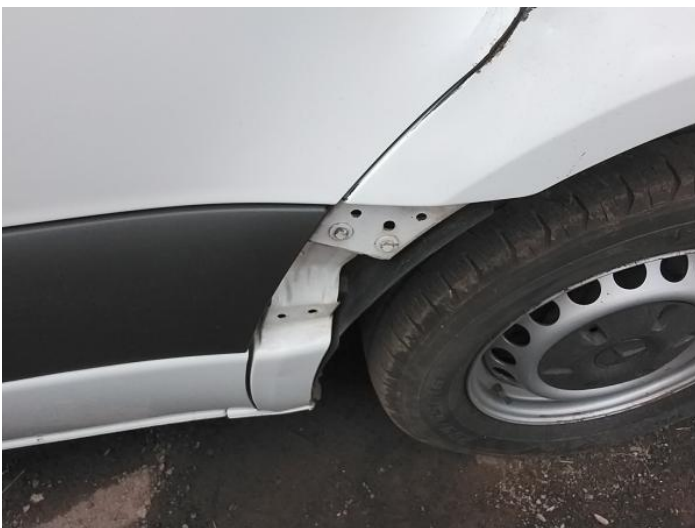
55: Door Moulding osf
Missing
Replace

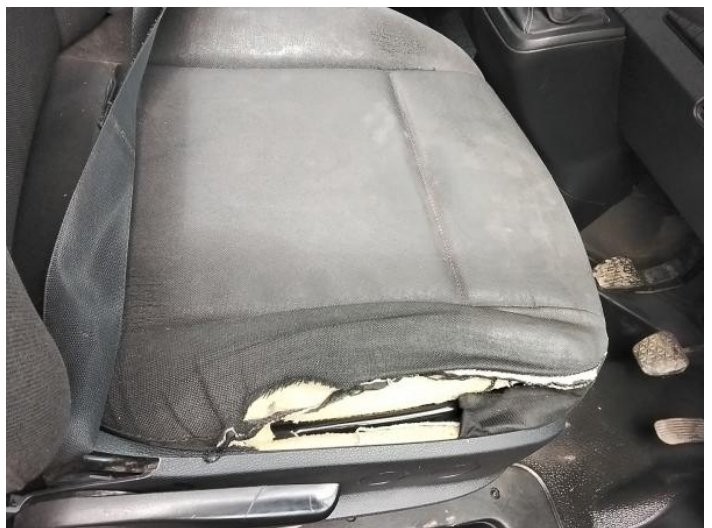
56: Seat Base Cover osf
Torn
Over 3mm

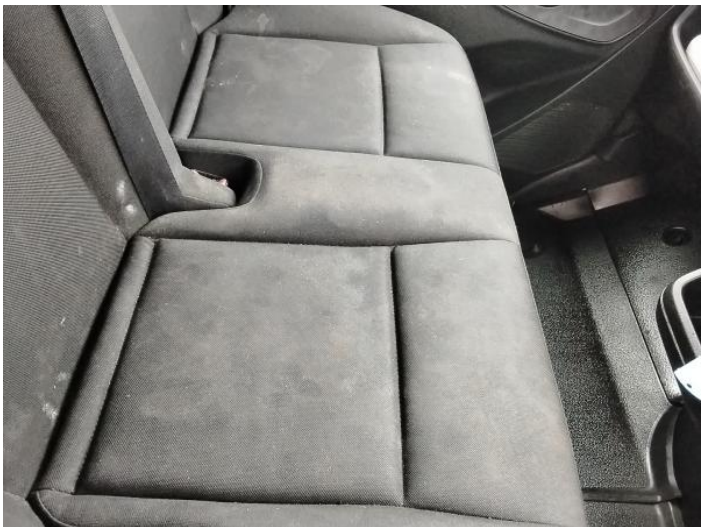
58: Seat Base Cover nsf
Soiled
Heavy

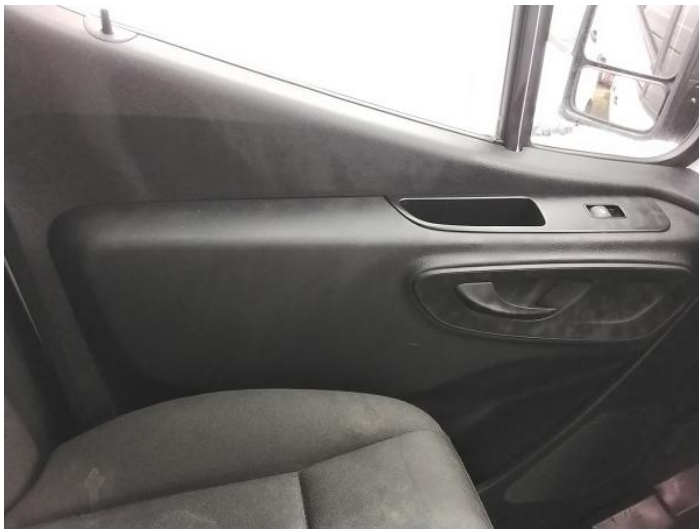
59: Door Pad nsf
Soiled
Heavy
