VEHICLE INSPECTION REPORT

YH20UEV

Mercedes-Benz Sprinter 314 CDI

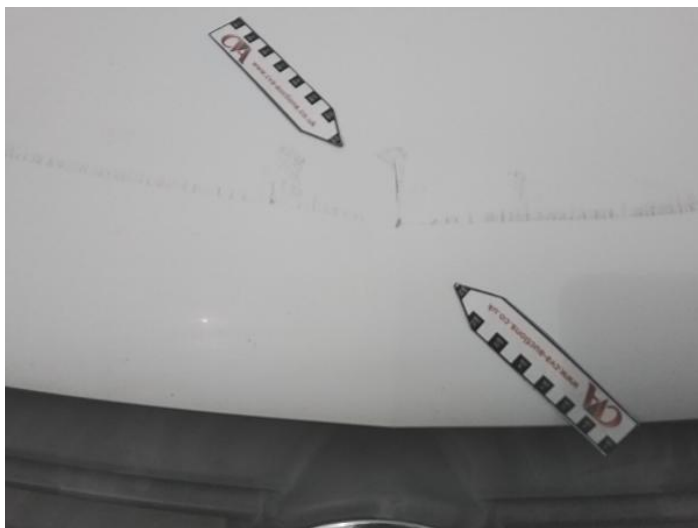
1: Bonnet
Dented
With Paint Damage

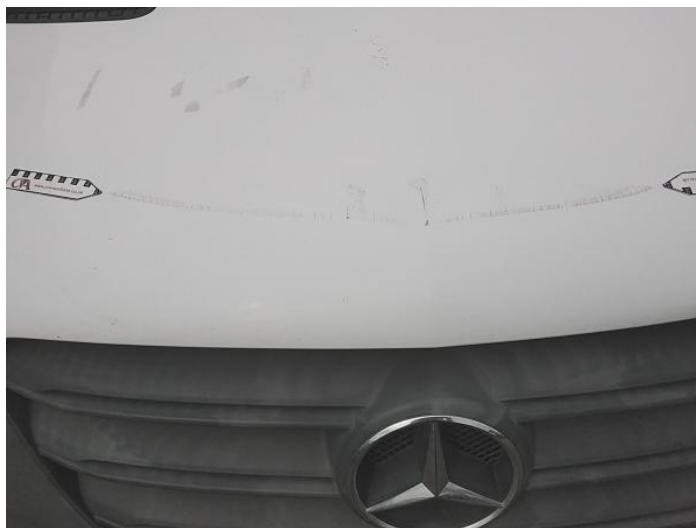
2: Bonnet
Scratched
Over 25mm Thru Paint

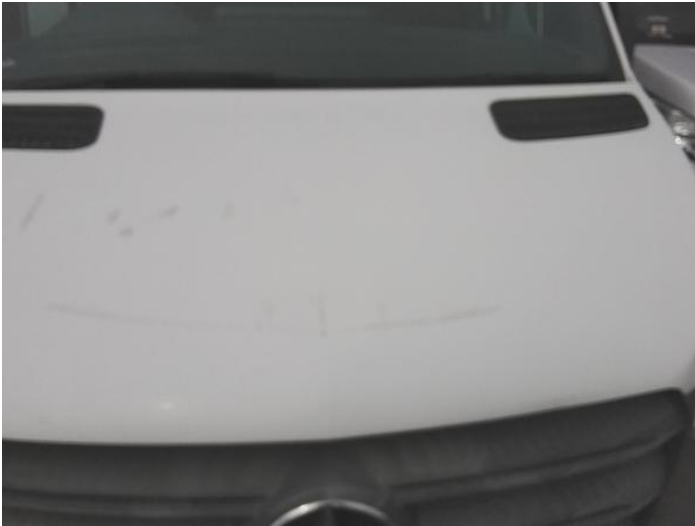
3: Bonnet
Chipped
Multiple Chips

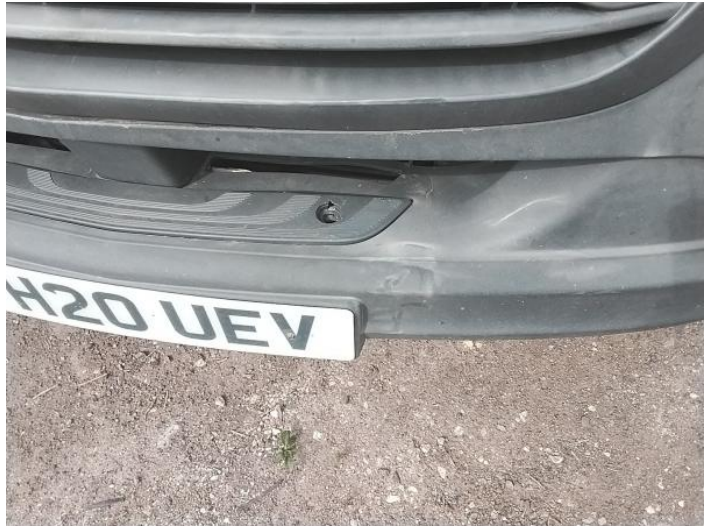
4: Bumper Front
Dented
Over 30mm

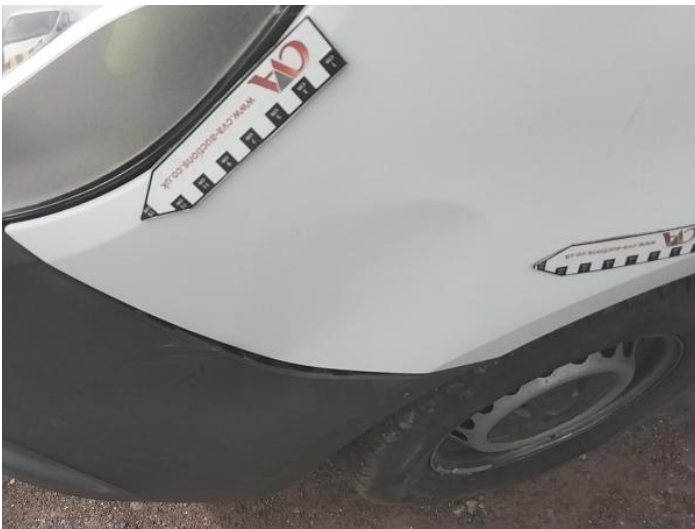
5: Wing nsf
Dented
Over 30mm

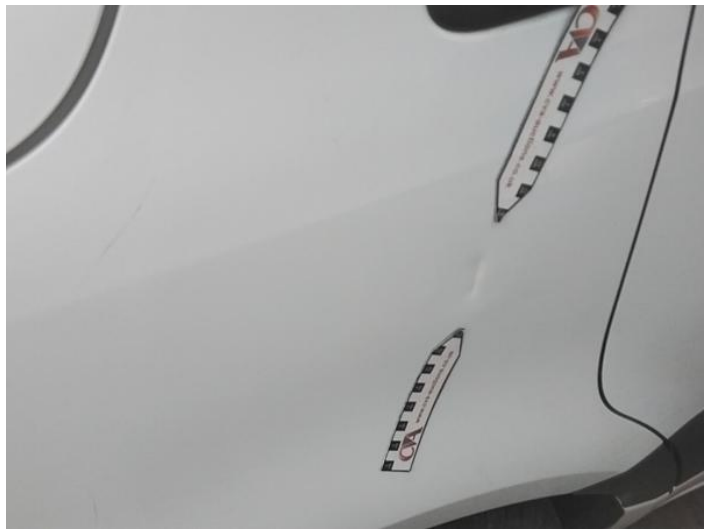
6: Wing nsf
Dented
Over 30mm

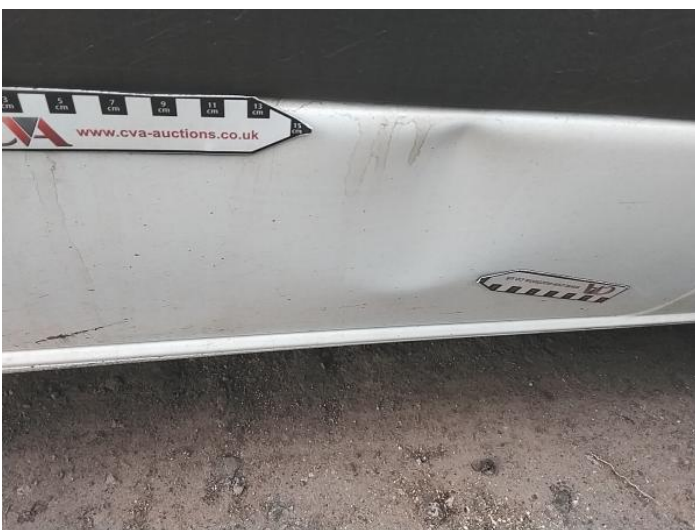
7: Door nsf
Dented
Over 30mm

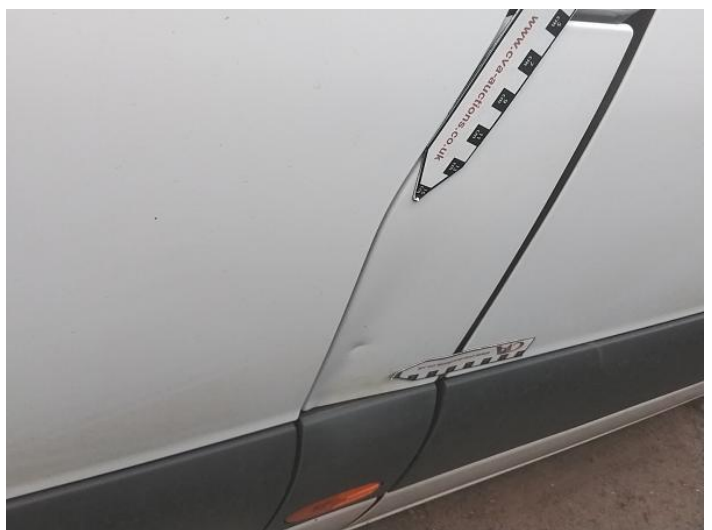
8: Fuel Flap
Dented
Over 30mm

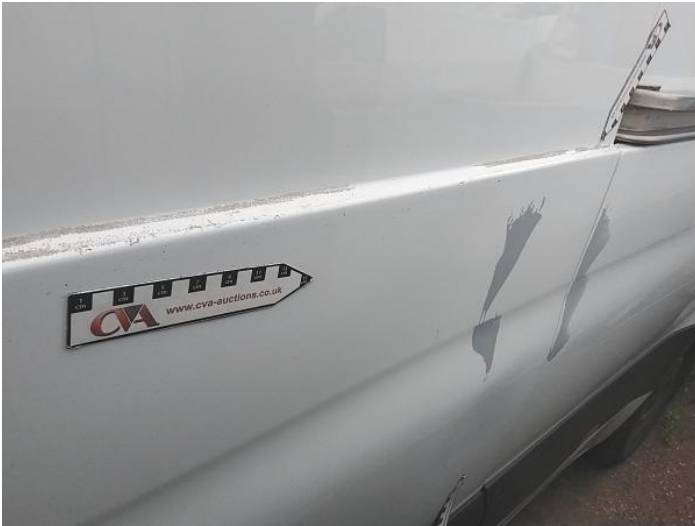
9: Qtr Panel nsr
Dented
With Paint Damage

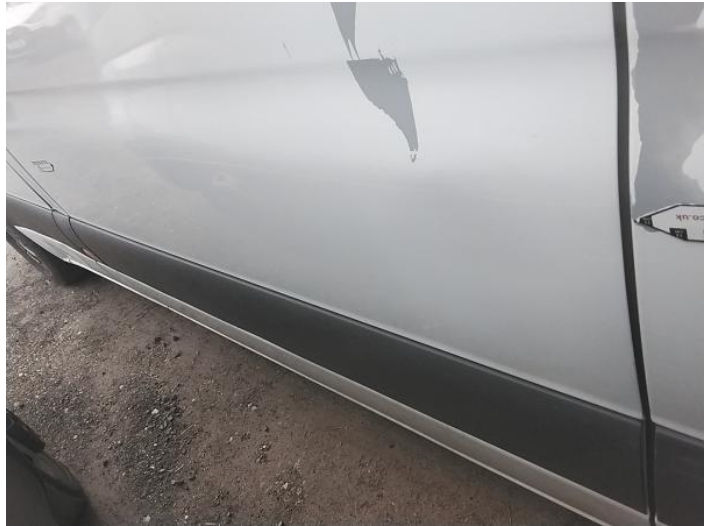
10: Qtr Panel nsr
Scratched
Over 25mm Thru Paint

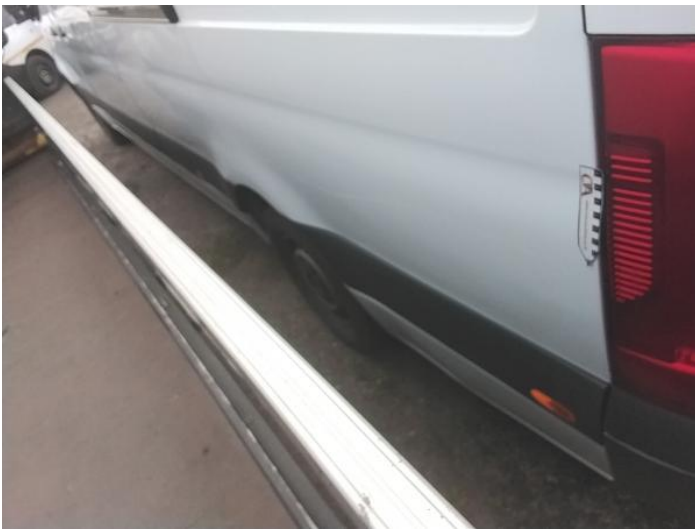
11: Qtr Panel nsr
Scratched
Over 25mm Thru Paint

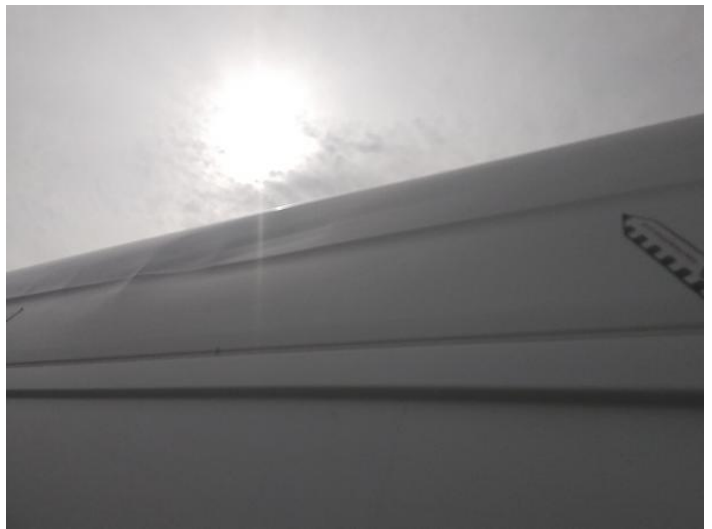
12: Qtr Panel nsr
Dented
Over 30mm

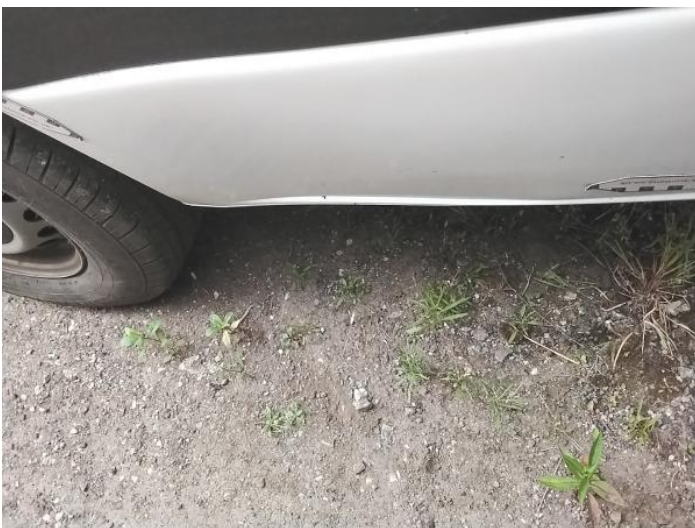
13: Qtr Panel nsr
Dented
Over 30mm

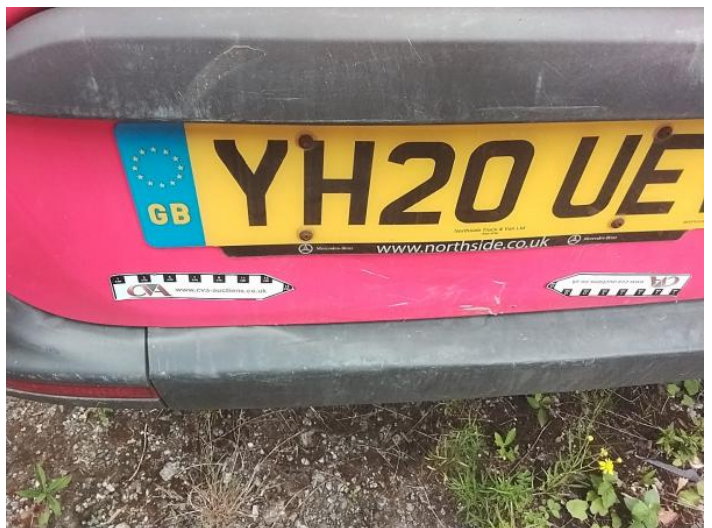
14: Door nsr
Dented
With Paint Damage

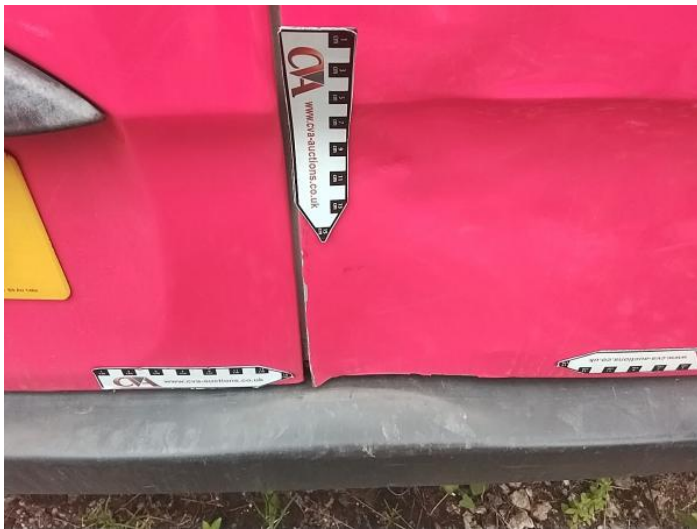
15: Door osr
Dented
With Paint Damage

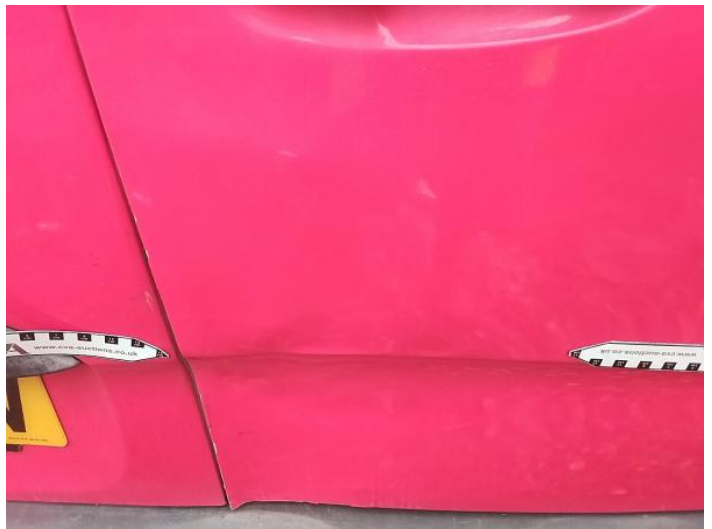
16: Door osr
Dented
Over 30mm

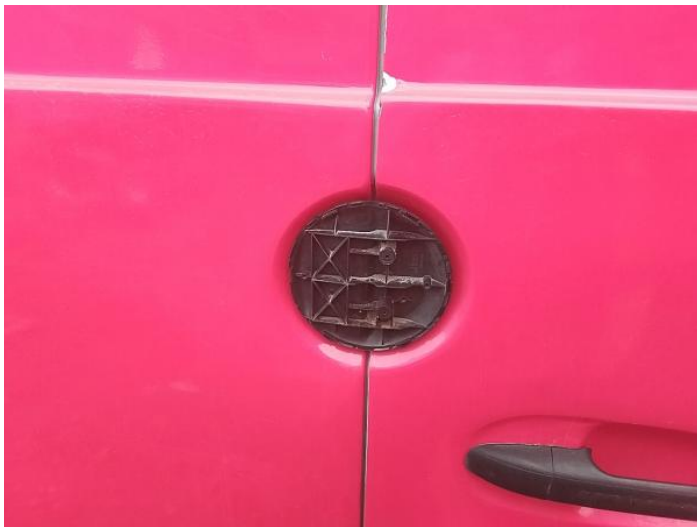
17: Badgedecal Rear
Broken
Replace

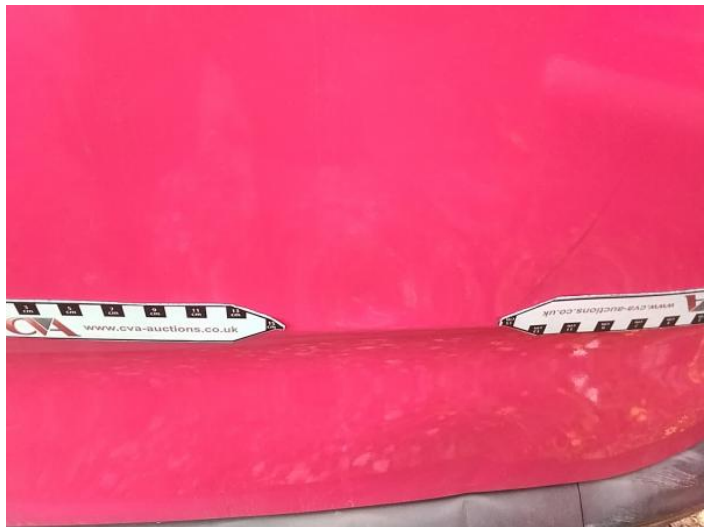
18: Door osr
Dented
Over 30mm

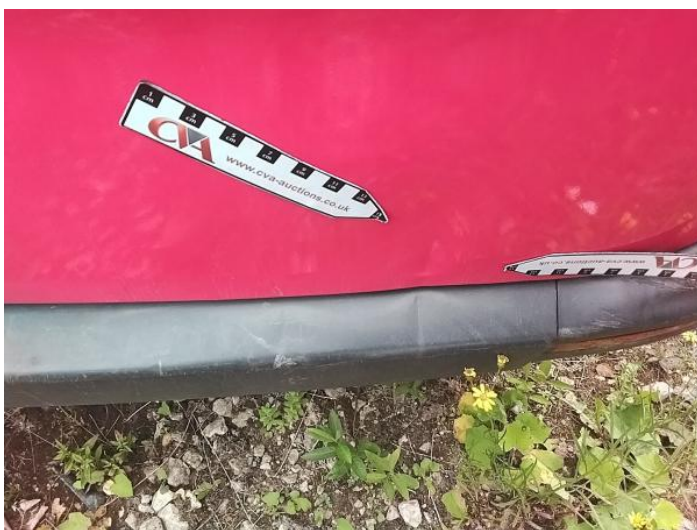
19: Door osr
Dented
Over 30mm

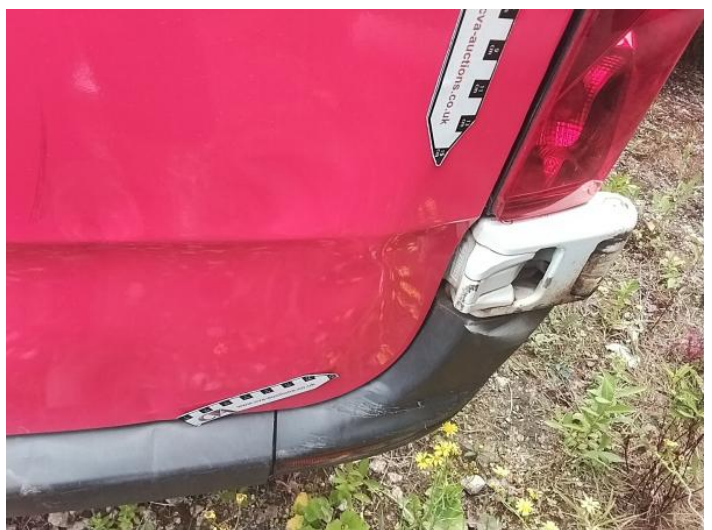
20: Door osr
Dented
Over 30mm

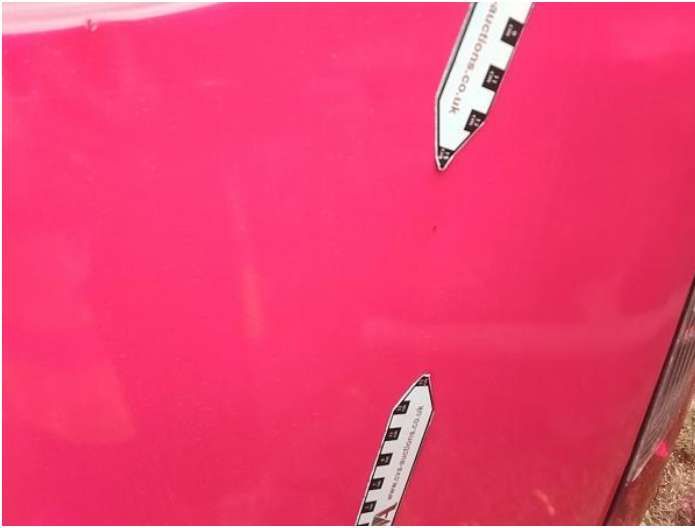
21: Door osr
Dented
Over 30mm

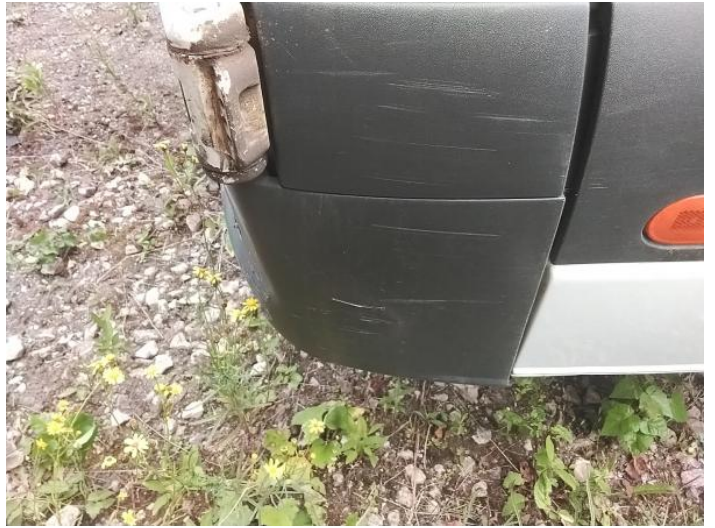
22: Bumper Rear
Scratched
Over 100mm Thru Paint

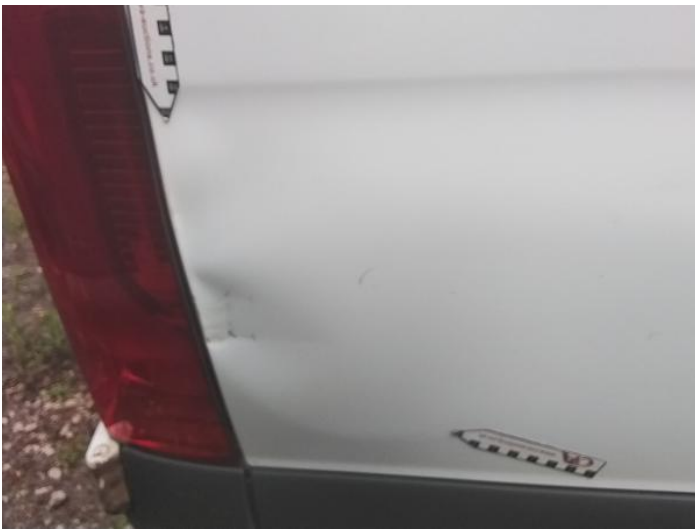
23: Qtr Panel osr
Dented
With Paint Damage

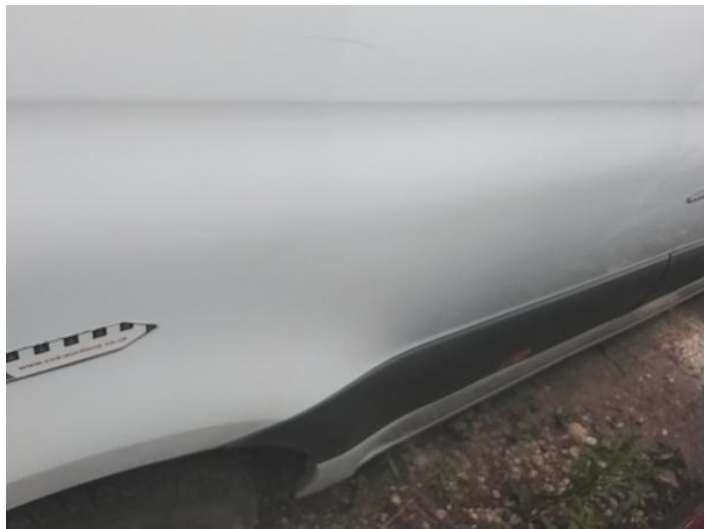
24: Qtr Panel osr
Scratched
Over 25mm Thru Paint

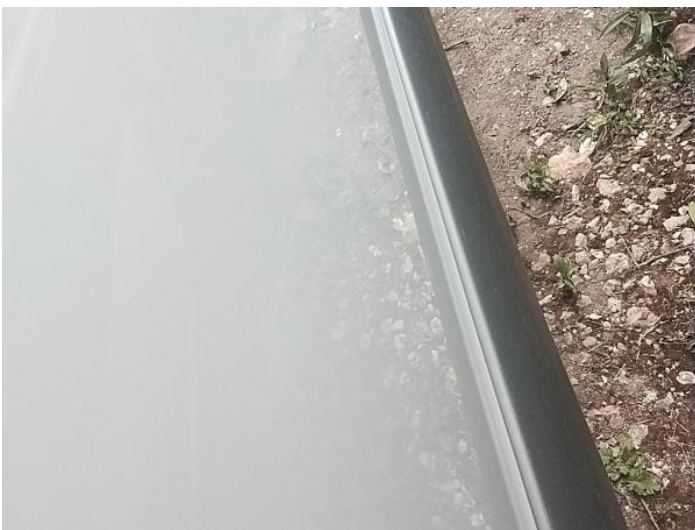
25: Qtr Panel Moulding os
Scuffed (Unpainted)
Over 100mm

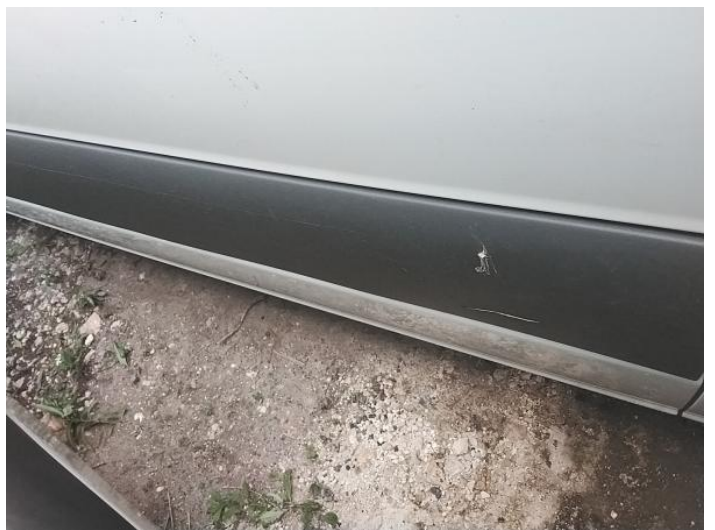
26: Qtr Panel Moulding os
Scuffed (Unpainted)
Over 100mm

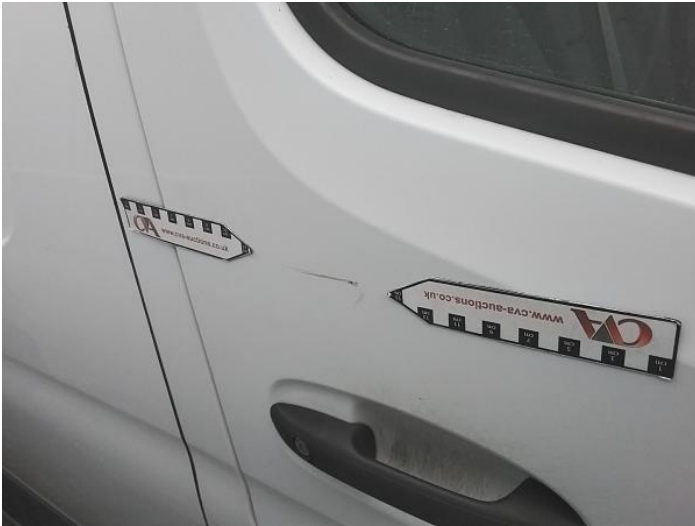
27: Door osf
Scratched
Over 25mm Thru Paint

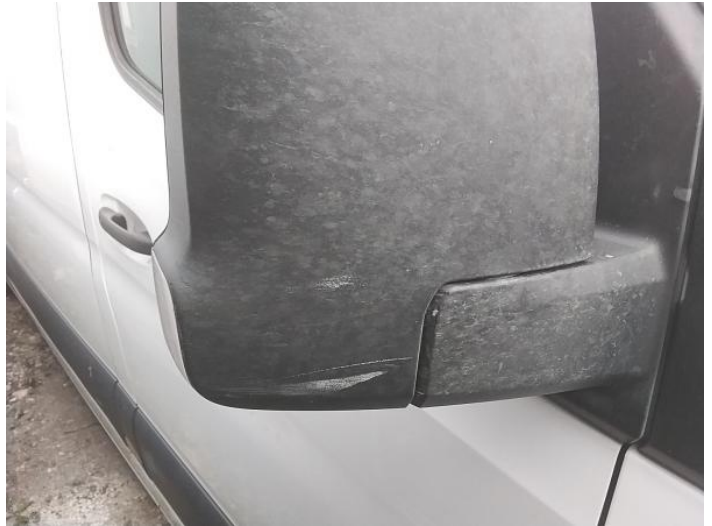
28: Door Mirror Assy osf
Scuffed (Unpainted)
UpTo 100mm

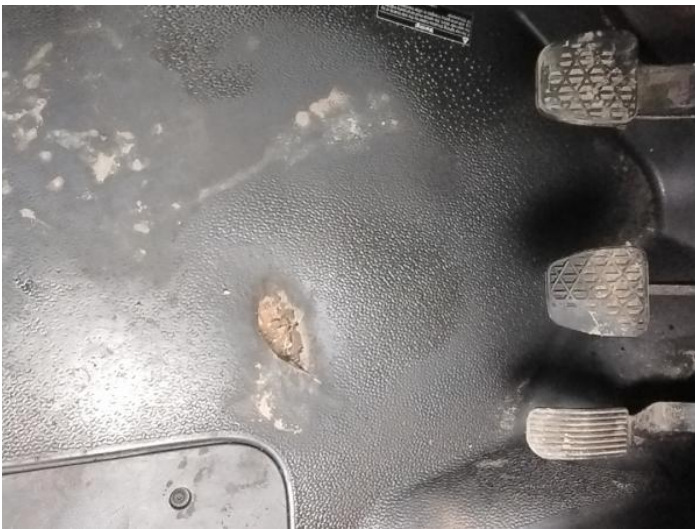
29: Carpets Front
Holed
Over 3mm

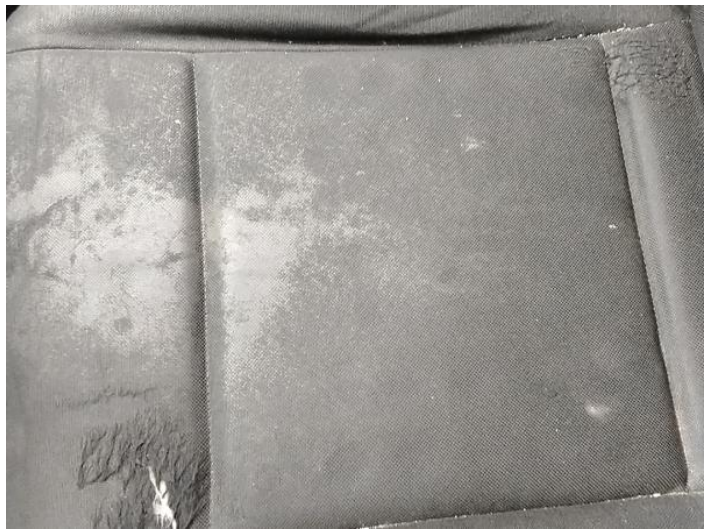
30: Seat Base Cover osf
Torn
Over 3mm

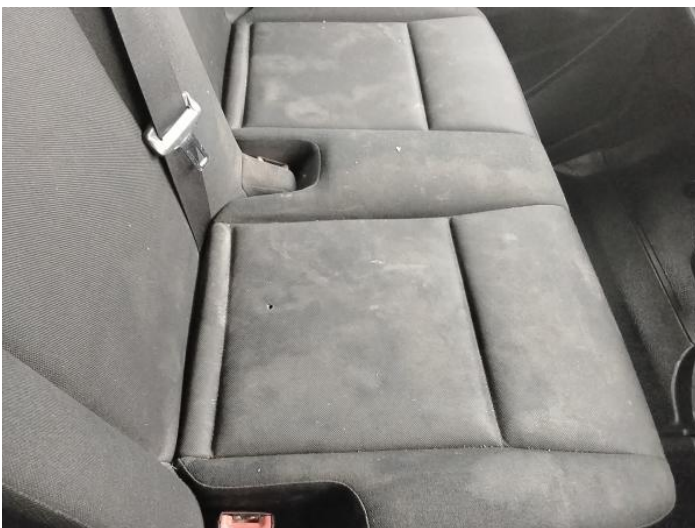
31: Seat Base Cover nsf
Holed
Over 3mm

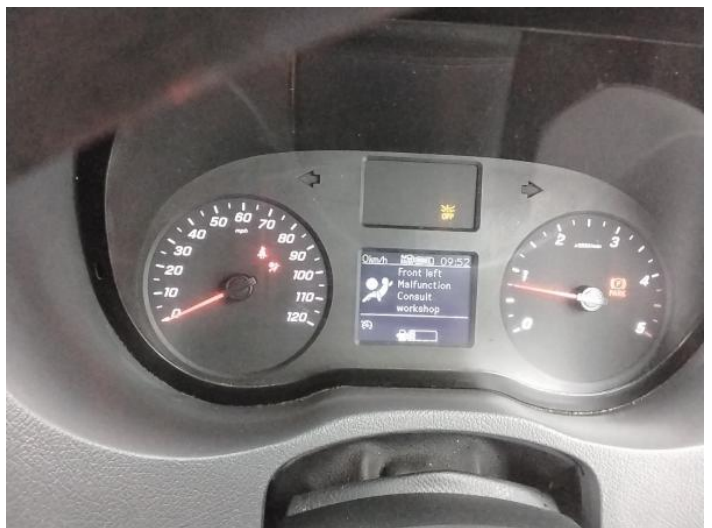
32: Dash Warning Lights
Displayed
No Action

Carpet Condition	Poor	Upholstery Condition	OK
Seat Condition	Poor	Odour	No
Engine Runs	OK	No Excessive Smoking	OK
EML light illuminated	OK	DPF light illuminated	OK
Airbag light illuminated	Fault		
ABS light illuminated	OK
