VEHICLE INSPECTION REPORT

YK70EFW

Mercedes-Benz Sprinter 315 3.5 PROGRESSIVE

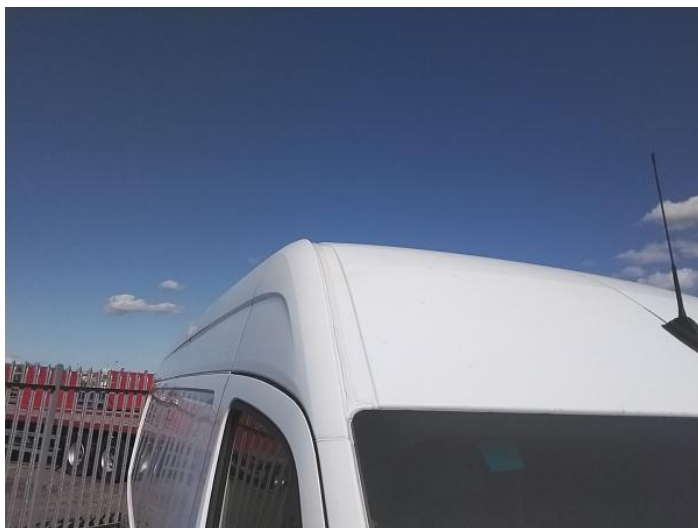
1: Roof
Dented
Over 30mm

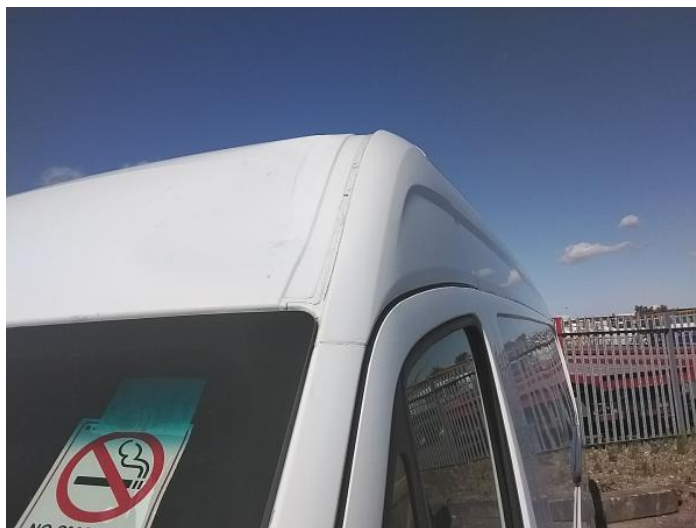
2: Roof
Dented
With Paint Damage

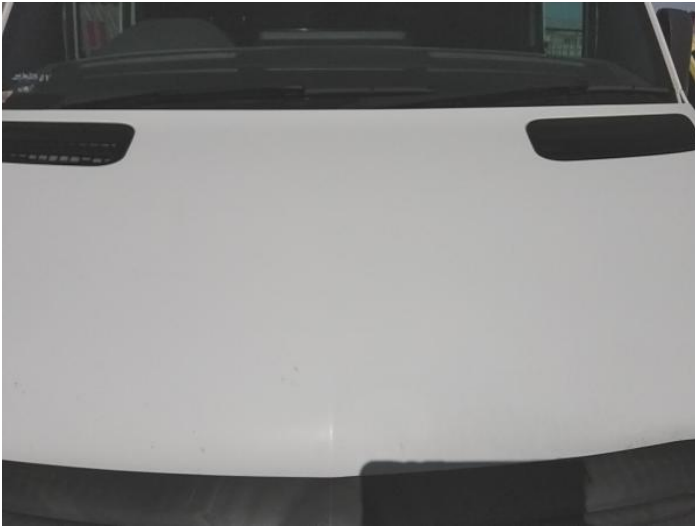
3: Bonnet
Chipped
Multiple Chips

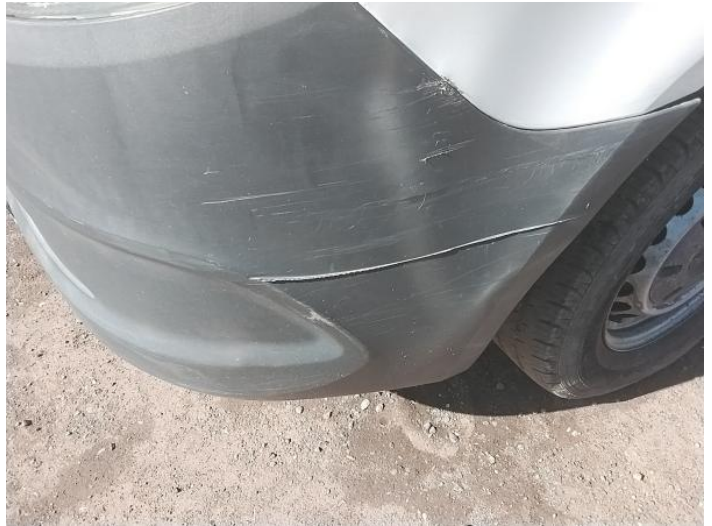
4: Bumper Front
Scratched
Over 100mm Thru Paint

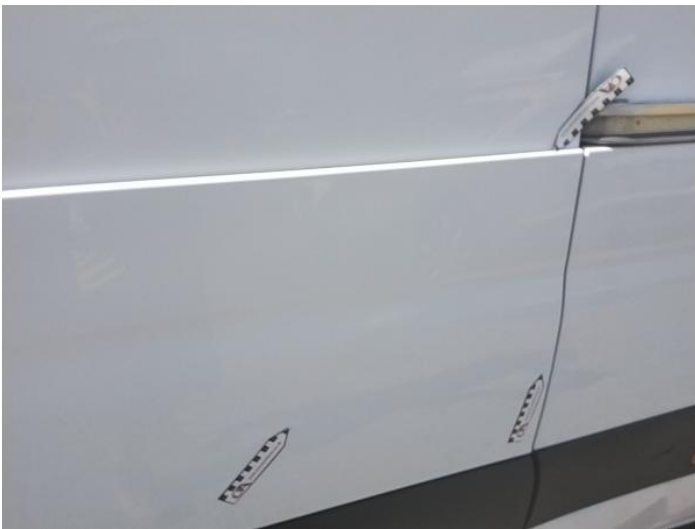
5: Qtr Panel nsr
Dented
Over 30mm

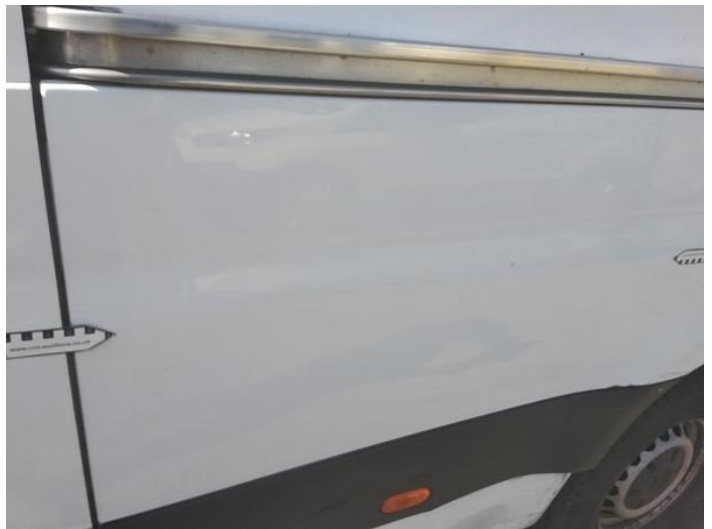
6: Qtr Panel nsr
Dented
With Paint Damage

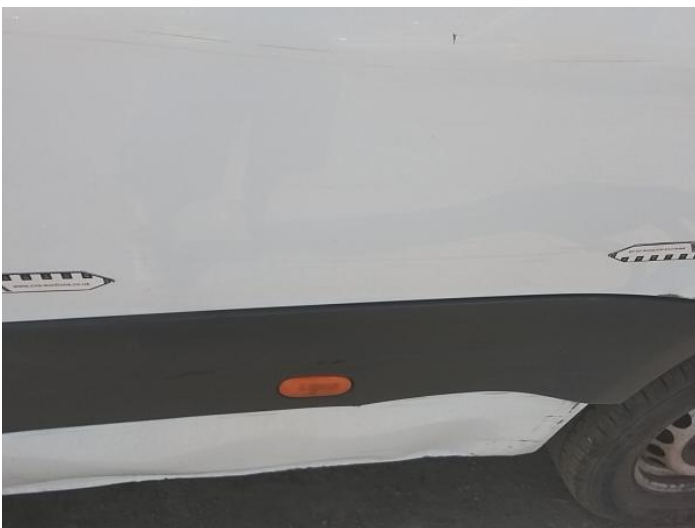
7: Qtr Panel nsr
Dented
With Paint Damage

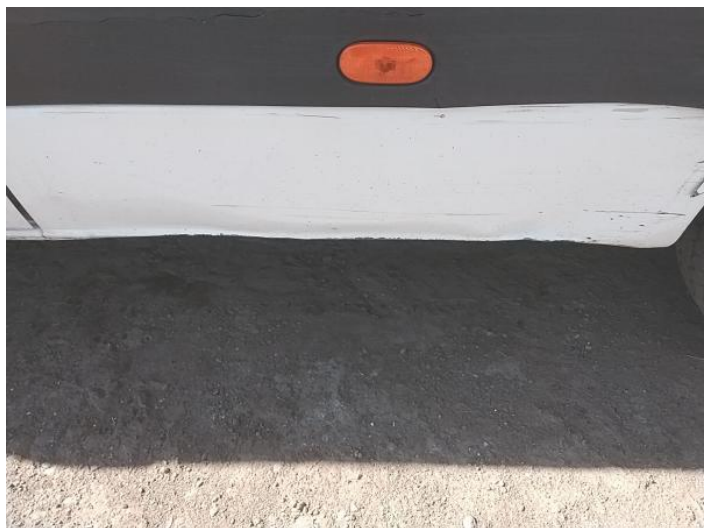
8: Qtr Panel nsr
Dented
With Paint Damage

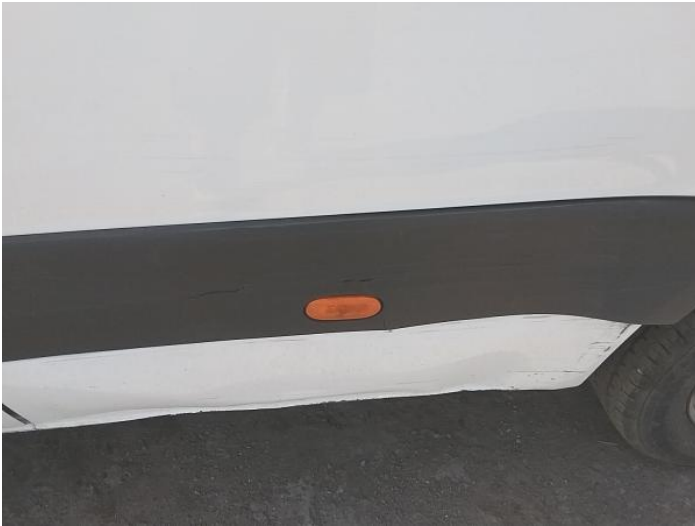
9: Qtr Panel Moulding ns
Broken
Replace

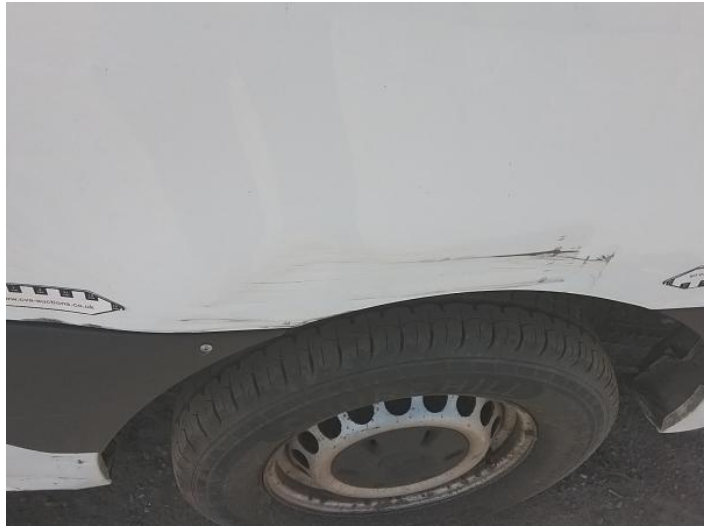
10: Qtr Panel nsr
Dented
With Paint Damage

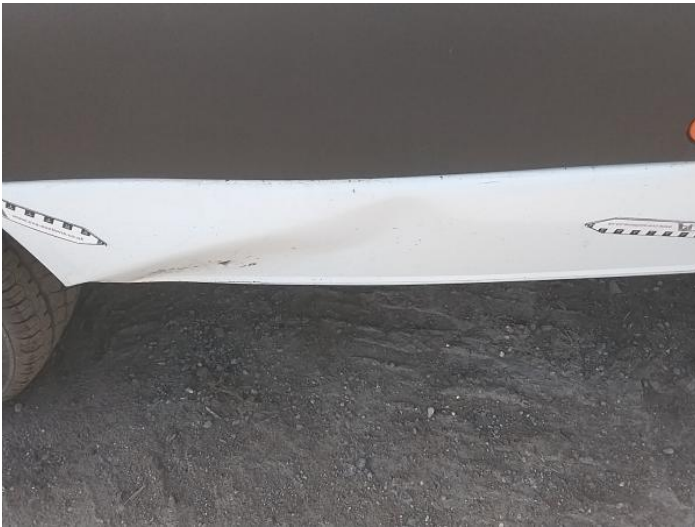
11: Qtr Panel nsr
Dented
With Paint Damage

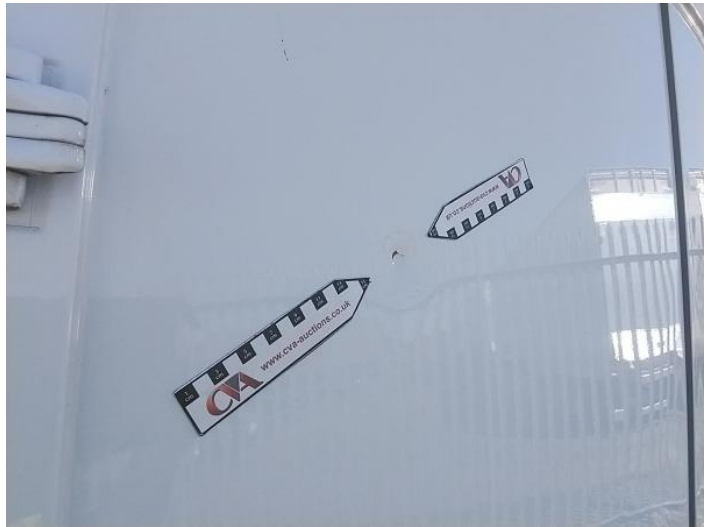
12: Door nsr
Dented
With Paint Damage

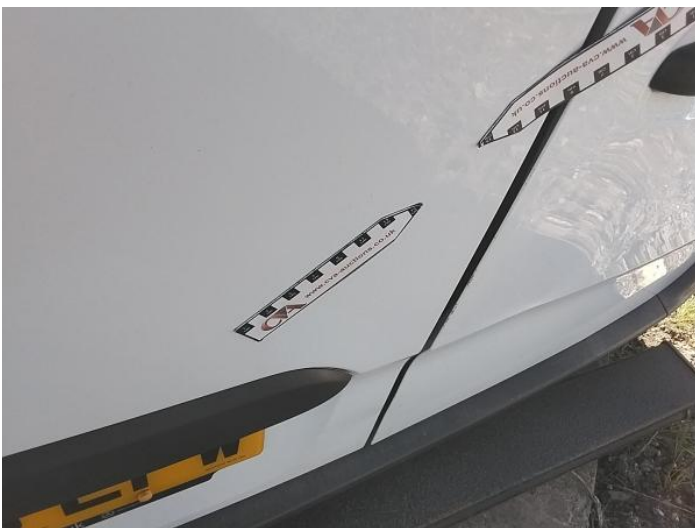
13: Door nsr
Dented
Over 30mm

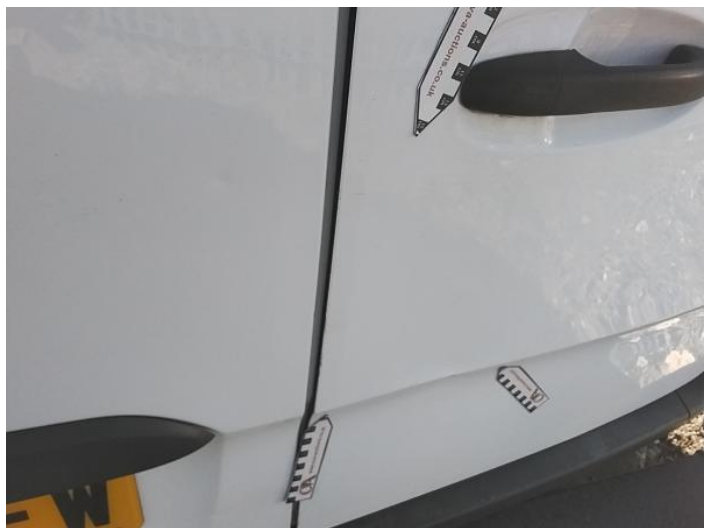
14: Door osr
Dented
Over 30mm

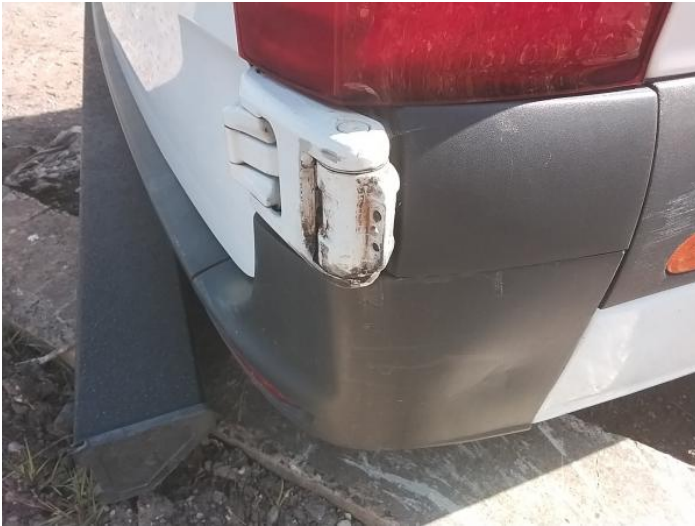
15: Bumper Rear Moulding
Scuffed (Unpainted)
Over 100mm

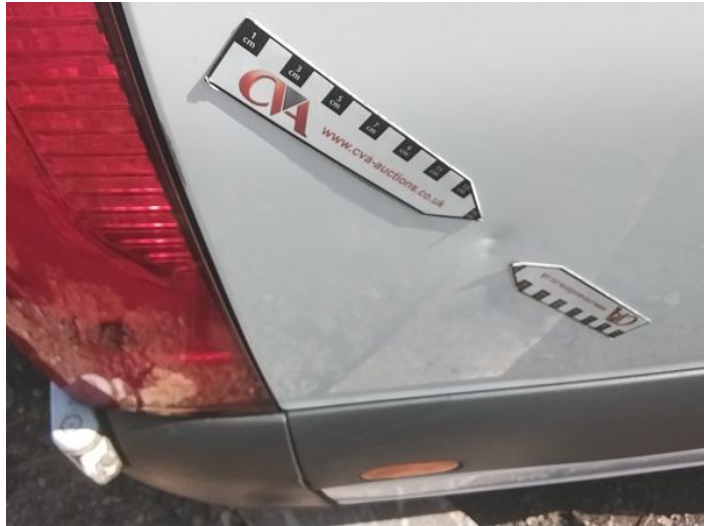
16: Qtr Panel osr
Dented
Over 30mm

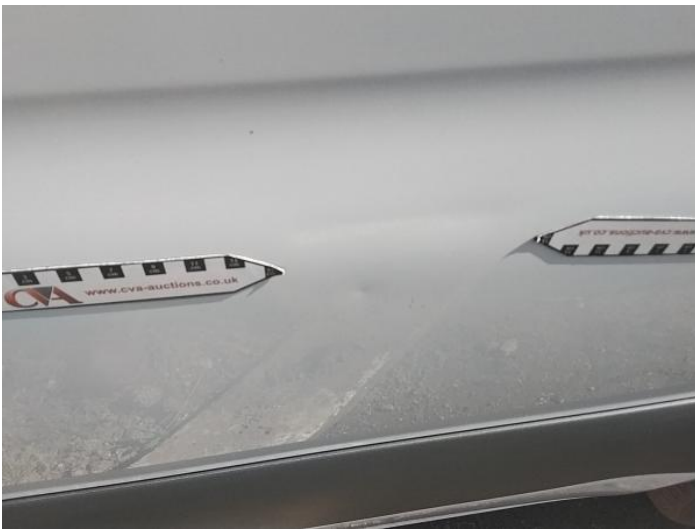
17: Qtr Panel osr
Dented
Over 30mm

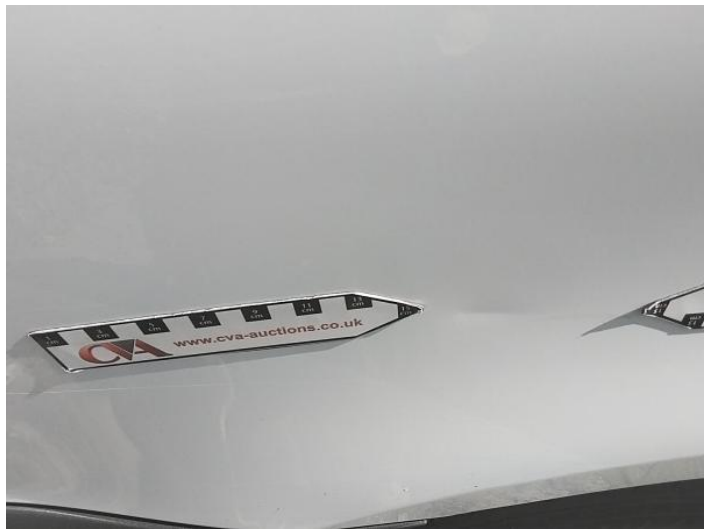
18: Qtr Panel osr
Dented
Over 30mm

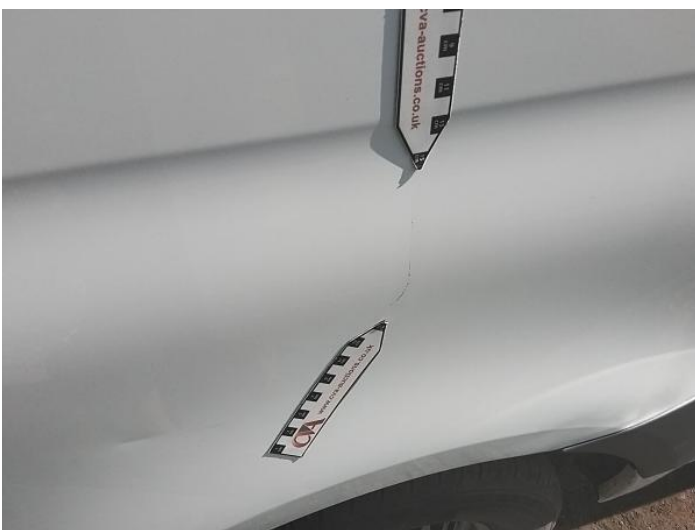
19: Qtr Panel osr
Scratched
Over 25mm Thru Paint

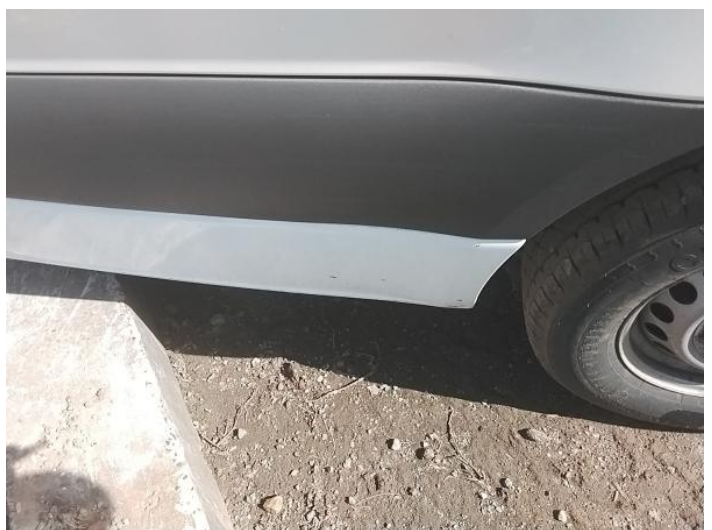
20: Qtr Panel Moulding os
Scuffed (Unpainted)
Over 100mm

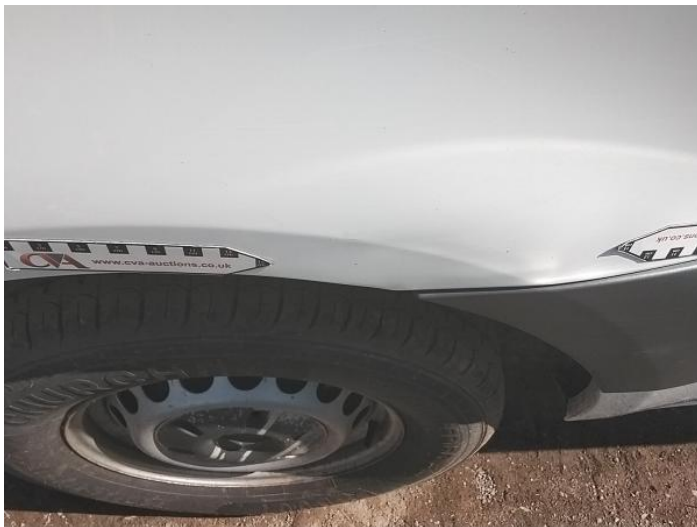
21: Qtr Panel osr
Dented
With Paint Damage

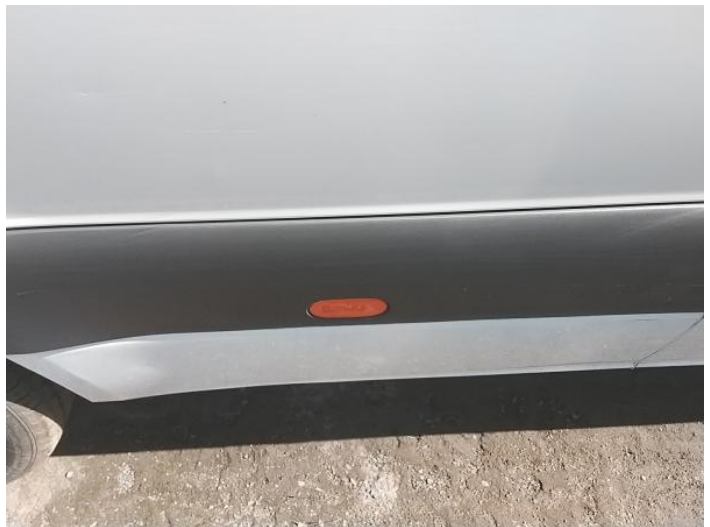
22: Qtr Panel Moulding os
Scuffed (Unpainted)
Over 100mm

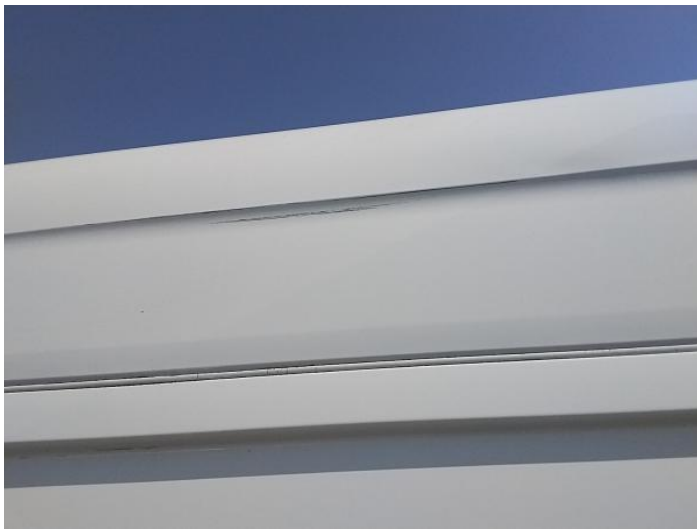
23: Qtr Panel osr
Scratched
Over 25mm Thru Paint

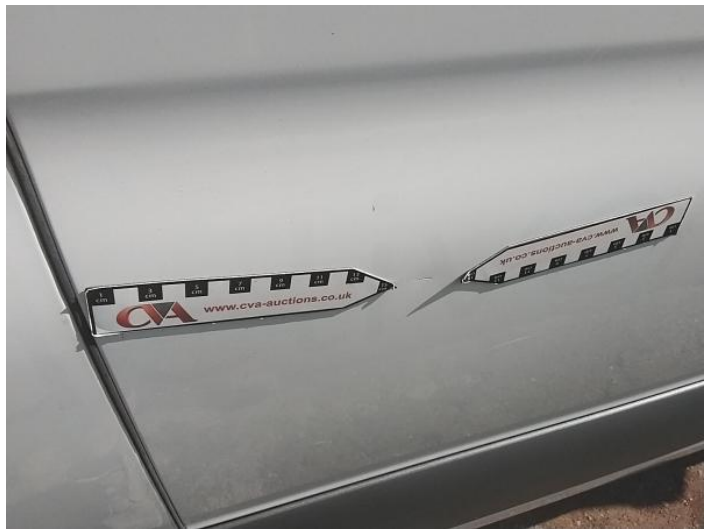
24: Qtr Panel osr
Dented
With Paint Damage

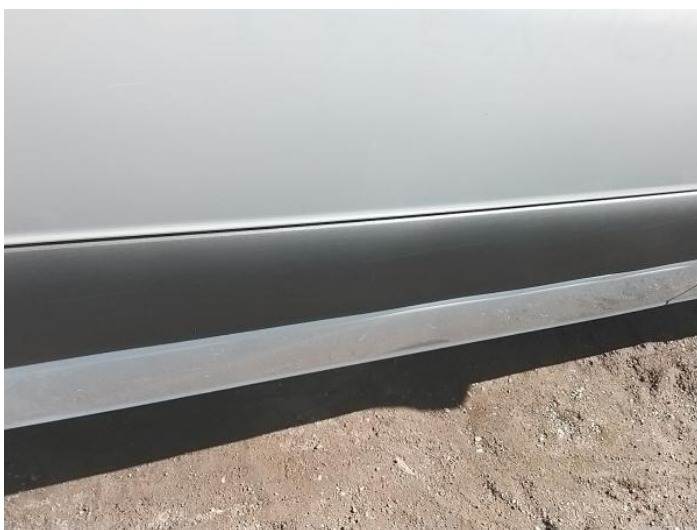
25: Qtr Panel Moulding os
Scuffed (Unpainted)
Over 100mm

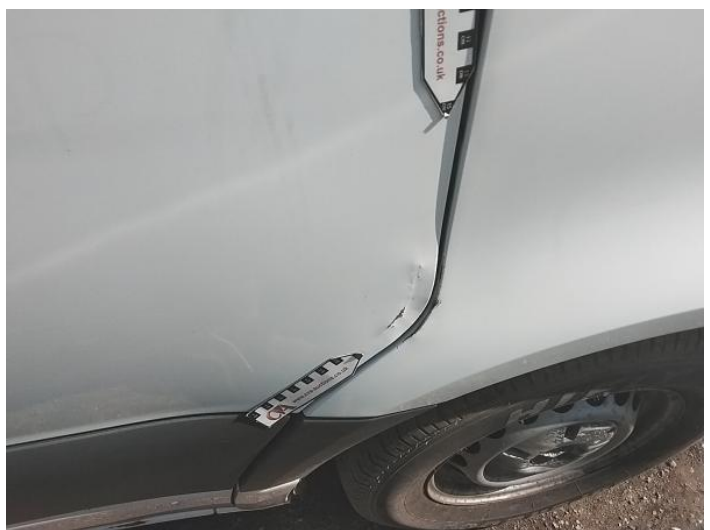
26: Door osf
Dented
With Paint Damage

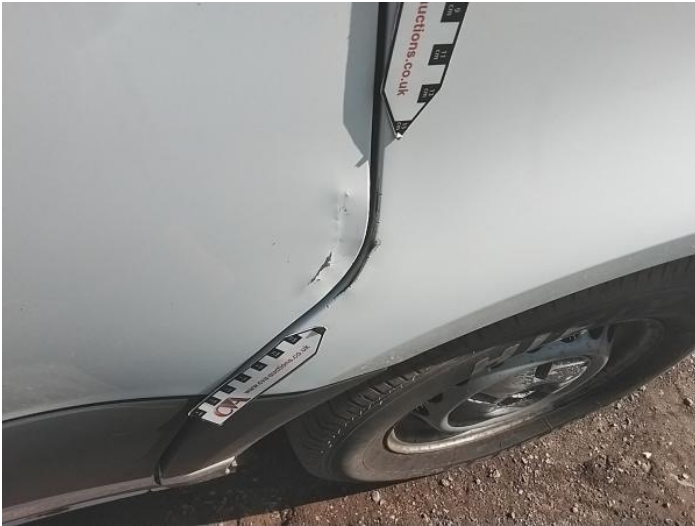
27: Wing osf
Dented
With Paint Damage

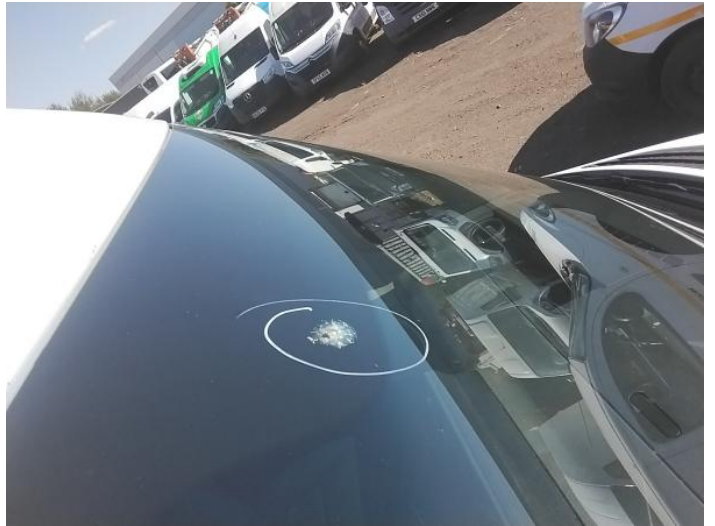
28: Screen Front
Chipped
Over 10mm

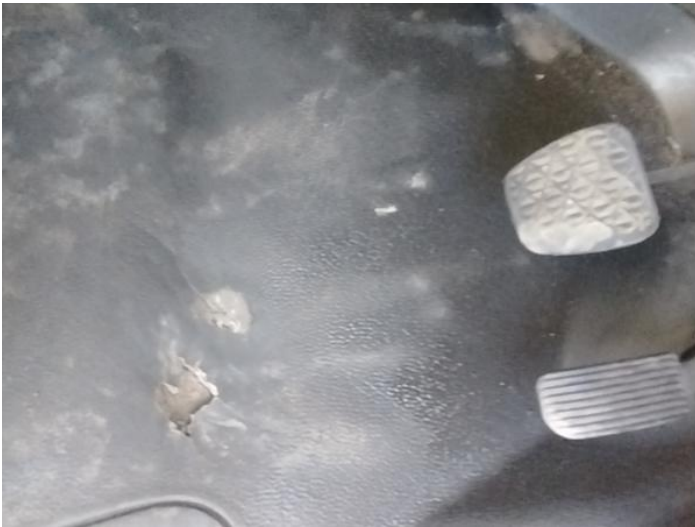
29: Carpets Front
Holed
Over 3mm

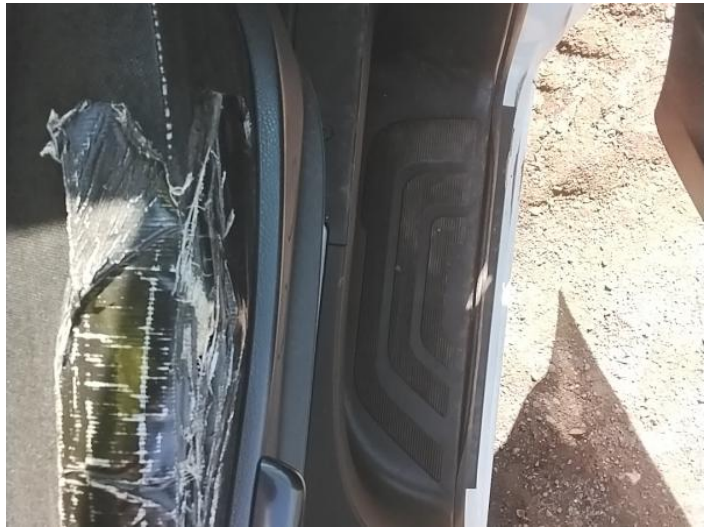
30: Seat Base Cover osf
Torn
Over 3mm

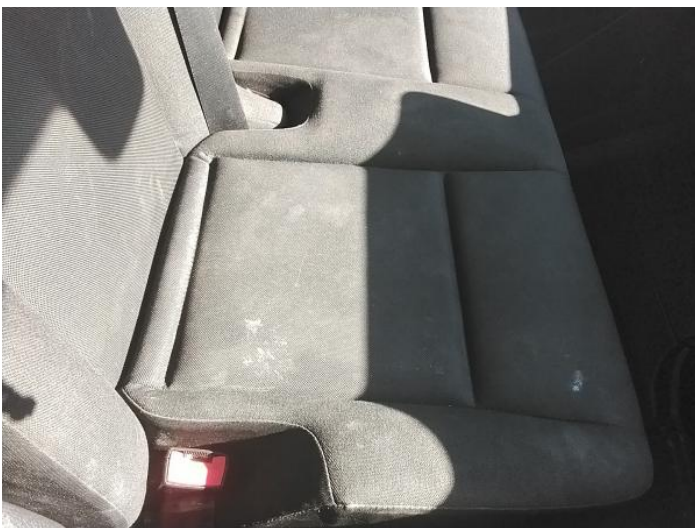
31: Seat Base Cover nsf
Soiled
Heavy
