VEHICLE INSPECTION REPORT

YK70EFZ

Mercedes-Benz Sprinter 3.5t H2 Progressive Van

Non Runner
Inspection

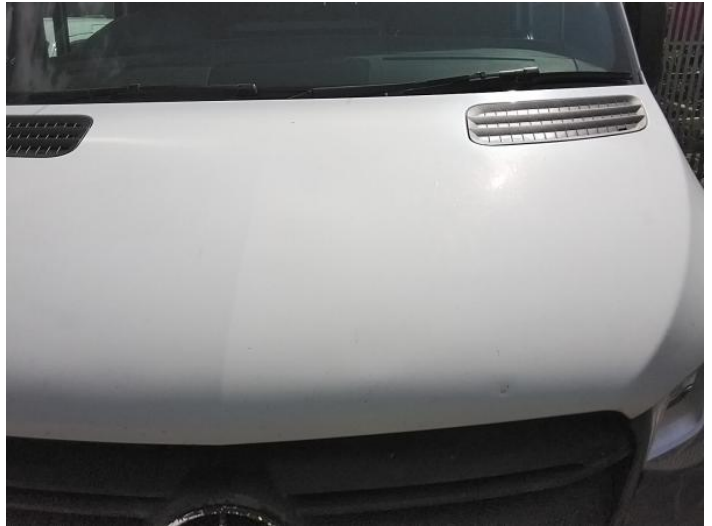
4: Bonnet
Chipped
Multiple Chips

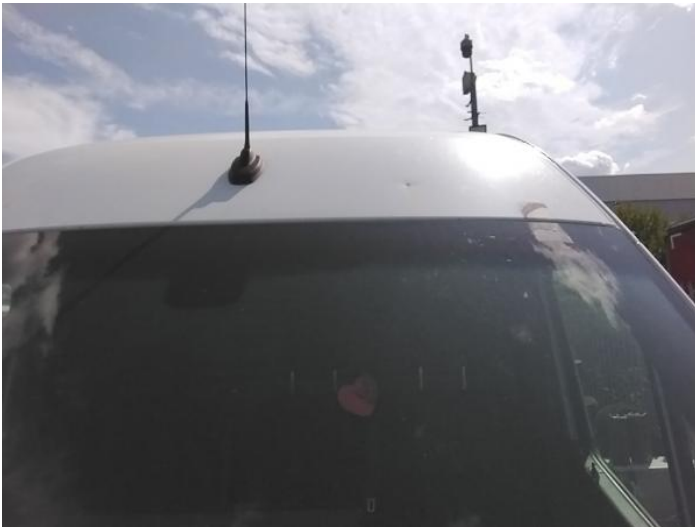
5: Roof
Dented
With Paint Damage

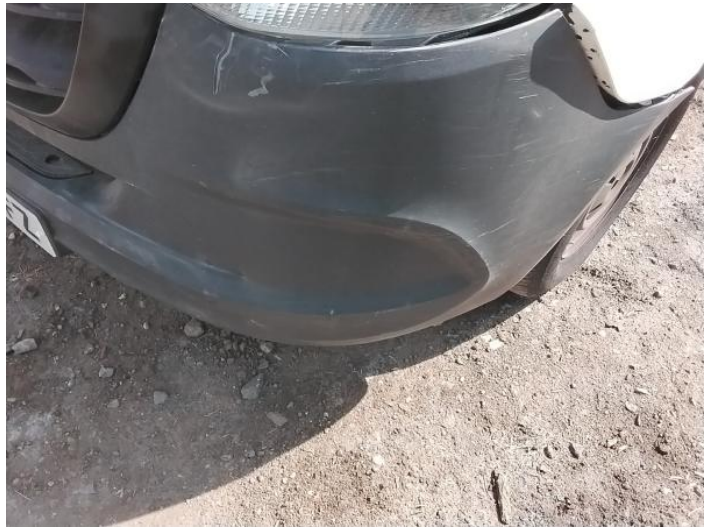
6: Bumper Front
Scratched
Over 100mm Thru Paint

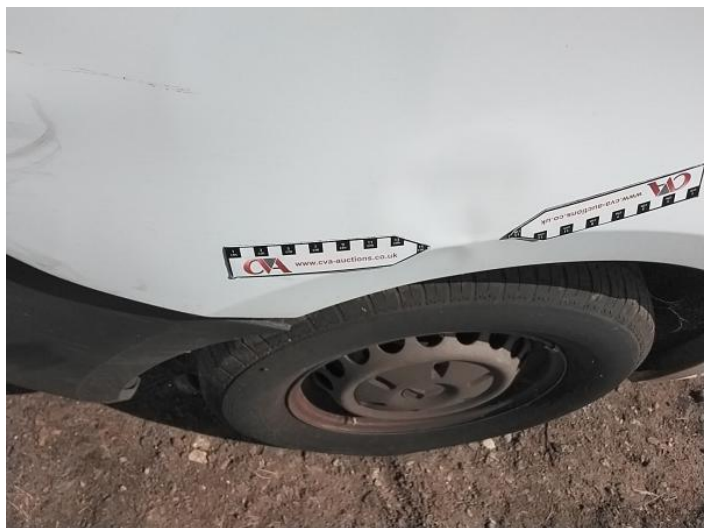
8: Wing nsf
Dented
Over 30mm
