## VEHICLE INSPECTION REPORT

**LG70EVM**

### Citroen Relay 35 2.2 BLUE HDI 140PS

**Non Runner**  
Inspection

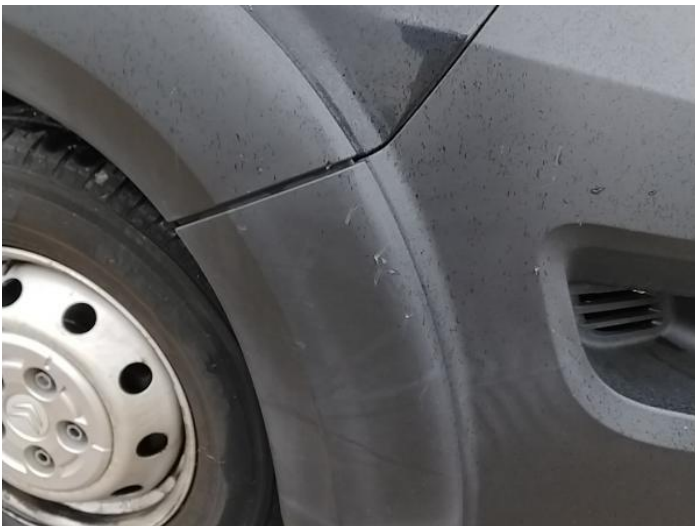
1: Wing Front Arch Extension os  
Scuffed (Unpainted)  
UpTo 100mm

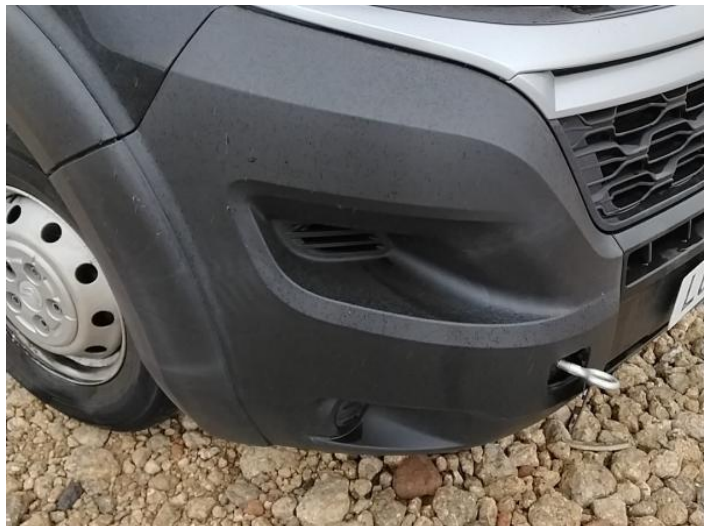
2: Bumper Front Moulding  
Scuffed (Unpainted)  
UpTo 100mm

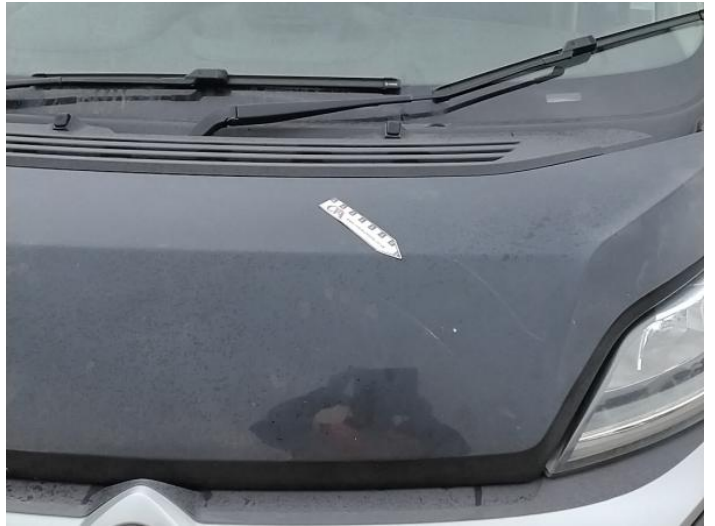
4: Bonnet  
Scratched  
UpTo 25mm Thru Paint

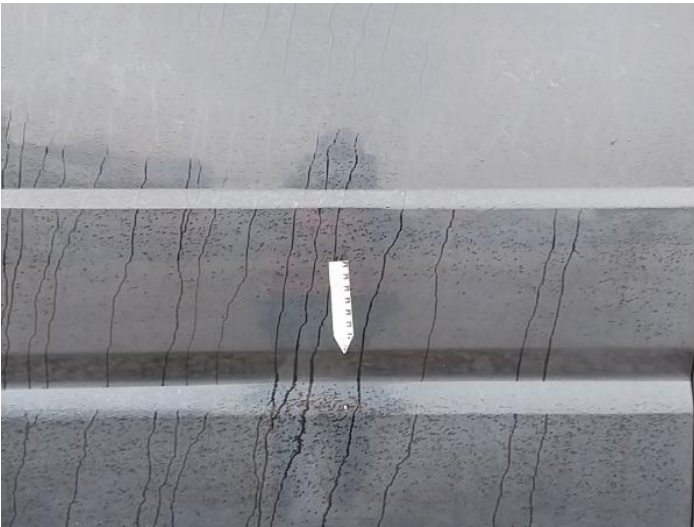
5: Door nsr  
Chipped  
Multiple Chips

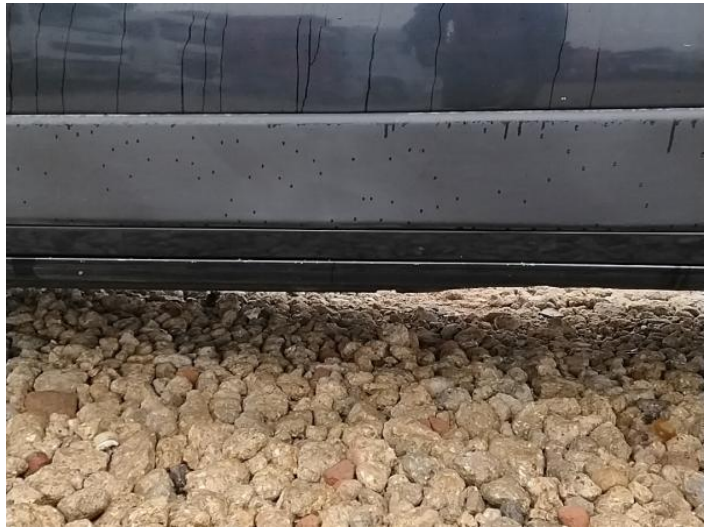
6: Sill ns  
Chipped  
Multiple Chips

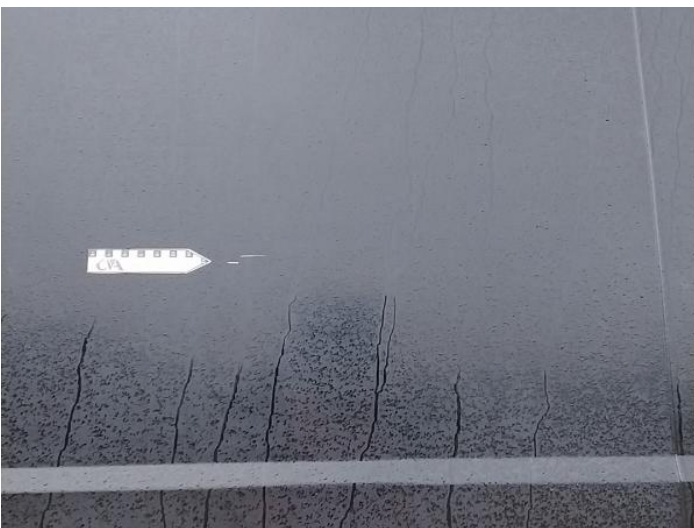
7: Qtr Panel nsr  
Scratched  
UpTo 25mm Thru Paint

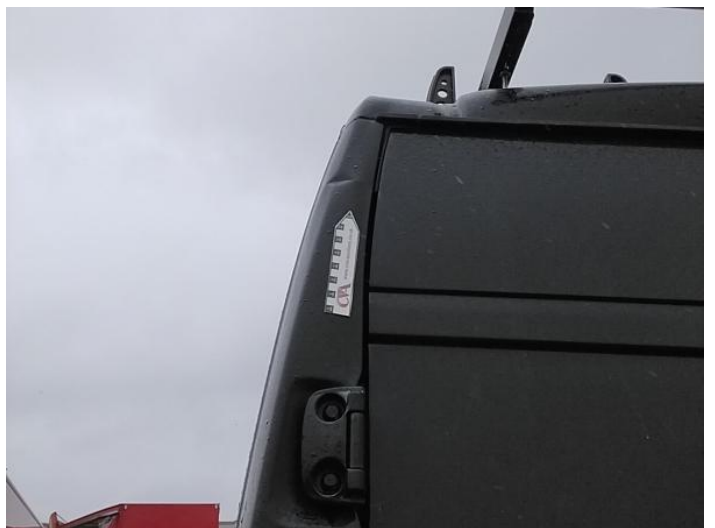
8: Panel Rear  
Dented  
Between 10mm + 30mm

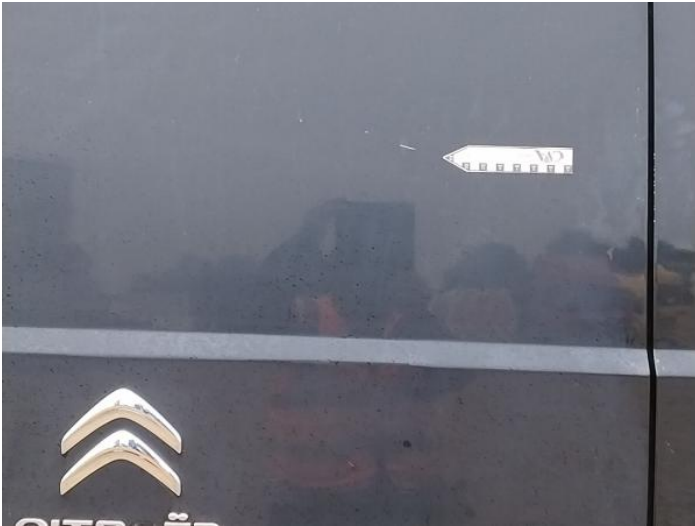
9: Door nsr  
Scratched  
UpTo 25mm Thru Paint

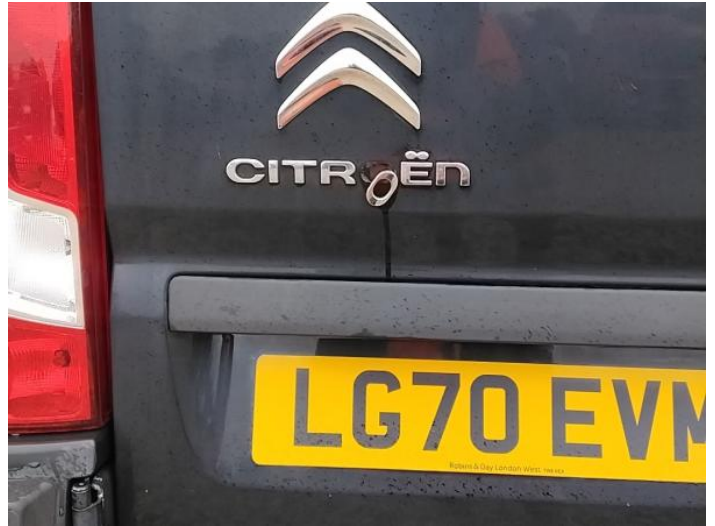
10: Badgedecal Rear  
Broken  
Replace

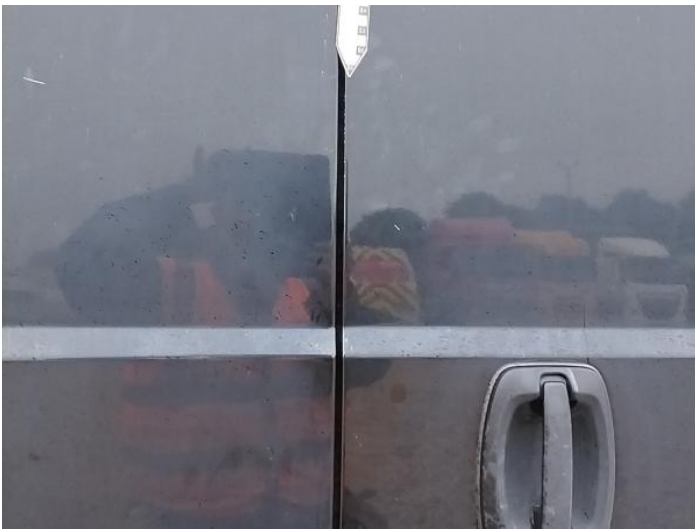
11: Door osr  
Chipped  
Edge Chip

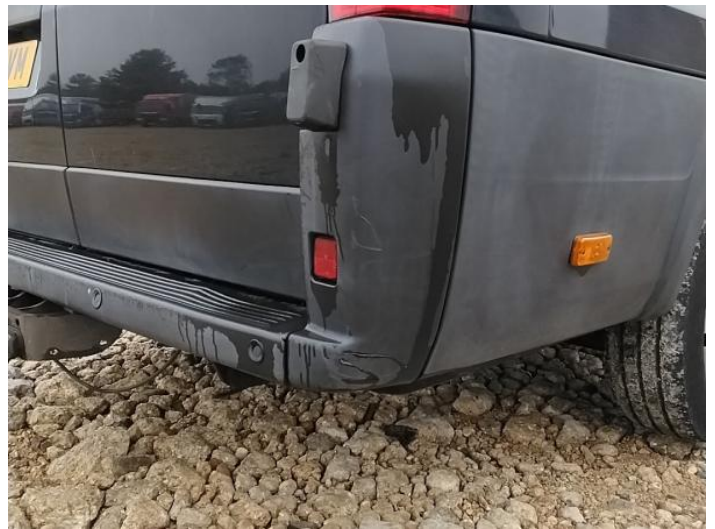
12: Bumper Rear Moulding  
Scuffed (Unpainted)  
UpTo 100mm

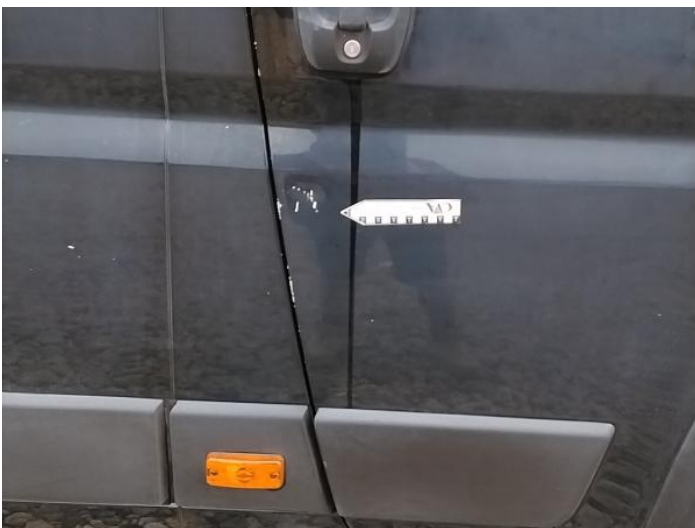
13: Door osf  
Scratched  
Over 25mm Thru Paint

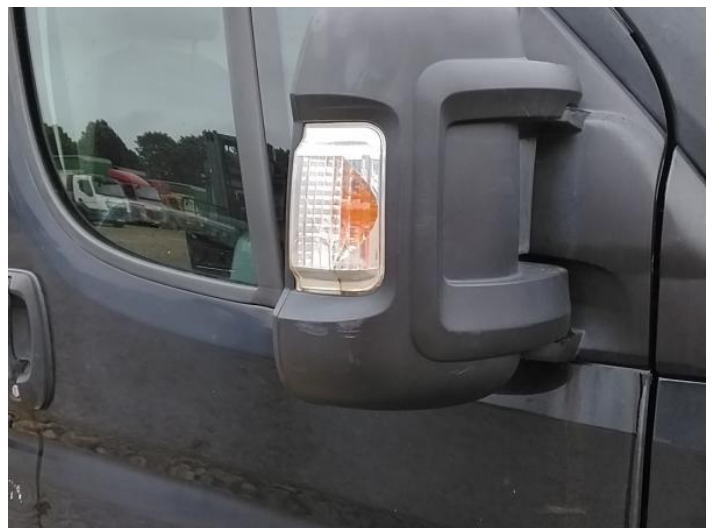
14: Door Mirror Assy osf  
Scuffed (Unpainted)  
UpTo 100mm

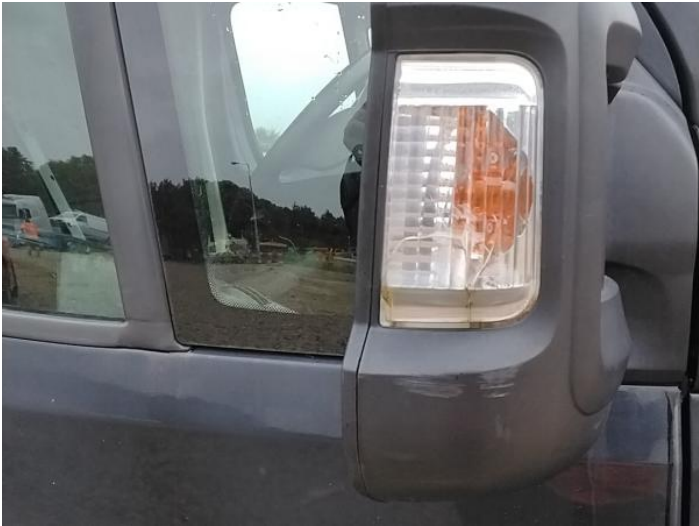
15: Flasher Side Repeater os  
Broken  
Replace

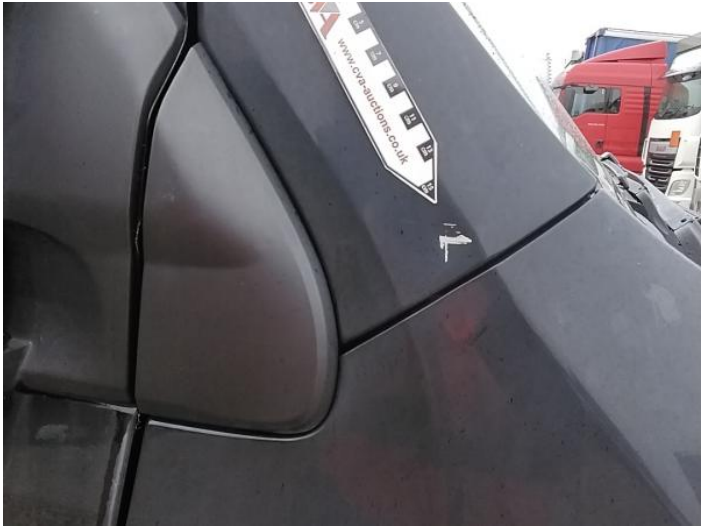
16: A Post os  
Scratched  
UpTo 25mm Thru Paint

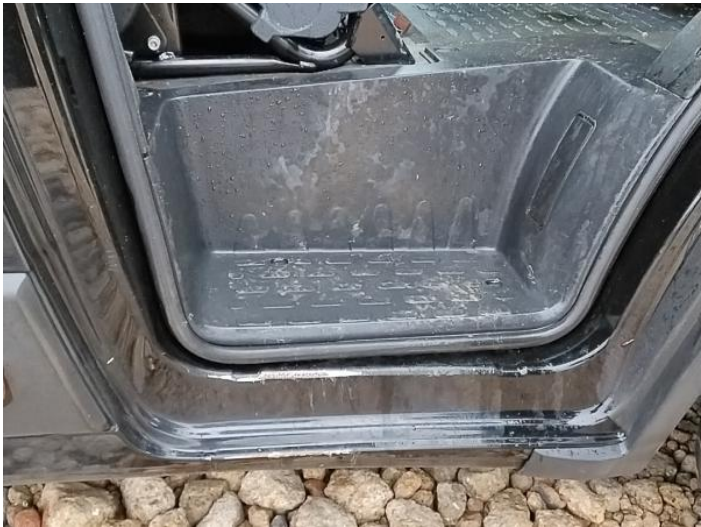
18: Sill os  
Rusted  
Over 5mm
