VEHICLE INSPECTION REPORT

PN19DLK

Fiat Ducato 35 2.3 MULTIJET 130PS

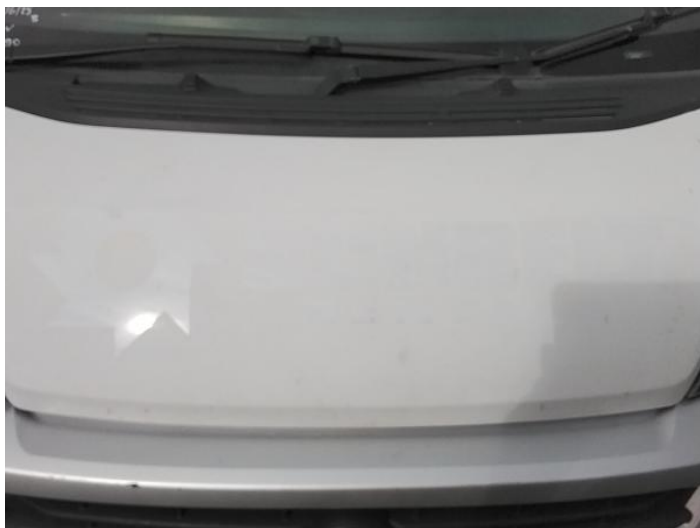
1: Bonnet
Chipped
Multiple Chips

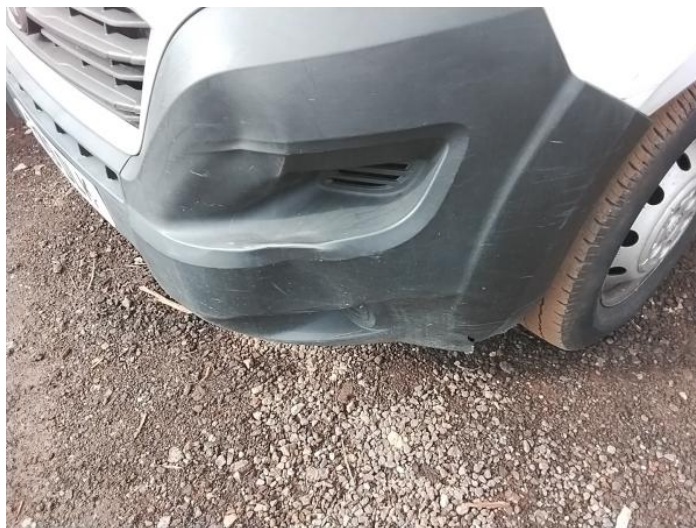
2: Bumper Front
Cracked
Over 25mm

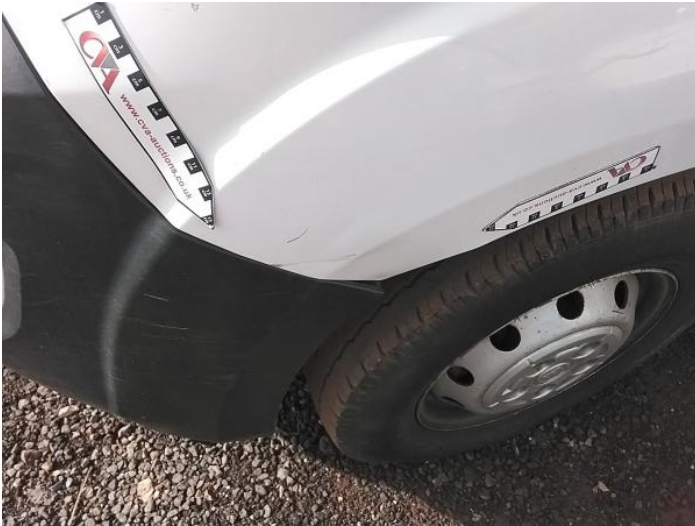
3: Wing nsf
Dented
With Paint Damage

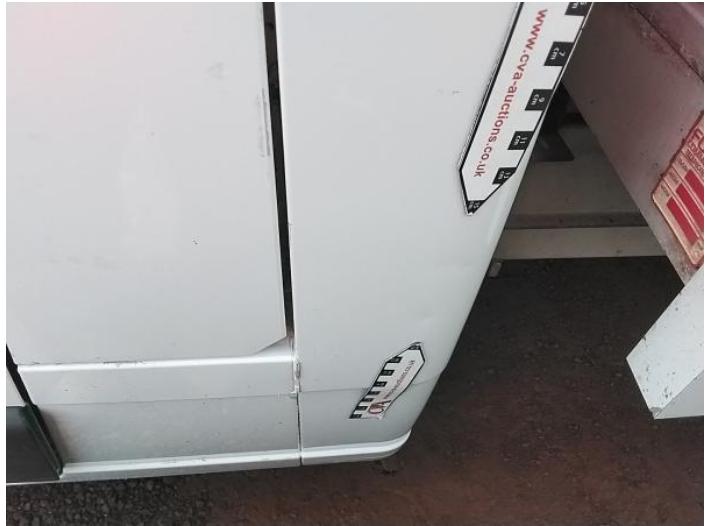
4: B Post ns
Dented
Over 30mm

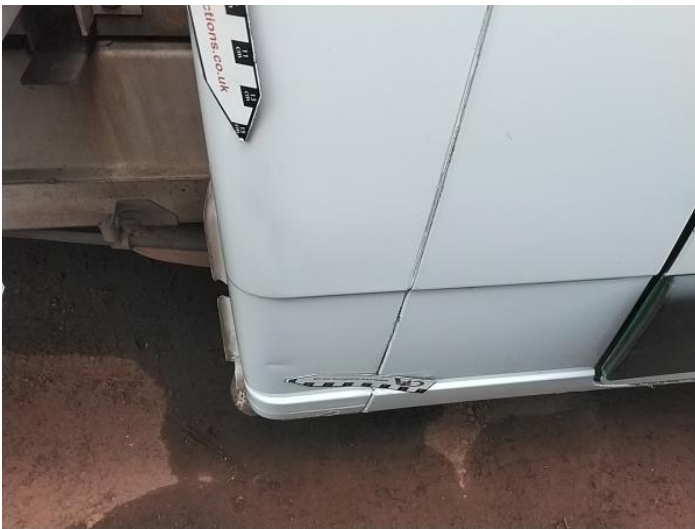
5: B Post os
Dented
Over 30mm

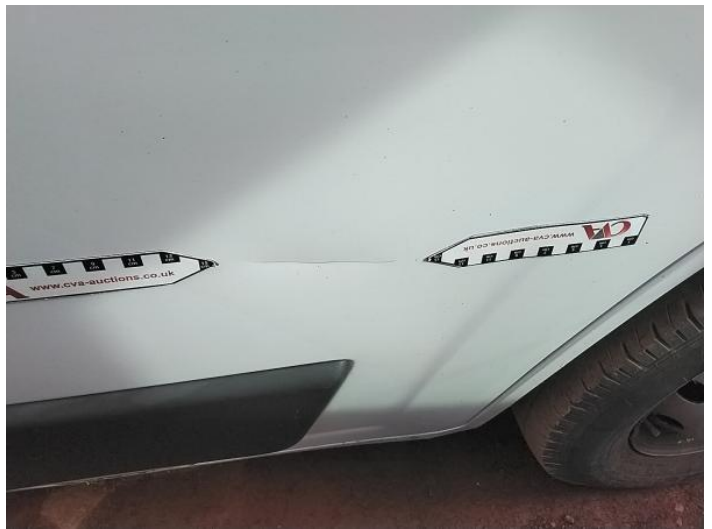
6: Door osf
Dented
With Paint Damage

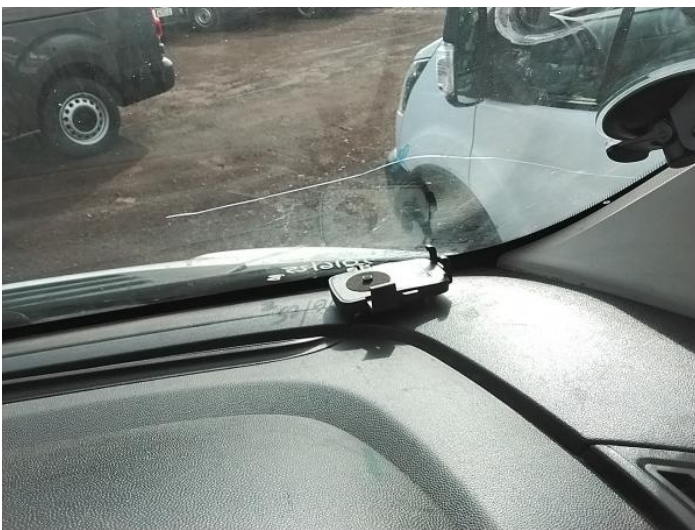
LARGE CRACK IN WINDSCREEN E/ MIRRORS, TOW BAR

7: Screen Front
Cracked
Replace

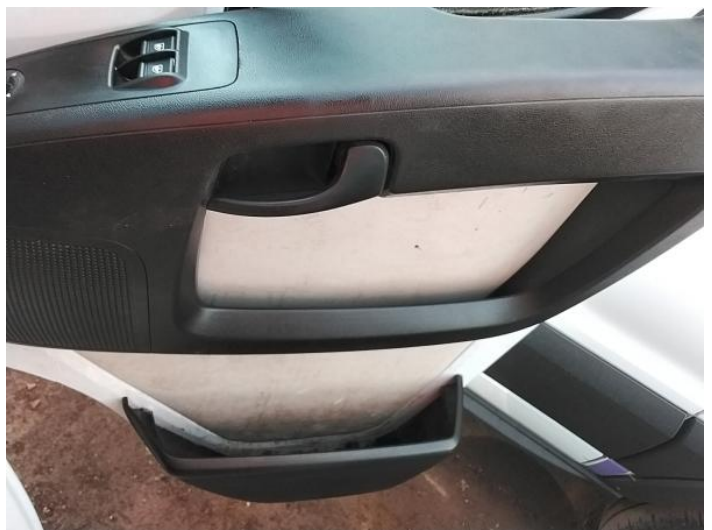
8: Door Pad osf
Soiled
Heavy

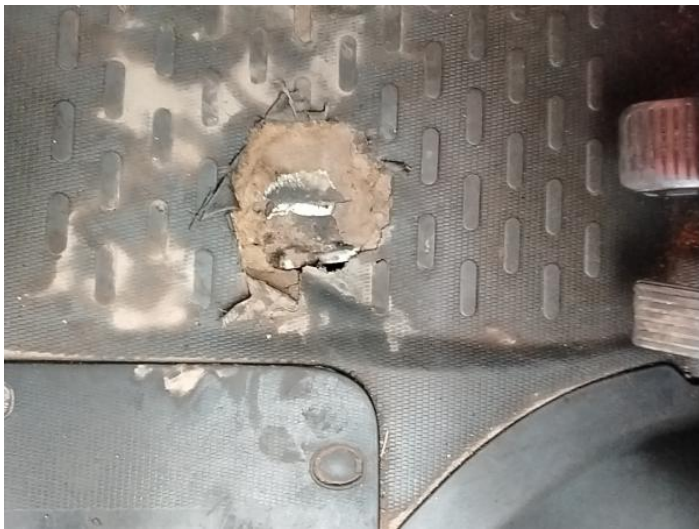
9: Carpets Front
Holed
Over 3mm

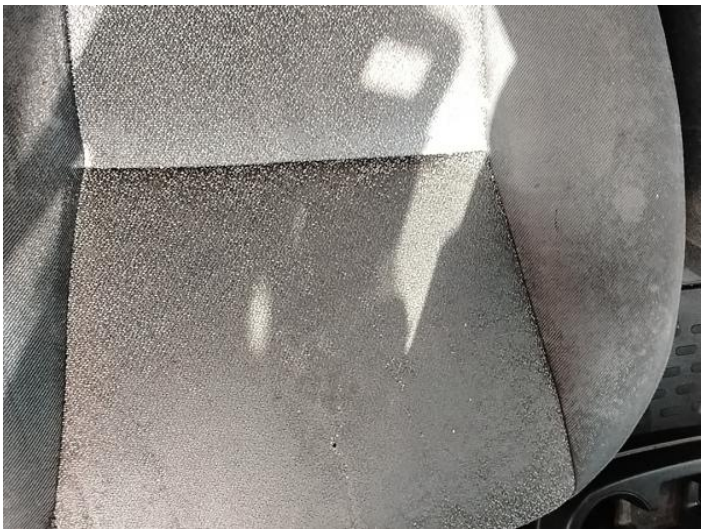
10: Seat Base Cover osf
Torn
Over 3mm

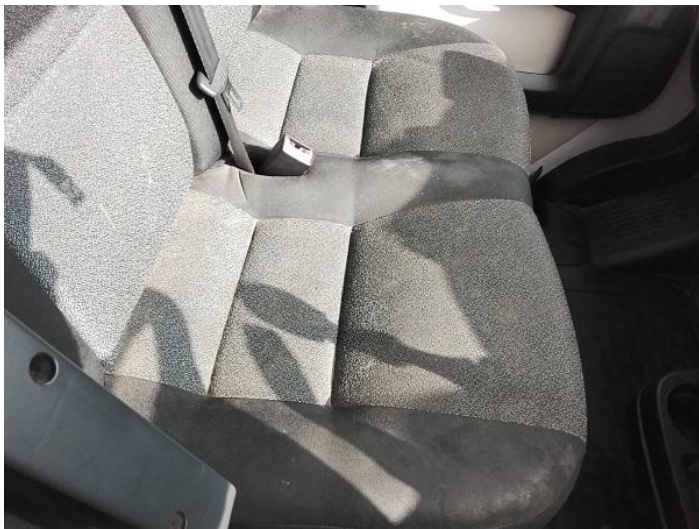
11: Seat Base Cover nsf
Soiled
Heavy

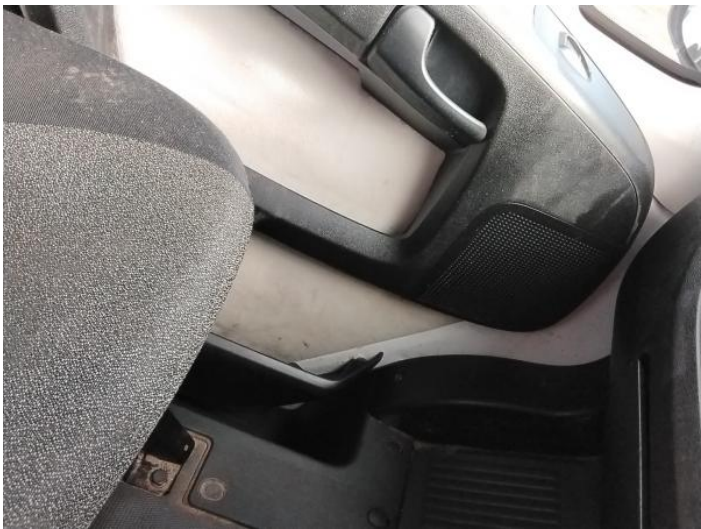
12: Door Pad nsf
Soiled
Heavy
