VEHICLE INSPECTION REPORT

Isuzu N75 190

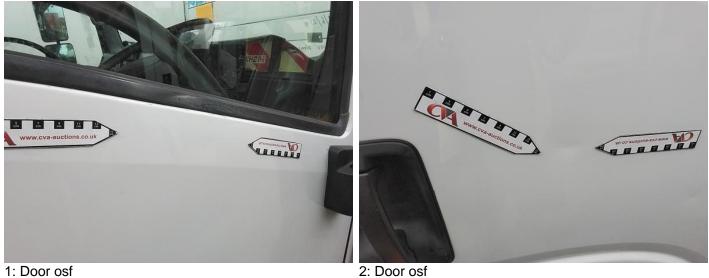
1: Door osf Dented Over 30mm 2: Door osf Dented Over 30mm

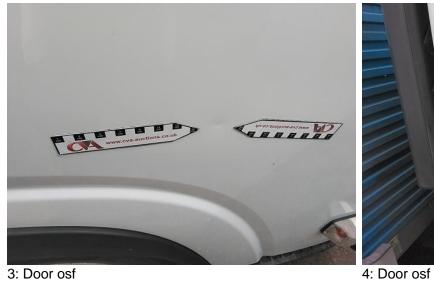
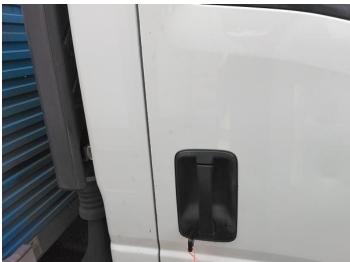
3: Door osf Dented Over 30mm

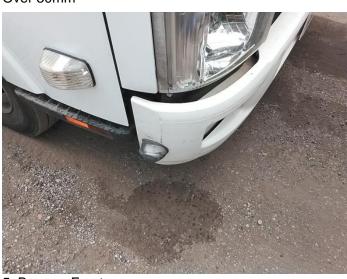
5: Bumper Front Scratched Over 100mm Thru Paint

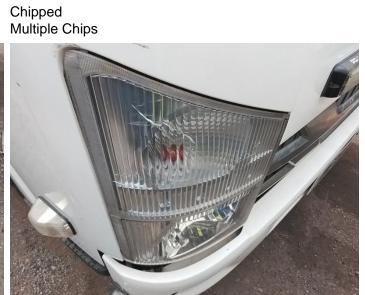
6: Headlamp os Broken Replace

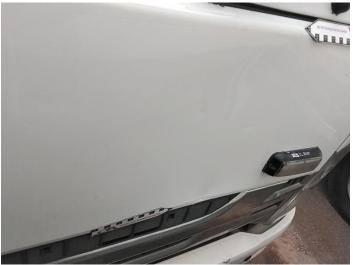
8: Bonnet Dented Over 30mm

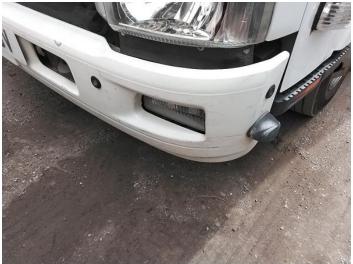
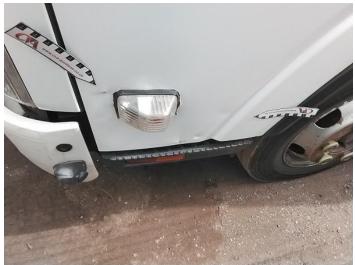
9: Bumper Front Scratched Over 100mm Thru Paint
