VEHICLE INSPECTION REPORT

LN69XVD

Isuzu N75 190

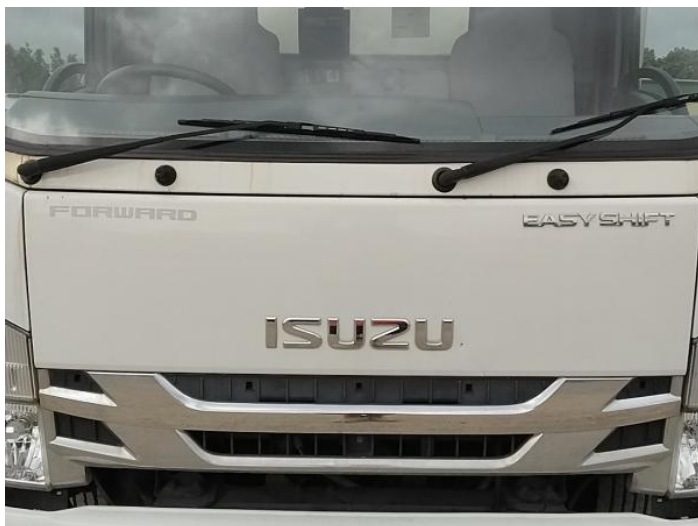
1: Bonnet
Chipped
Multiple Chips

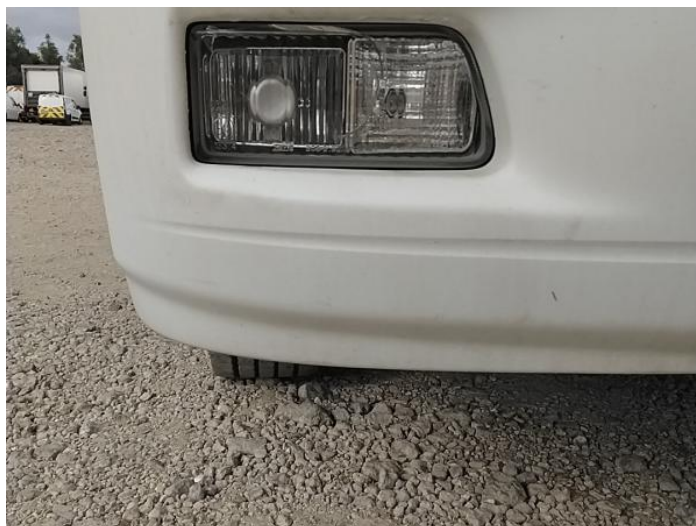
2: Fogdriving Lamp osf
Broken
Replace

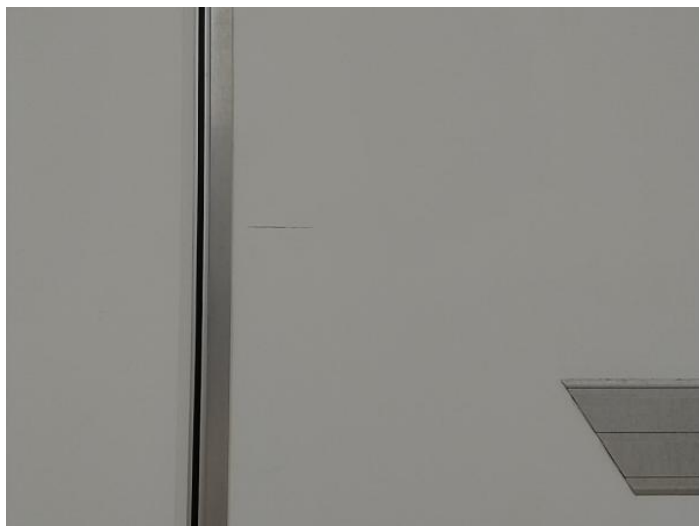
4: Qtr Panel nsr
Scratched
UpTo 25mm Not Thru Paint

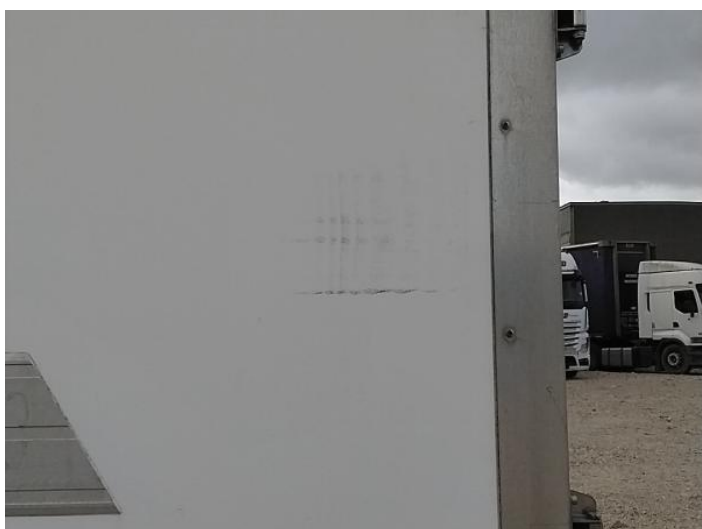
5: Qtr Panel nsr
Scratched
Over 25mm Not Thru Paint

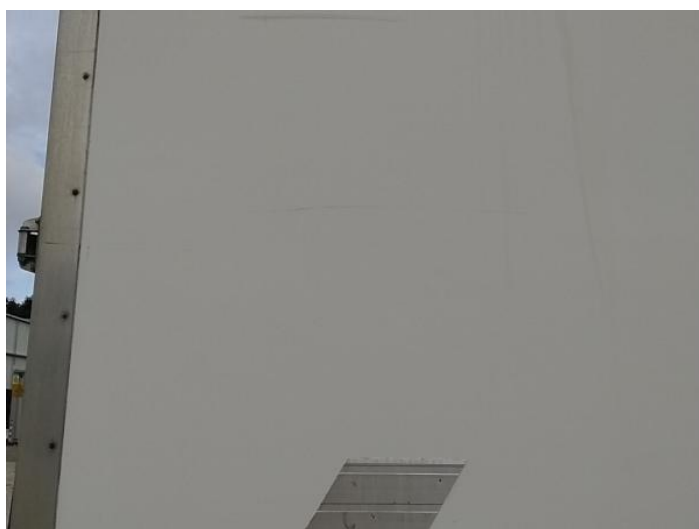
6: Qtr Panel osr
Scratched
Over 25mm Not Thru Paint
