# VEHICLE INSPECTION REPORT

**HV640HS**

## Mercedes-Benz Sprinter 316 CDI

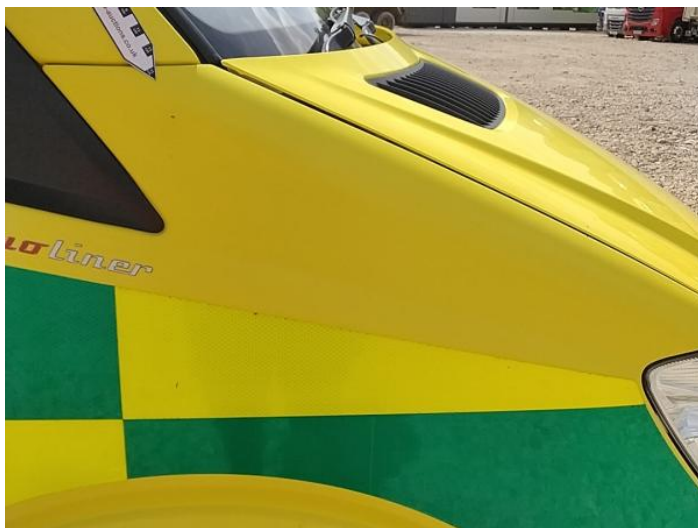
1: Wing of  
Chipped  
1 To 5

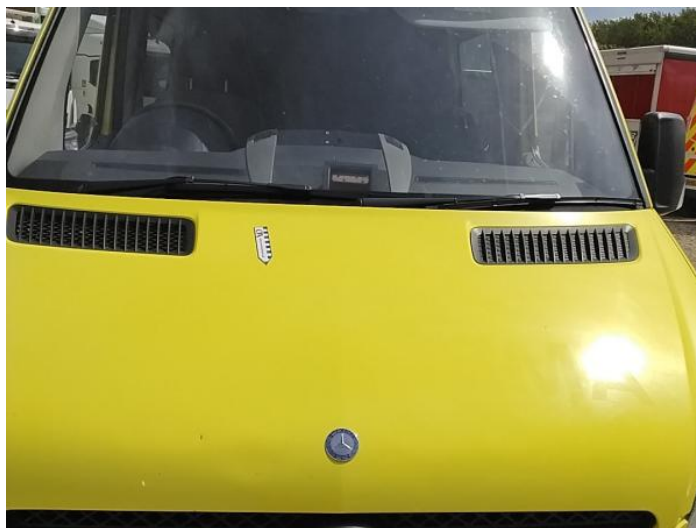
2: Bonnet  
Chipped  
Multiple Chips

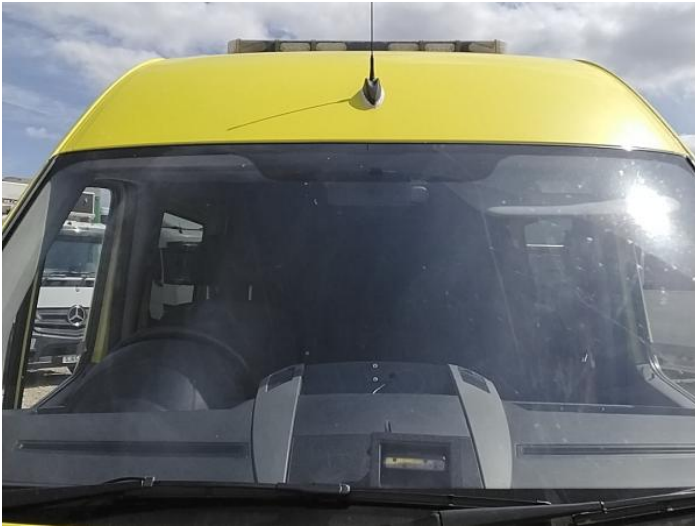
3: Screen Front  
Chipped  
UpTo 10mm

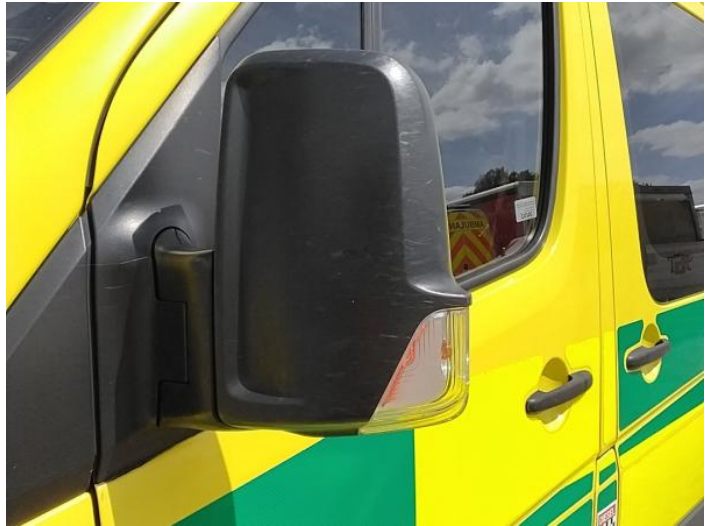
4: Door Mirror Assy nsf  
Scuffed (Unpainted)  
Over 100mm

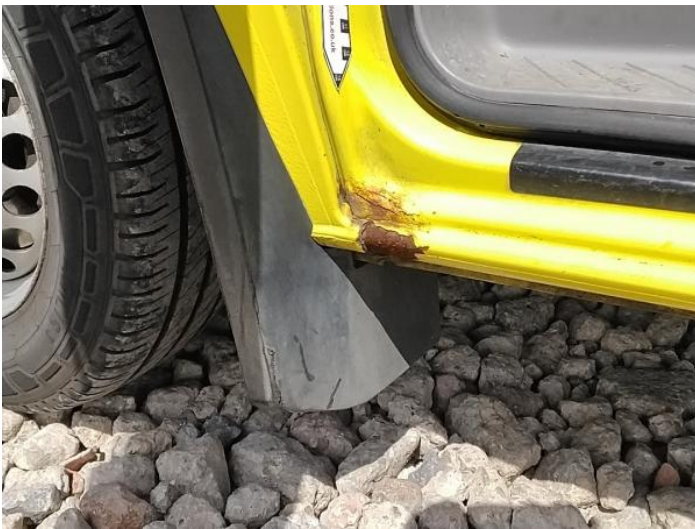
5: Sill ns  
Rusted  
Over 5mm

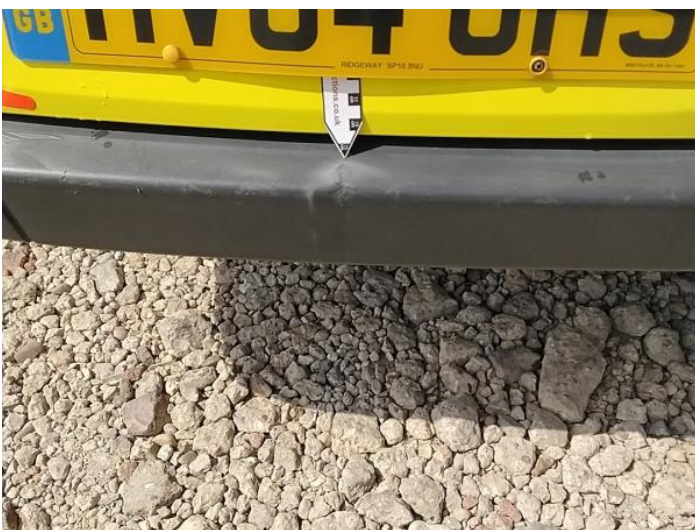
7: Bumper Rear  
Dented  
Over 2 UpTo 10mm

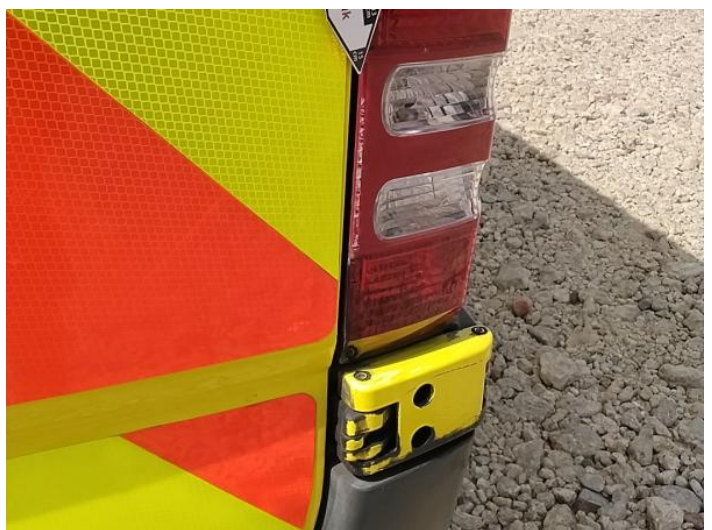
8: Lamp osr  
Broken  
Replace

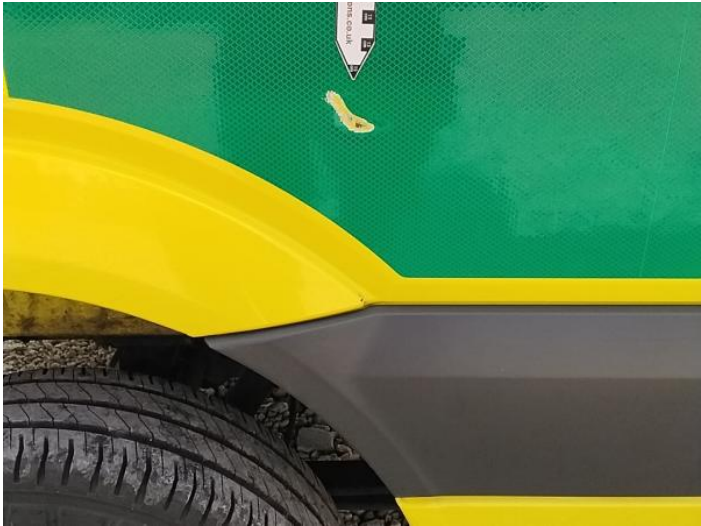
10: Qtr Panel osr  
Dented  
With Paint Damage
