# **VEHICLE INSPECTION REPORT**

YD67VHH

## Daf LF 260 18 TONNE

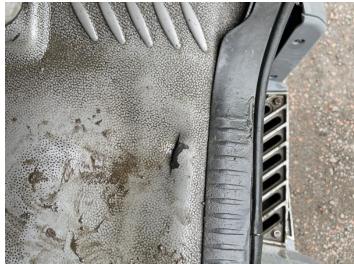
1: Carpets Front Torn Over 10mm

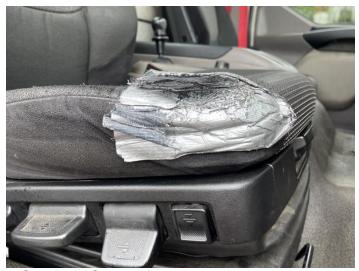
2: Seat Base Cover osf Torn Over 3mm

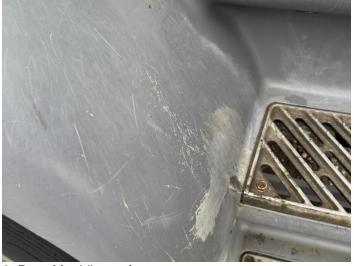
3: Door Moulding osf Scuffed (Unpainted) Over 100mm

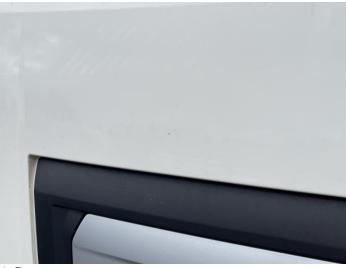
4: Bonnet Chipped 1 To 5

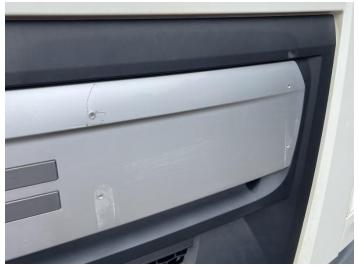
5: Bumper Front Grill Broken Replace

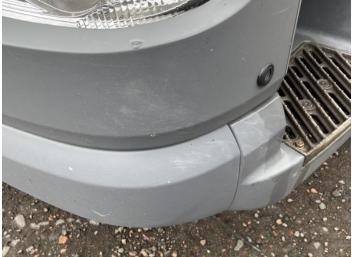
6: Bumper Front Scratched UpTo 25mm Not Thru Paint

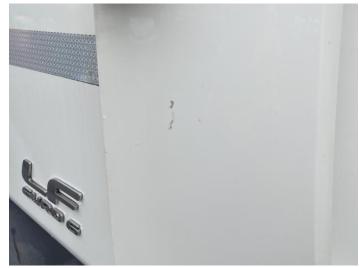
7: Wing osf Scratched UpTo 25mm Thru Paint

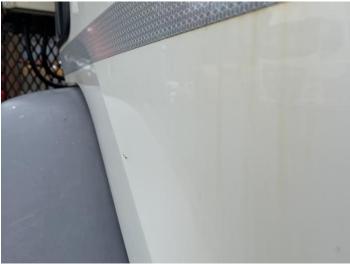
8: Door osf Dented Over 30mm

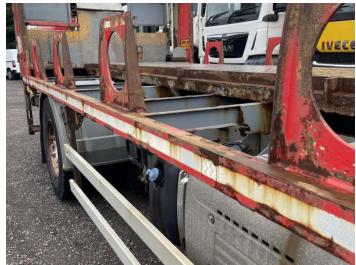
9: Qtr Panel osr Rusted Over 5mm

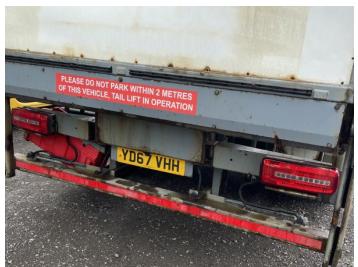
10: Tailgate Rusted Over 5mm

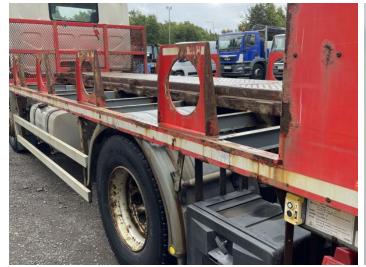
11: Qtr Panel nsr Rusted Over 5mm
