VEHICLE INSPECTION REPORT

PE63NPP

Daf LF 45.140

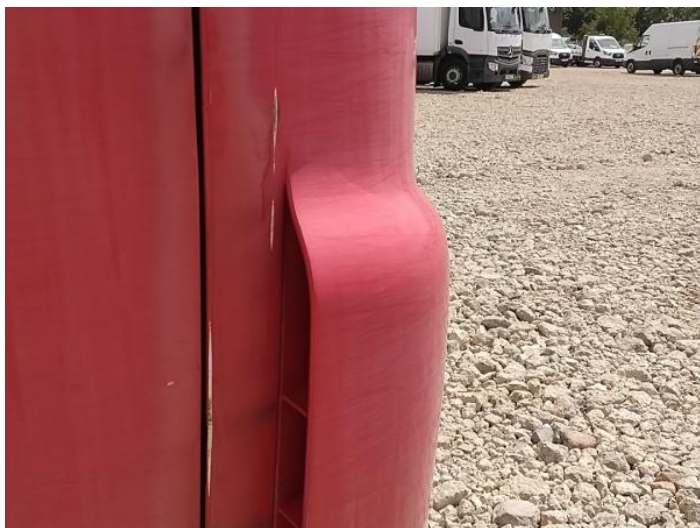
1: Wing osf
Scratched
Over 25mm Thru Paint

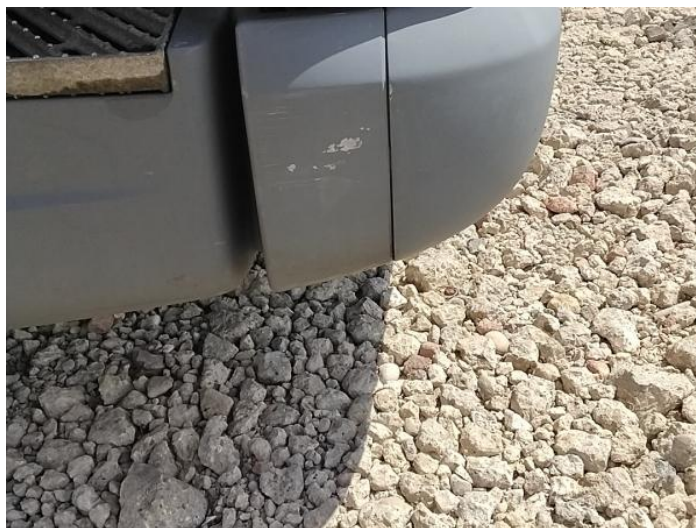
2: Bumper Front
Scratched
25 to 100mm Thru Paint

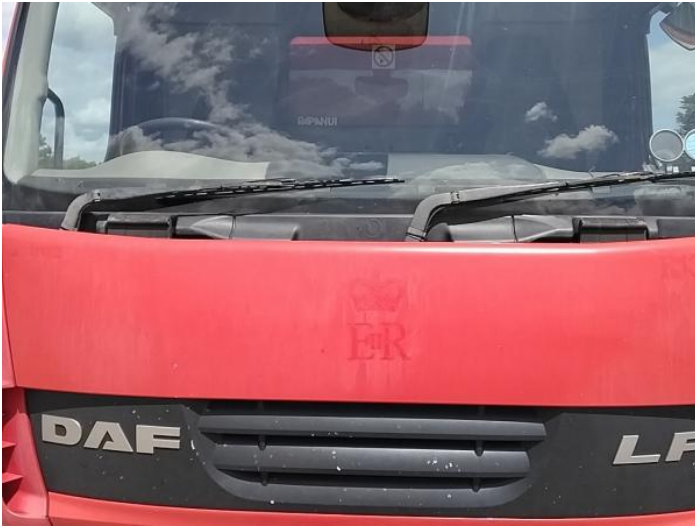
3: Bonnet
Chipped
Multiple Chips

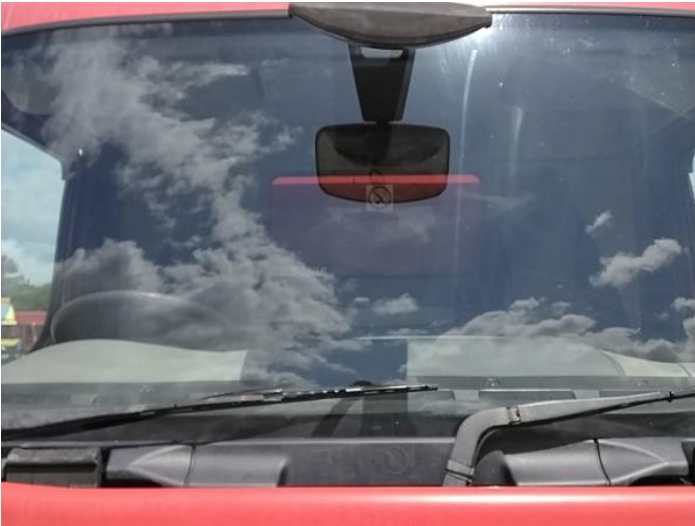
4: Screen Front
Chipped
UpTo 10mm

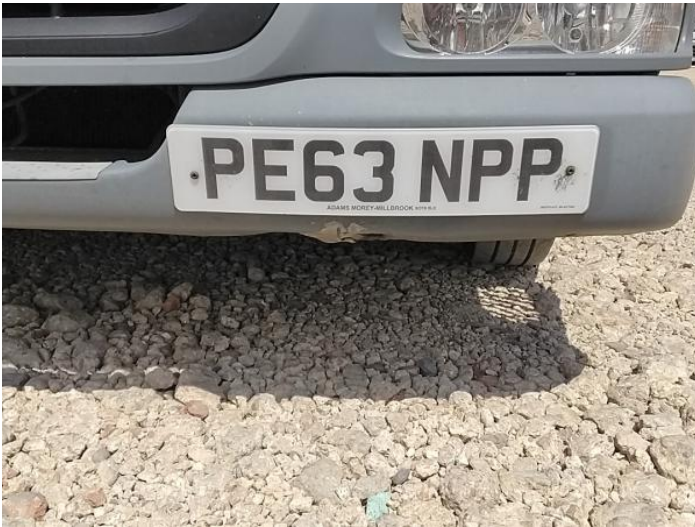
5: Bumper Front
Dented
With Paint Damage

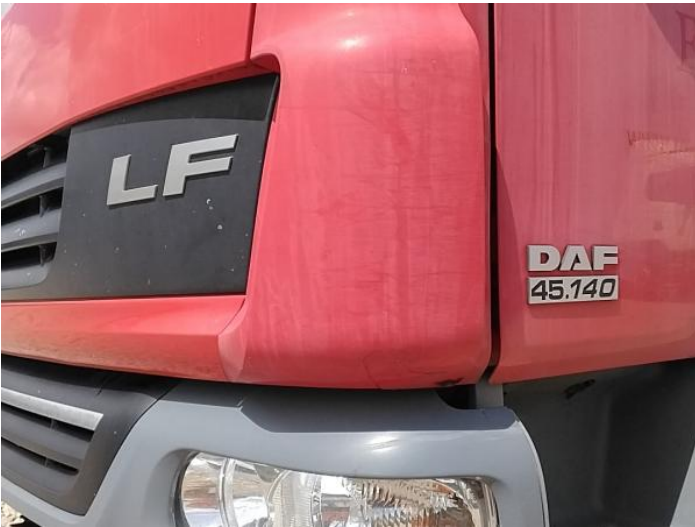
6: Wing nsf
Cracked
Replace

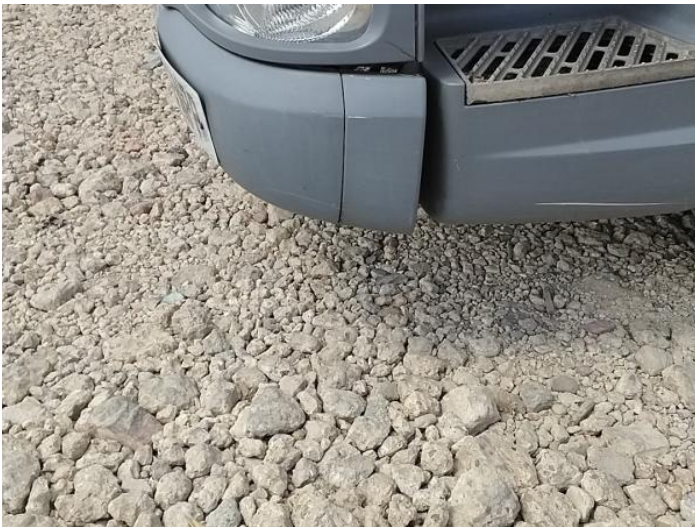
7: Bumper Front
Scratched
25 to 100mm Thru Paint

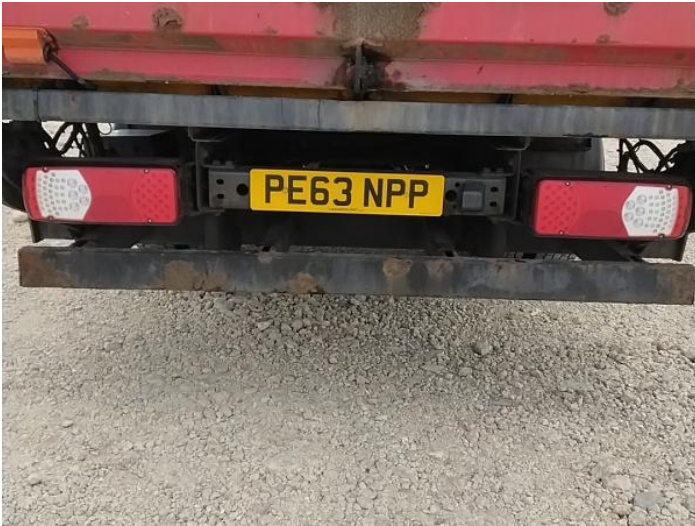
9: Bumper Rear
Rusted
Over 5mm

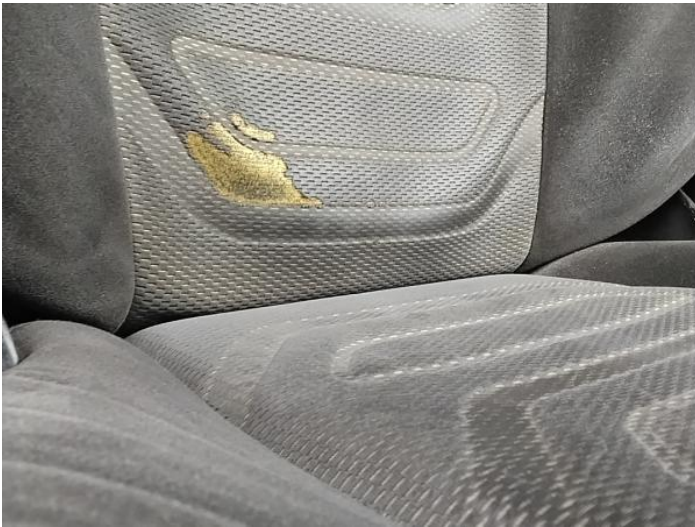
11: Seat Back Cover osf
Scuffed
Over 25mm

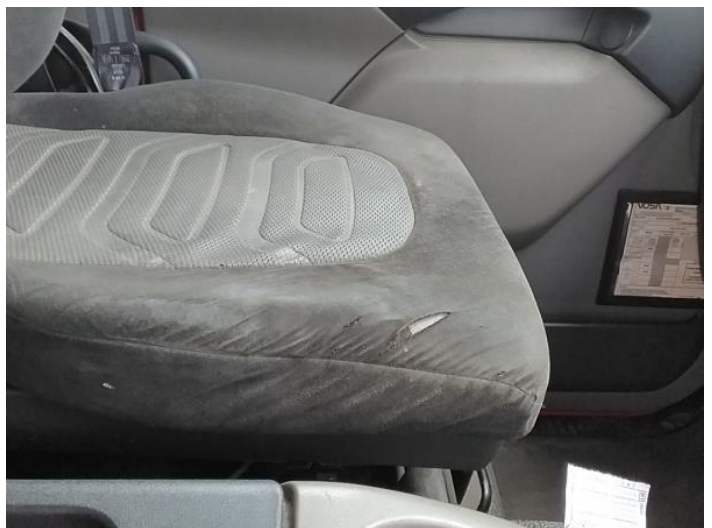
14: Seat Base Cover nsf
Torn
Over 3mm
