# **VEHICLE INSPECTION REPORT**

## Nissan Cabstar 35.14 DCI

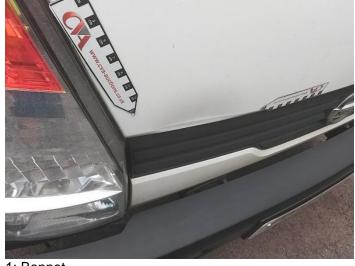
1: Bonnet Dented Over 30mm

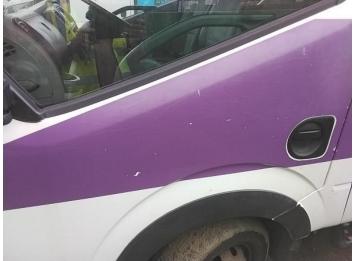
2: Panel Front Dented With Paint Damage

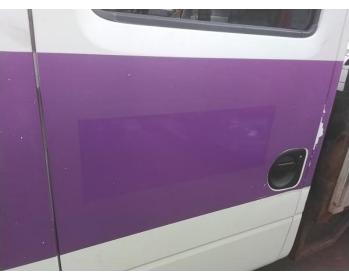
4: Door nsr Chipped Multiple Chips

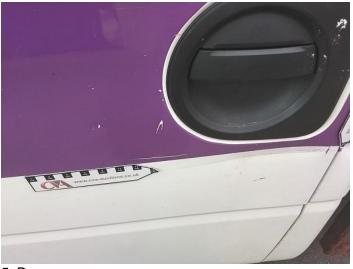
5: Door nsr Dented With Paint Damage

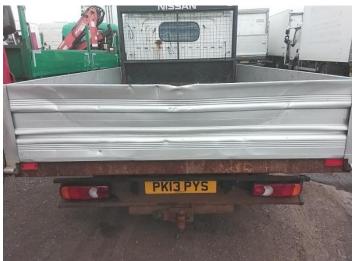
7: Tailgate Dented Over 30% Of Panel

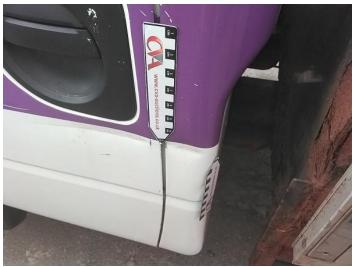
6: C Post ns Dented With Paint Damage

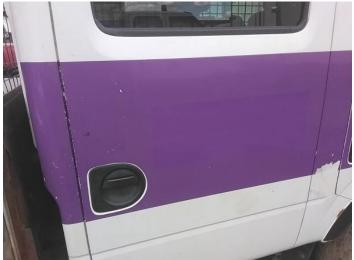
8: Door osr Chipped Multiple Chips

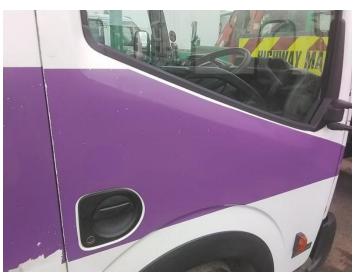
9: B Post os Rusted Holed

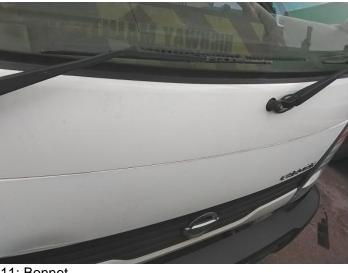
11: Bonnet Chipped Multiple Chips

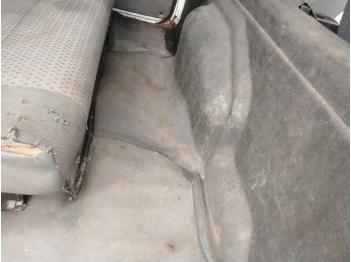
12: Carpets Rear Soiled Heavy

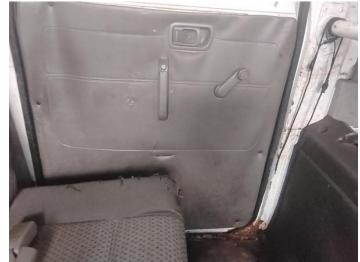
13: Door Pad nsr Holed Over 3mm

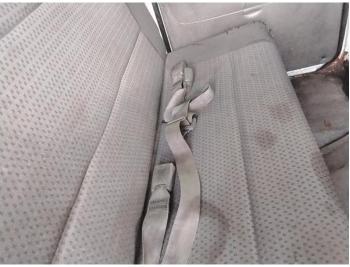
14: Seat Base Cover nsr Soiled Heavy

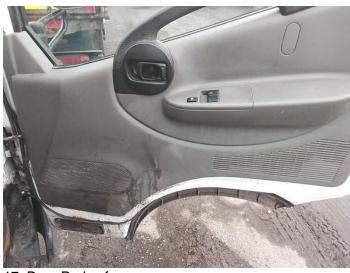
17: Door Pad osf Soiled Heavy

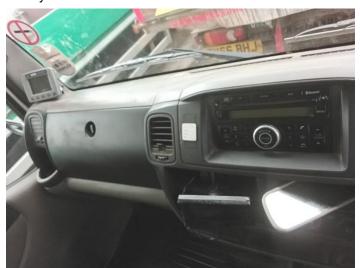
19: Fascia Panel Soiled Heavy

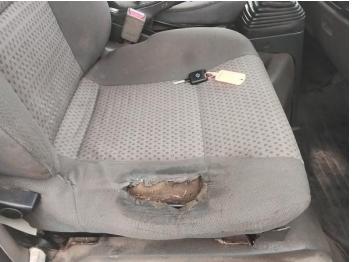
18: Seat Base Cover osf Holed Over 3mm
