VEHICLE INSPECTION REPORT

KU69XPY

Scania R 410

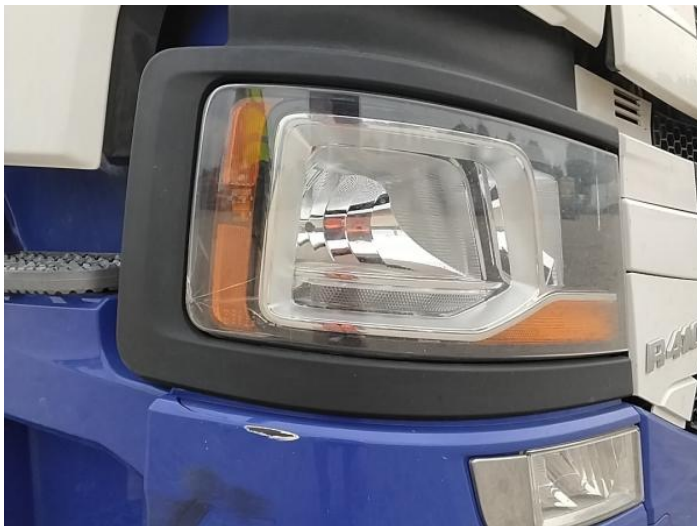
1: Headlamp os
Broken
Replace

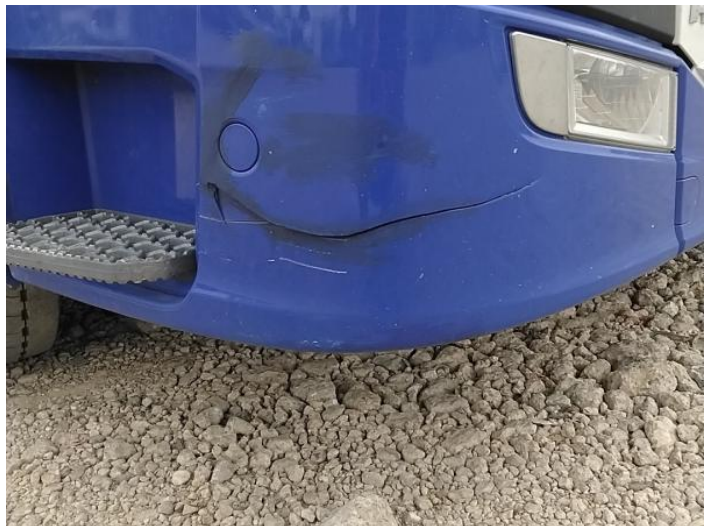
2: Bumper Front
Cracked
Over 25mm

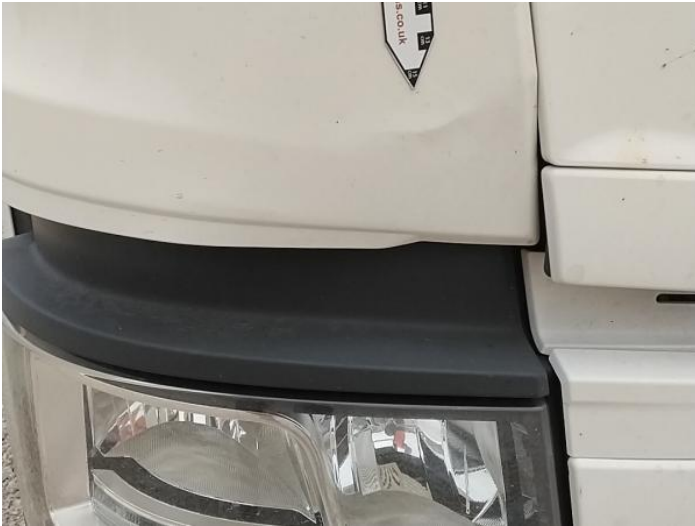
3: Wing osf
Dented
Over 30mm

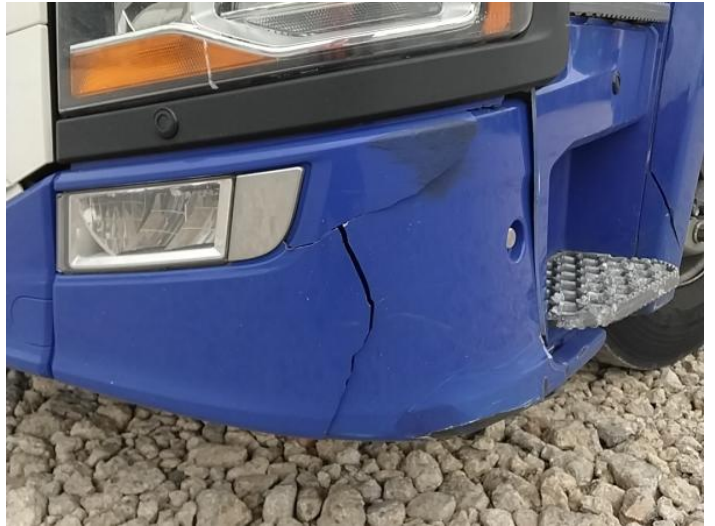
4: Bumper Front
Cracked
Over 25mm

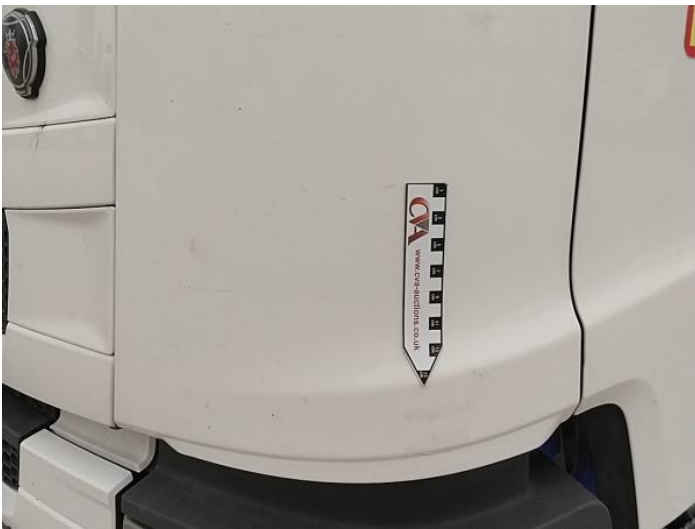
5: Wing nsf
Poor Previous Repair
Poor Paint

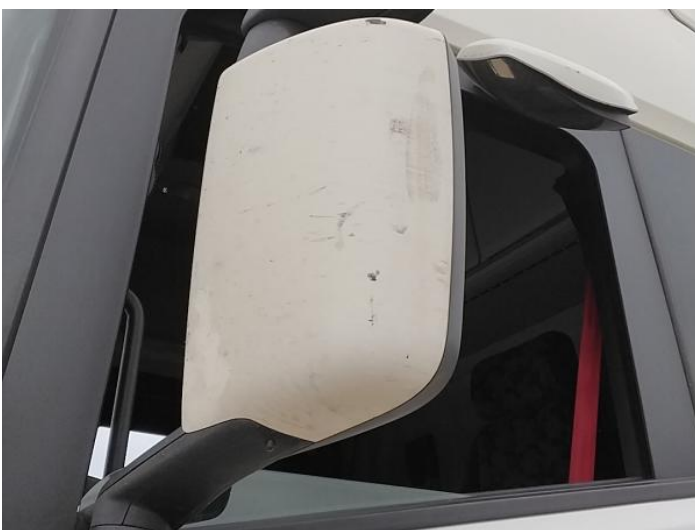
7: Door Mirror Assy nsf
Scratched (Painted)
Over 25mm Thru Paint

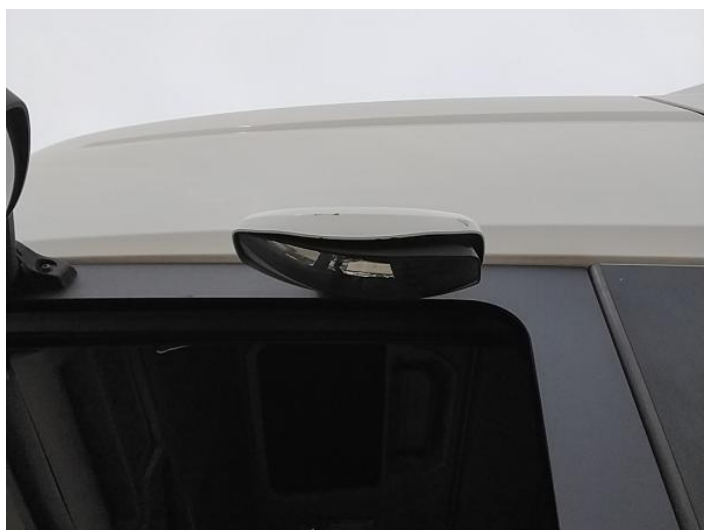
8: Door Mirror Assy nsf
Scratched (Painted)
UpTo 25mm Thru Paint

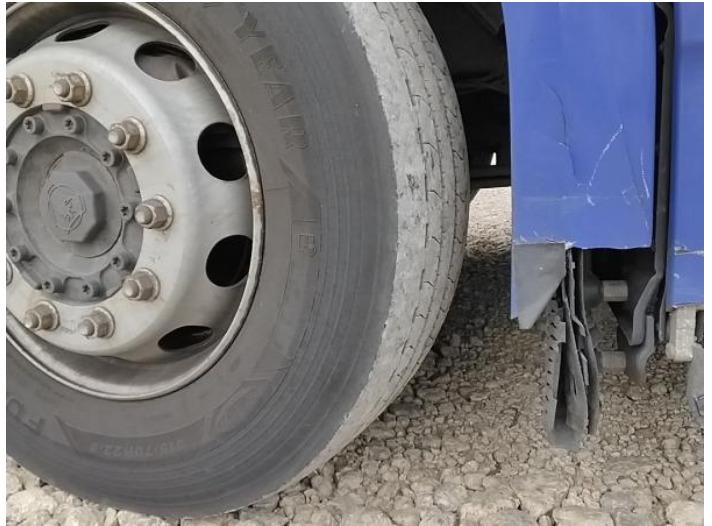
10: Wing Front Arch Extension ns
Broken
Replace

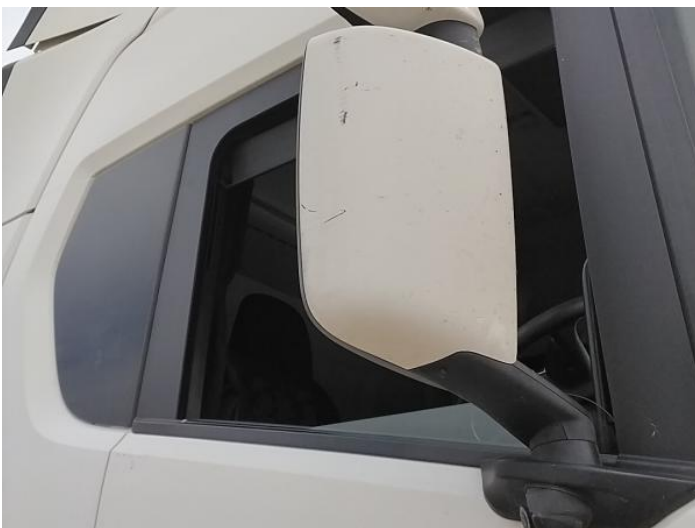
13: Door Mirror Assy osf
Scratched (Painted)
Over 25mm Thru Paint

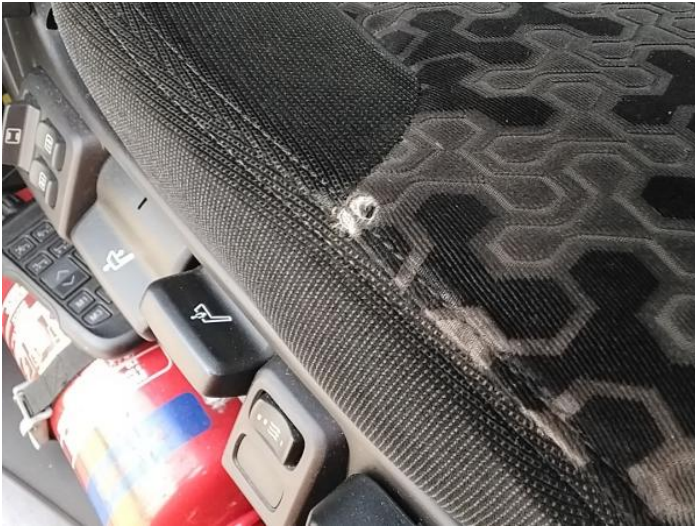
15: Seat Base Cover nsf
Holed
Over 3mm

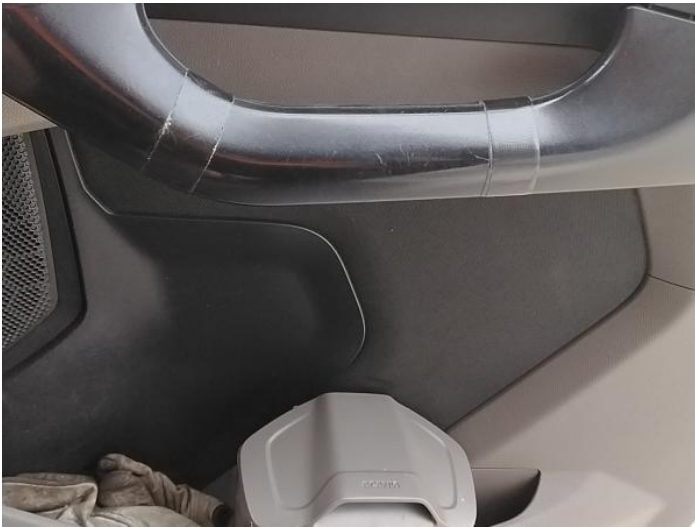
17: Handle Inner osf
Damaged
Replace
