# VEHICLE INSPECTION REPORT

**BU68HVV**

## ISUZU D-MAX 1.9 Double Cab 4x4

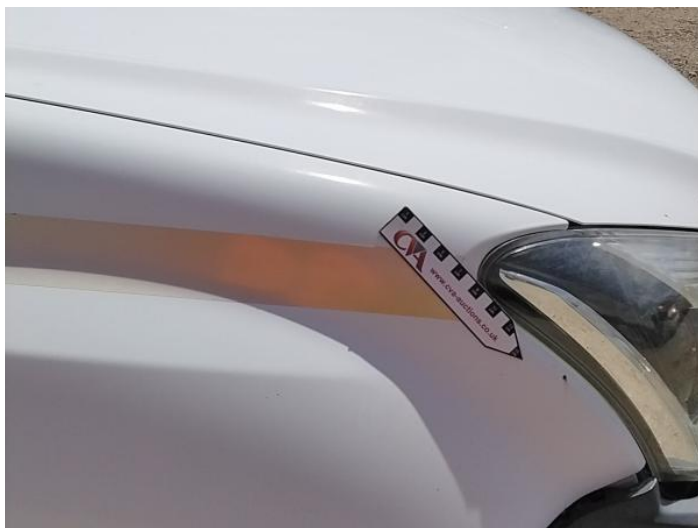
1: Wing osf  
Chipped  
1 To 5

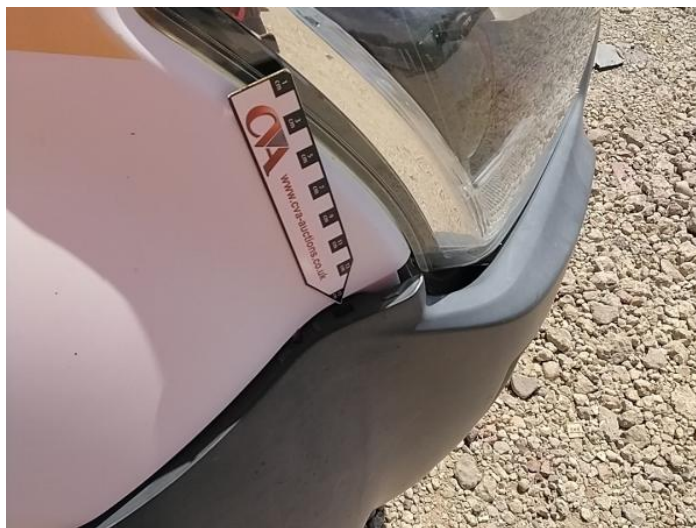
2: Bumper Front  
Insecure  
Action Required

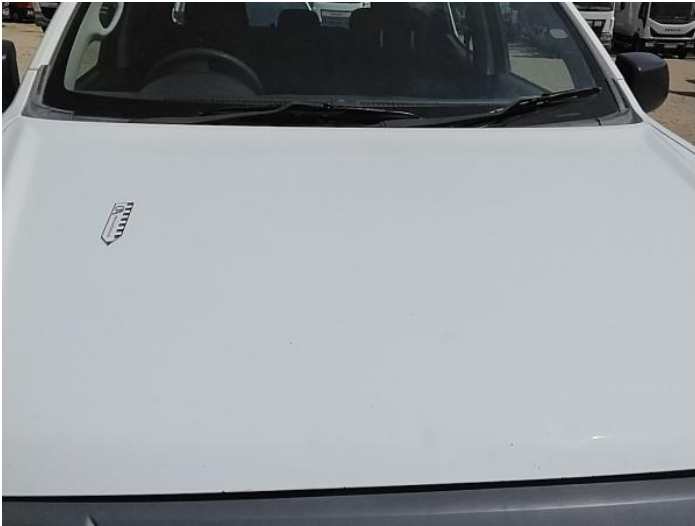
3: Bonnet  
Chipped  
Multiple Chips

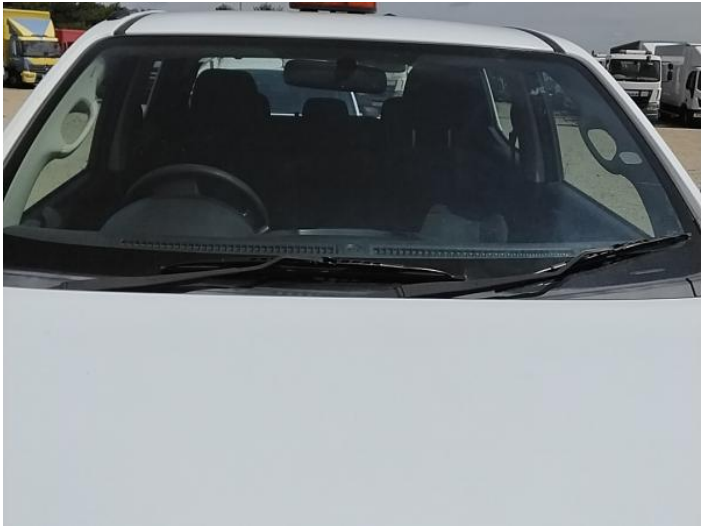
4: Screen Front  
Chipped  
UpTo 10mm

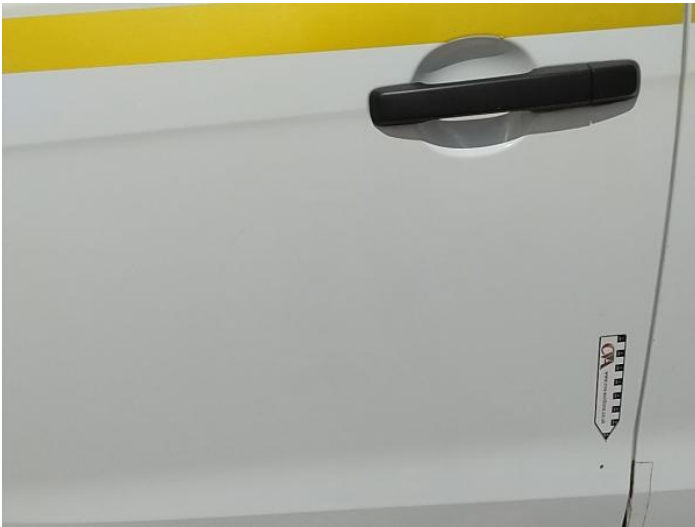
5: Door nsf  
Chipped  
Over 5mm

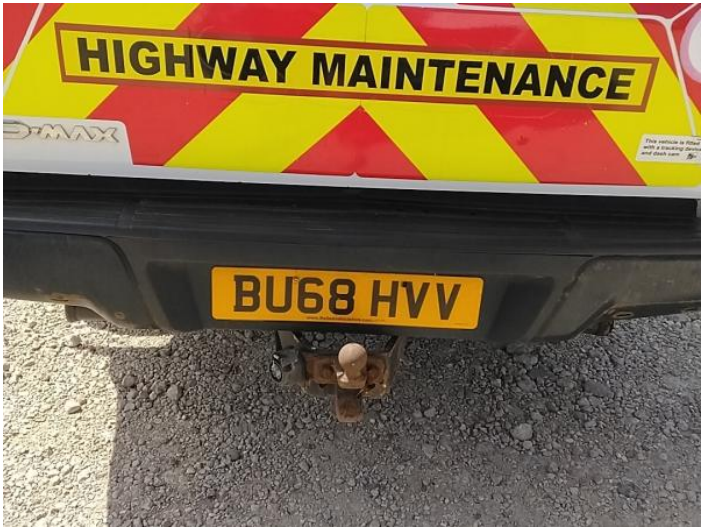
6: Bumper Rear  
Rusted  
Over 5mm
