VEHICLE INSPECTION REPORT

NU20OZE

Iveco Stralis 460

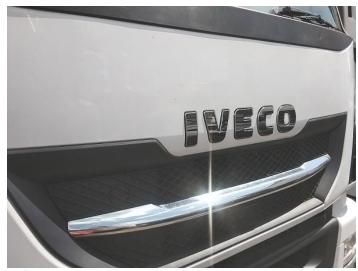
1: Bonnet Chipped Multiple Chips

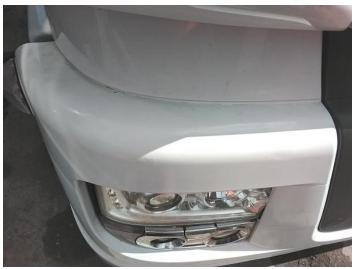
2: Panel Front Poor Previous Repair Rippled UpTo 30%

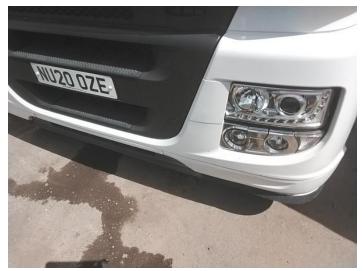
3: Bumper Front Chipped Multiple Chips

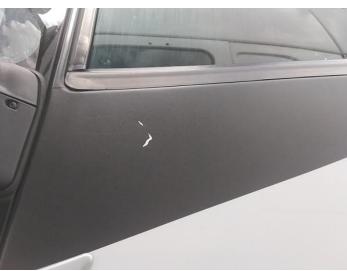
4: Door nsf Scratched Over 25mm Thru Paint

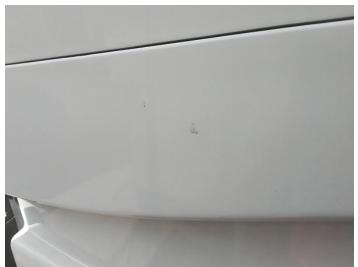
5: Door nsf Chipped Multiple Chips

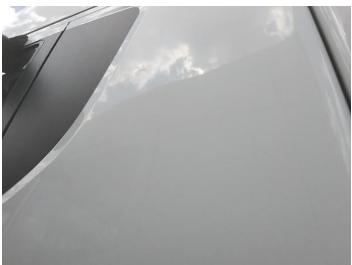
6: Qtr Panel nsr Scratched Over 25mm Not Thru Paint

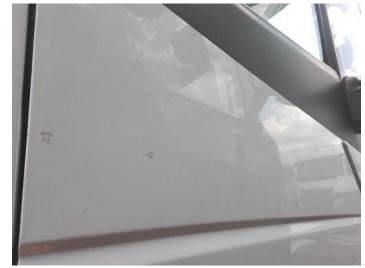
7: Door osf Chipped Multiple Chips
