## **VEHICLE INSPECTION REPORT**

**YO190WH**

## Ford Transit 350 2.0 TDCI 130PS

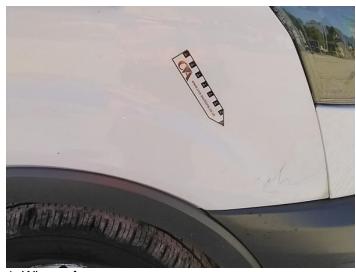
1: Wing osf Scratched Over 25mm Thru Paint

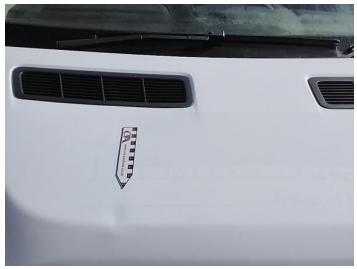
3: Bonnet Dented Between 10mm + 30mm

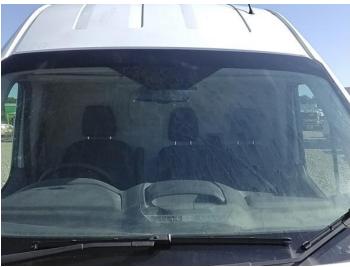
4: Screen Front Chipped UpTo 10mm

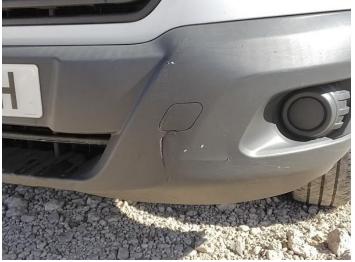
5: Bumper Front Cracked Over 25mm

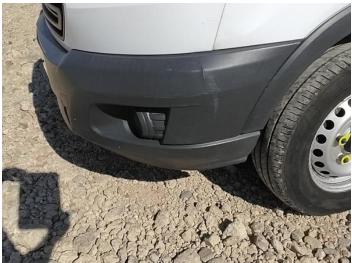
6: Bumper Front Scratched Over 25mm Not Thru Paint

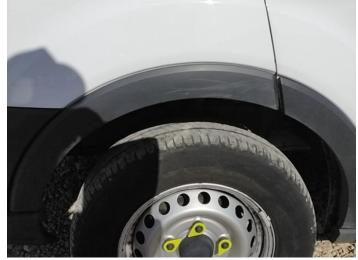
7: Moulding nsf Wing Scuffed (Unpainted) Over 100mm

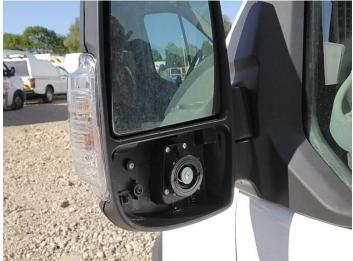
8: Door Mirror Glass ns Missing Replace

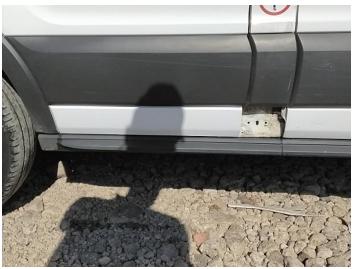
9: Door Moulding nsf Scuffed (Unpainted) Over 100mm

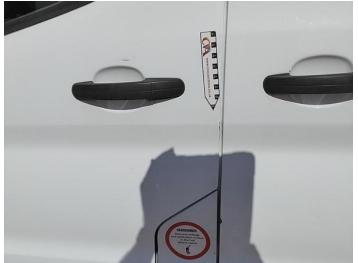
11: Door nsf Chipped Edge Chip

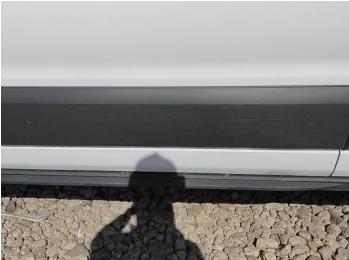
12: Qtr Panel Moulding ns Scuffed (Unpainted) Over 100mm

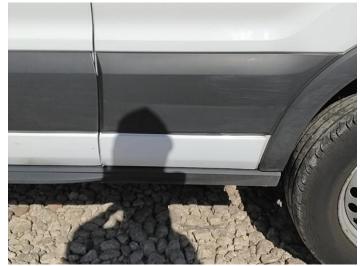
13: Qtr Panel Moulding ns Scuffed (Unpainted) Over 100mm

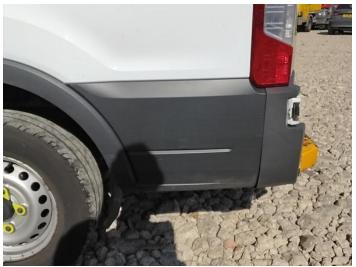
15: Qtr Panel Trim ns Scuffed Over 25mm

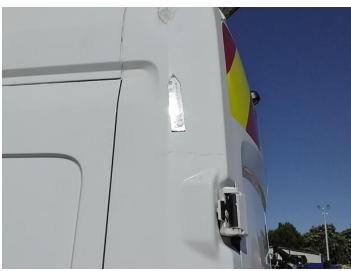
16: Qtr Panel nsrDentedWith Paint Damage

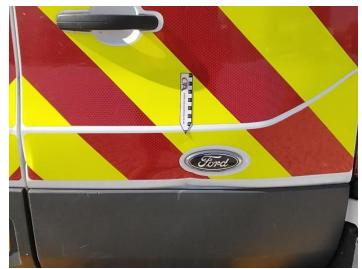
17: Door osr Dented With Paint Damage

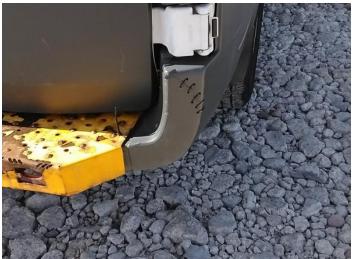
18: Bumper Rear Cracked Over 25mm

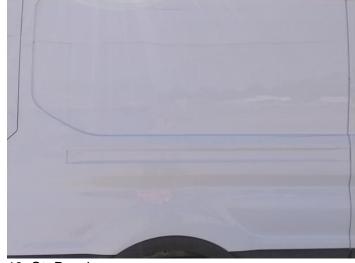
19: Qtr Panel osr Dented Over 30% Of Panel

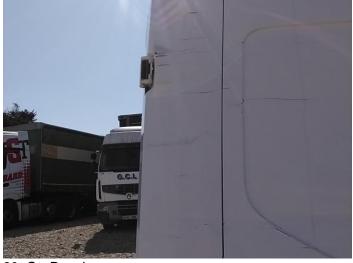
20: Qtr Panel osr Scratched Over 25mm Thru Paint

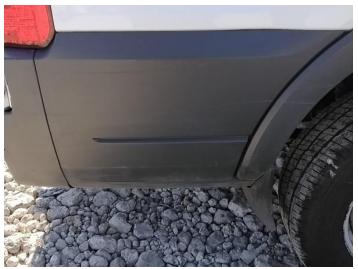
21: Qtr Panel Trim os Scuffed Over 25mm

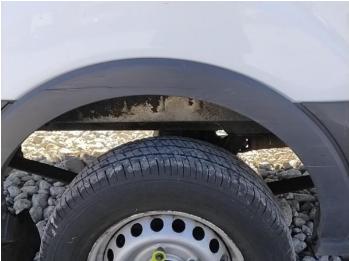
22: Qtr Panel Arch Extension os Scuffed (Unpainted) Over 100mm

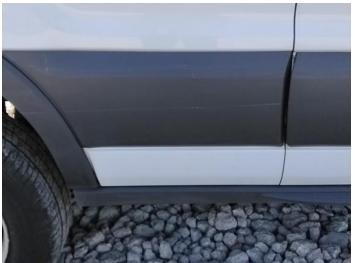
23: Qtr Panel Trim os Scuffed Over 25mm

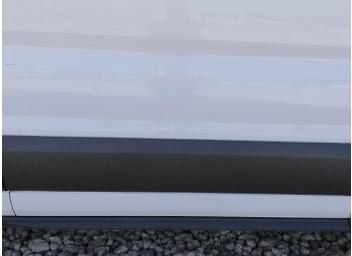
24: Qtr Panel Moulding os Scuffed (Unpainted) Over 100mm

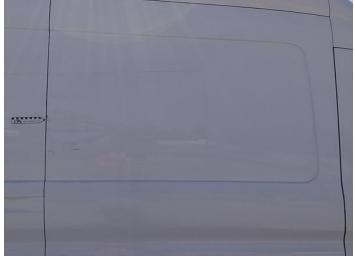
25: Qtr Panel osr Dented With Paint Damage

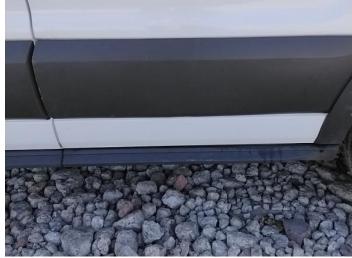
26: Door Moulding osf Scuffed (Unpainted) Over 100mm

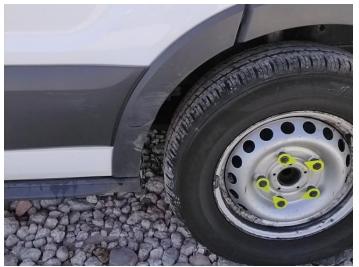
27: Moulding osf Wing Scuffed (Unpainted) Over 100mm
