# VEHICLE INSPECTION REPORT

**LL68FOT**

## Isuzu F110 210

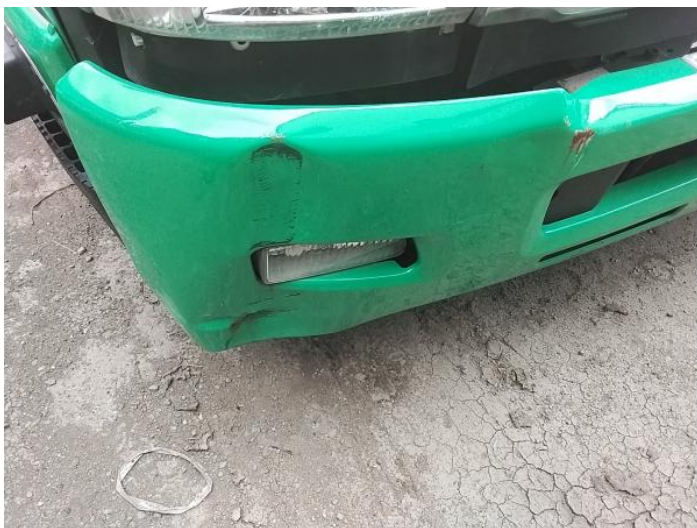
1: Bumper Front  
Dented  
With Paint Damage

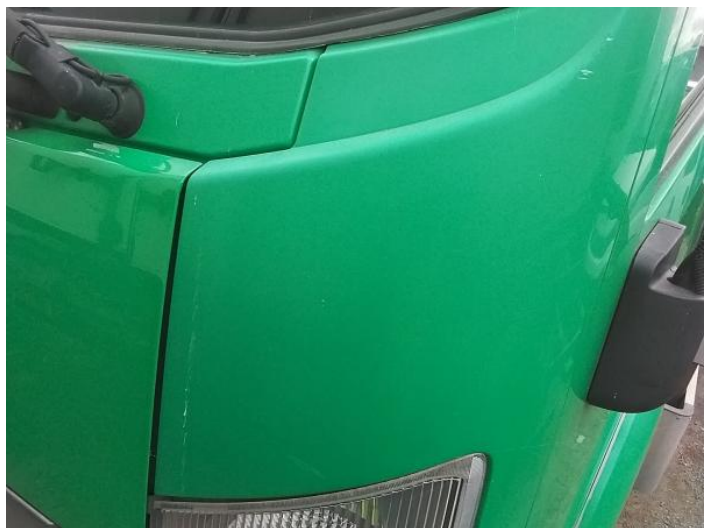
2: Panel Front  
Scratched  
Over 25mm Thru Paint

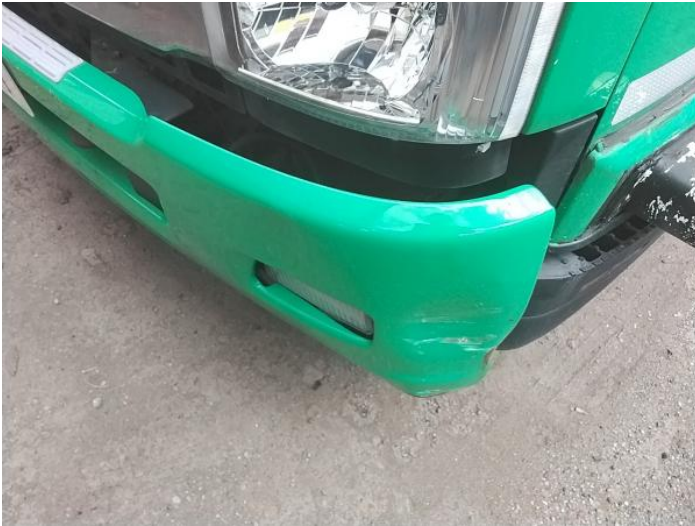
3: Bumper Front  
Dented  
With Paint Damage

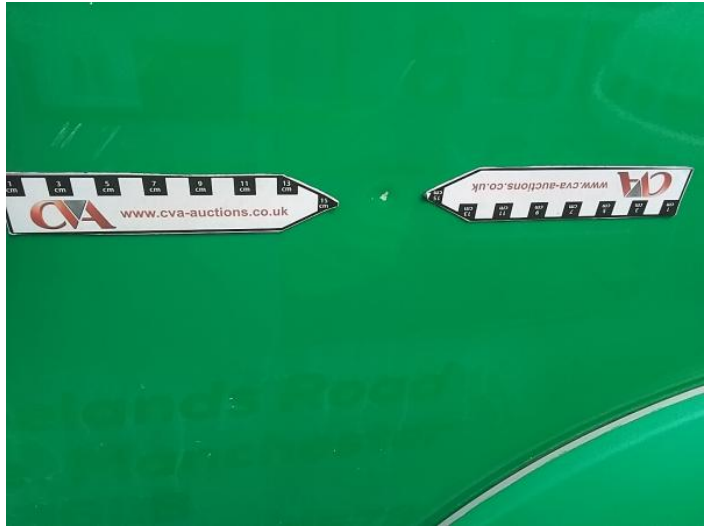
4: Door nsf  
Dented  
With Paint Damage

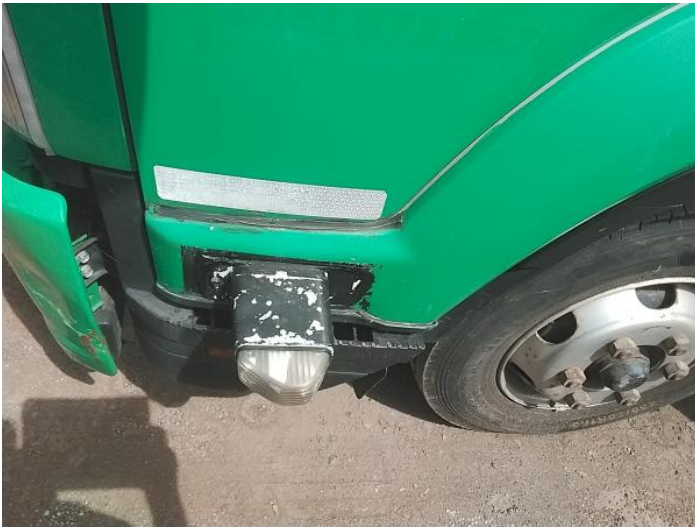
5: Door Moulding nsf  
Broken  
Replace

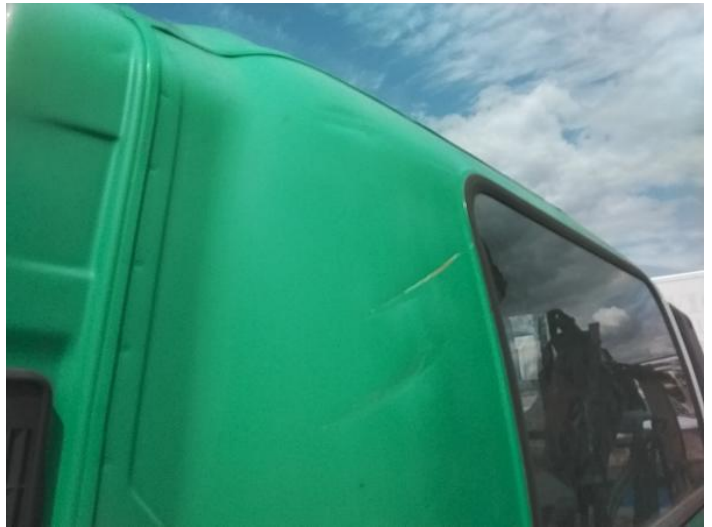
6: Panel Rear  
Dented  
With Paint Damage

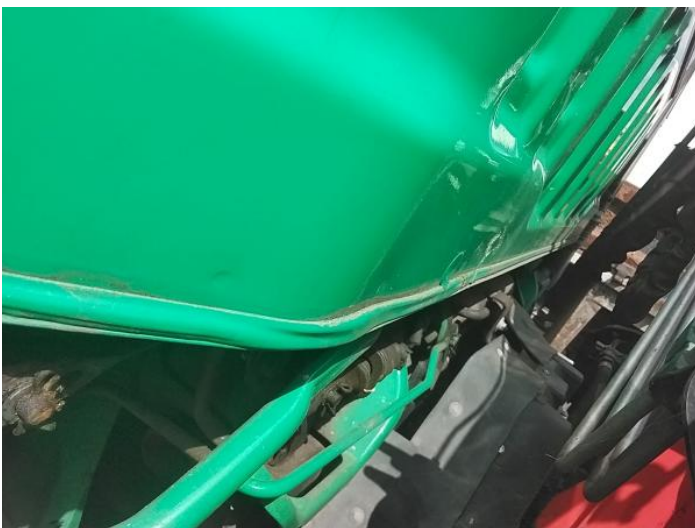
7: Panel Rear  
Dented  
With Paint Damage

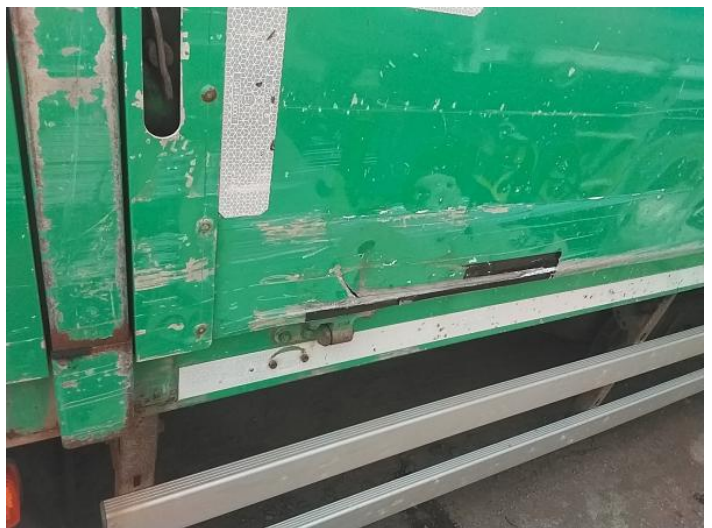
8: Qtr Panel osr  
Cracked  
Replace

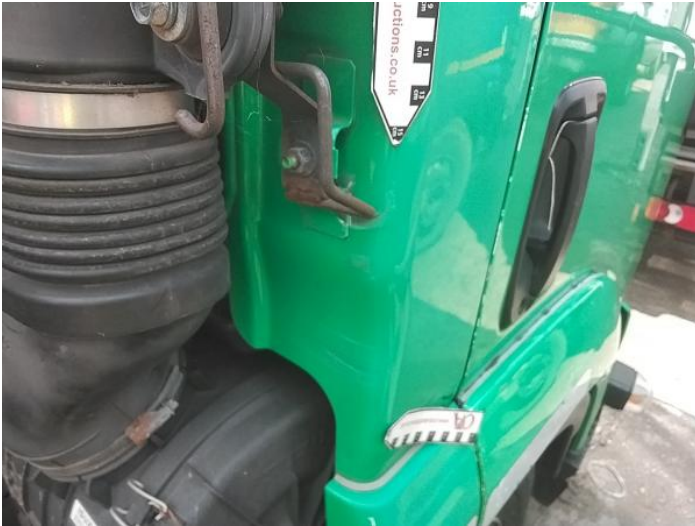
9: B Post os  
Scratched  
Over 25mm Thru Paint

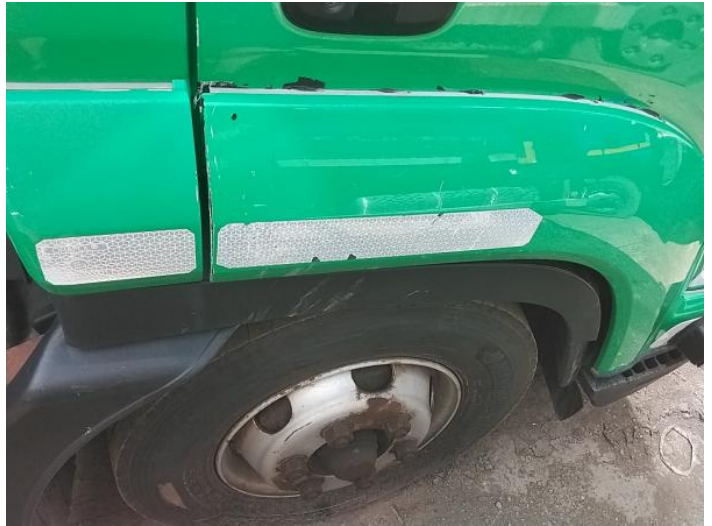
10: Door Moulding osf  
Scratched (Painted)  
Over 25mm Thru Paint

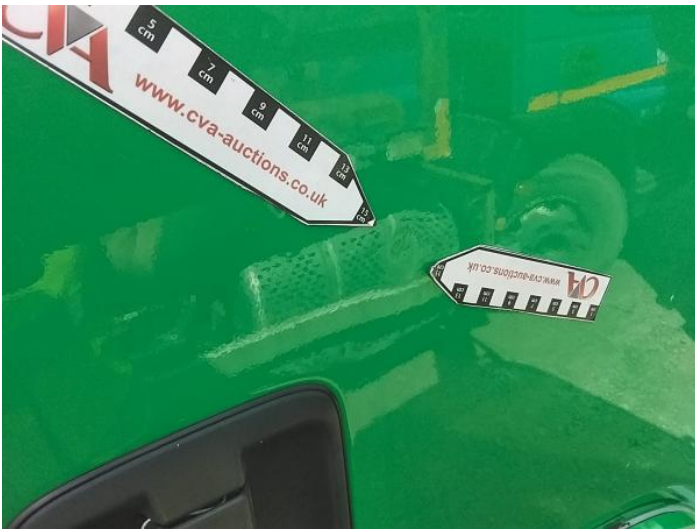
11: Door osf  
Dented  
With Paint Damage

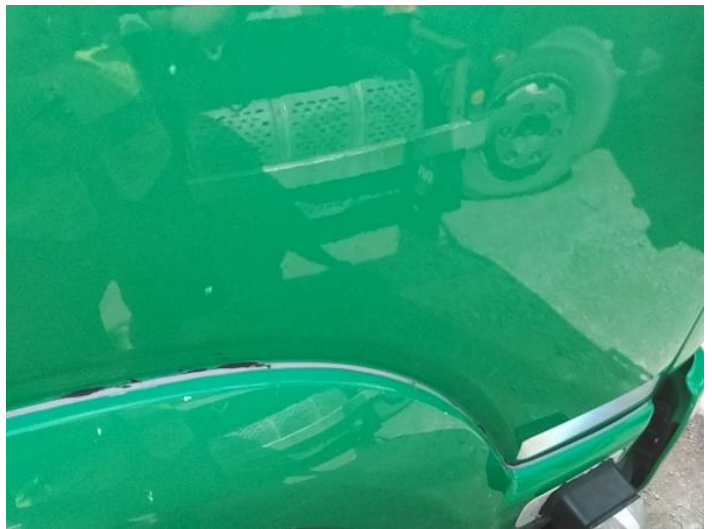
12: Door osf  
Chipped  
Multiple Chips

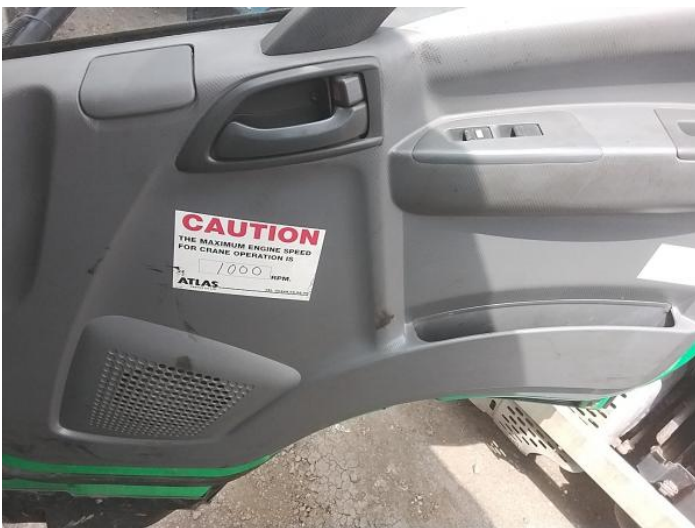
13: Door Pad osf  
Soiled  
Heavy

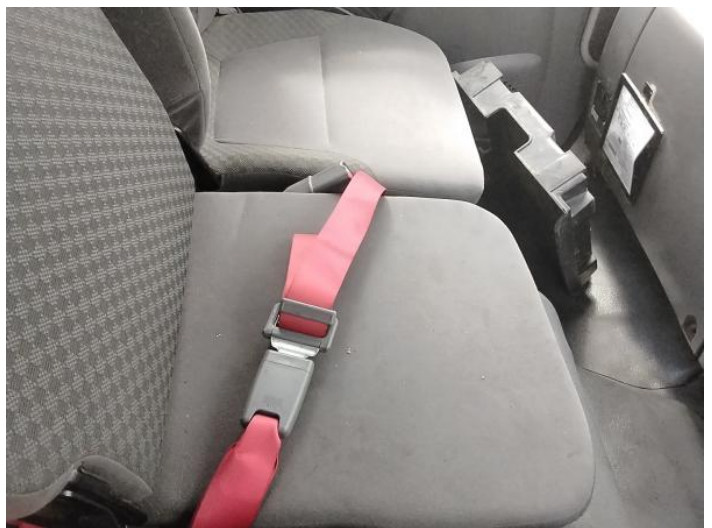
14: Seat Base Cover nsf  
Soiled  
Heavy
