# VEHICLE INSPECTION REPORT

**GM17NTD**

## Volvo FE 320

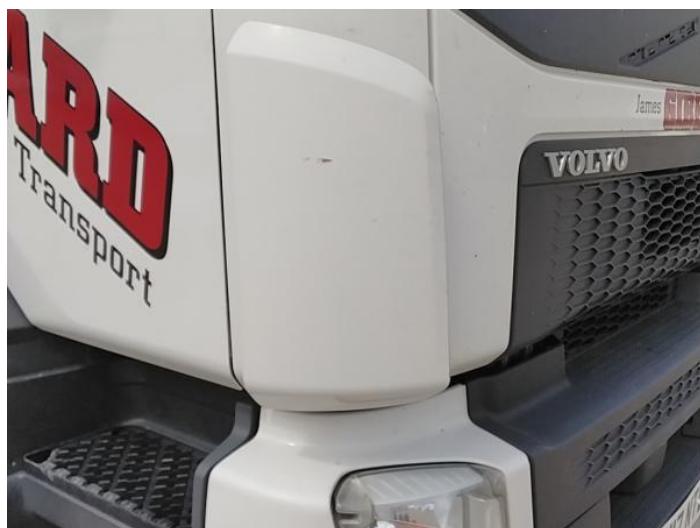
1: Wing osf  
Scratched  
Over 25mm Not Thru Paint

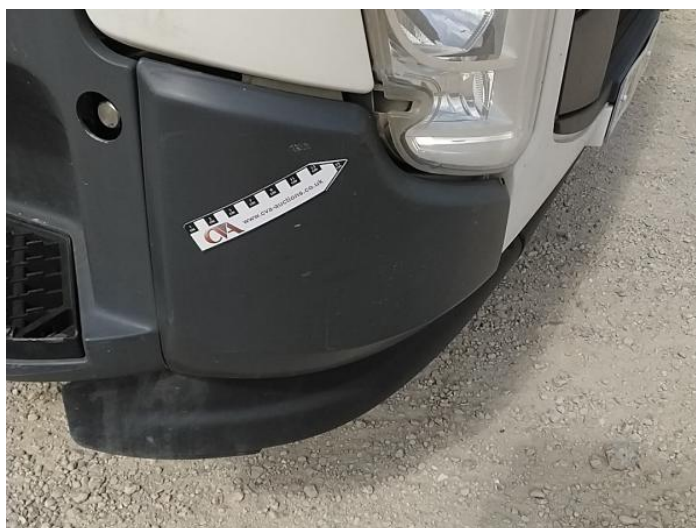
2: Bumper Front  
Rusted  
Over 5mm

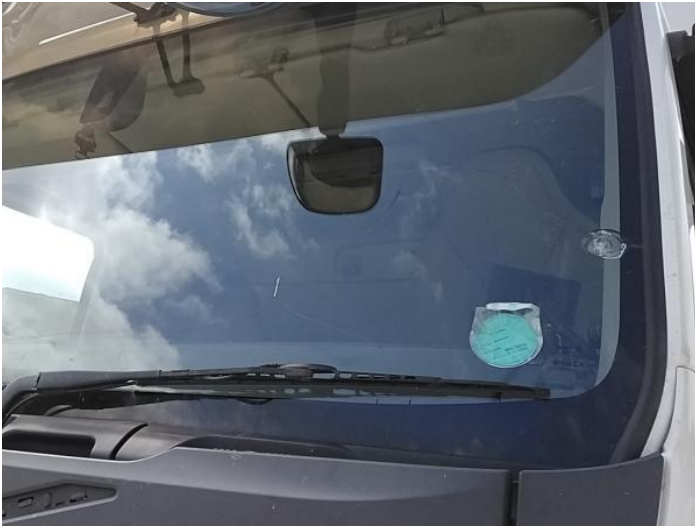
3: Screen Front  
Cracked  
Replace

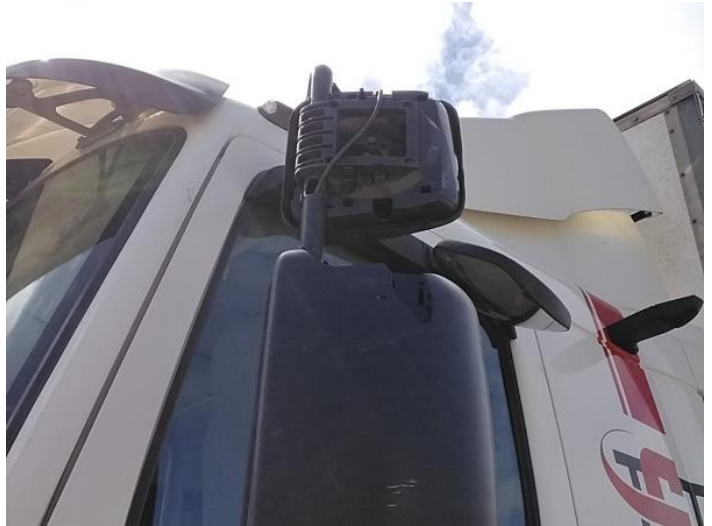
4: Door Mirror Assy nsf  
Missing  
Replace

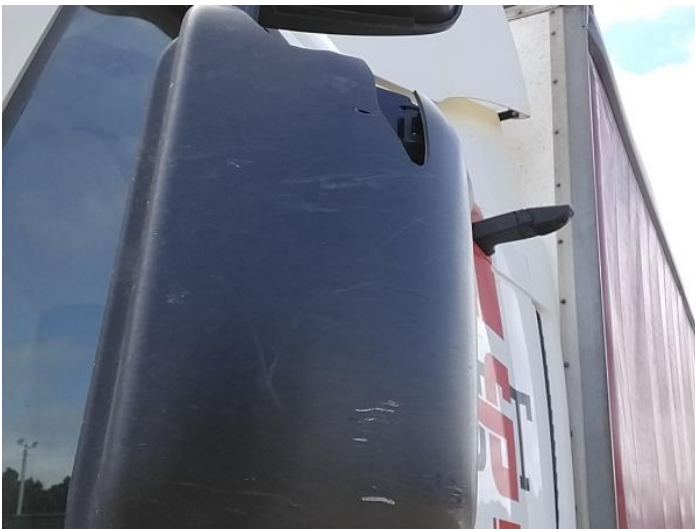
5: Door Mirror Assy nsf  
Broken  
Replace

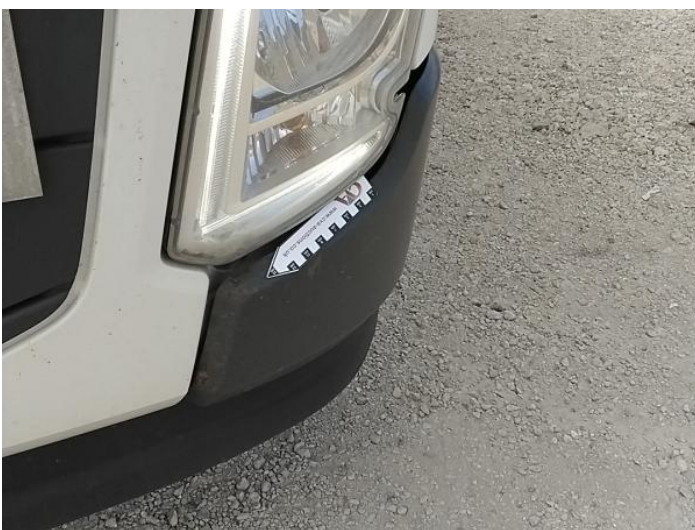
7: Bumper Front  
Rusted  
Over 5mm

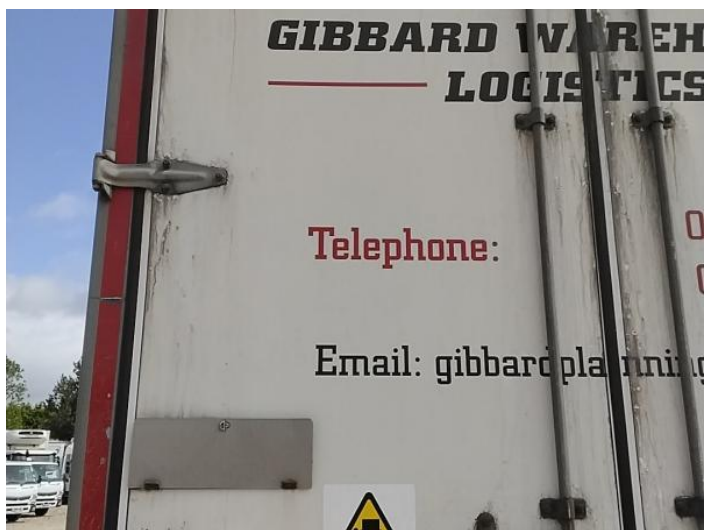
8: Door nsr  
Hole  
UpTo 10mm

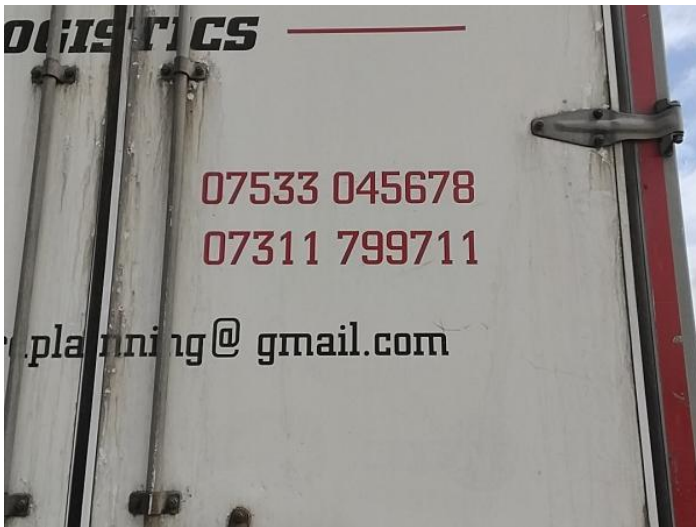
9: Door osr  
Hole  
UpTo 10mm

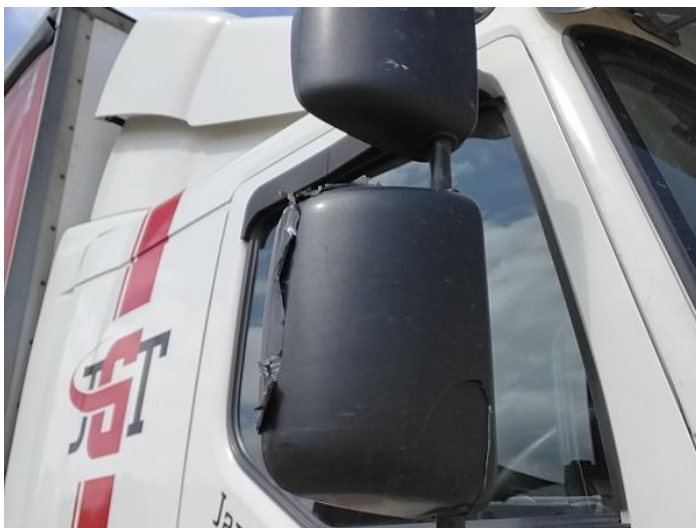
13: Door Mirror Assy osf  
Broken  
Replace

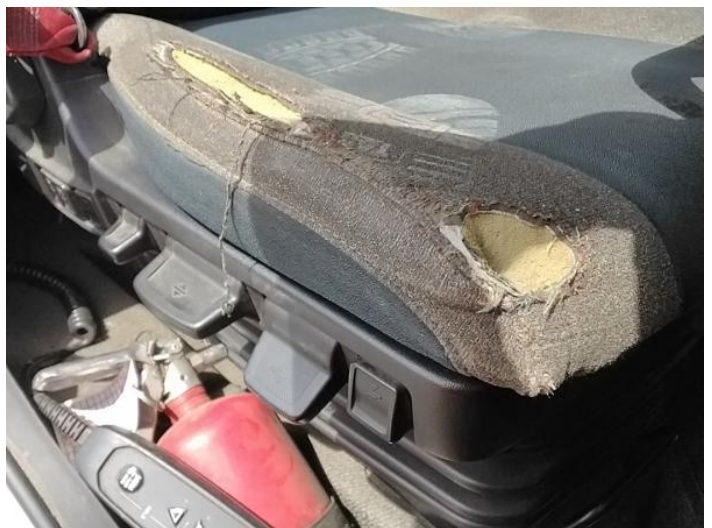
14: Seat Base Cover osf  
Torn  
Over 3mm

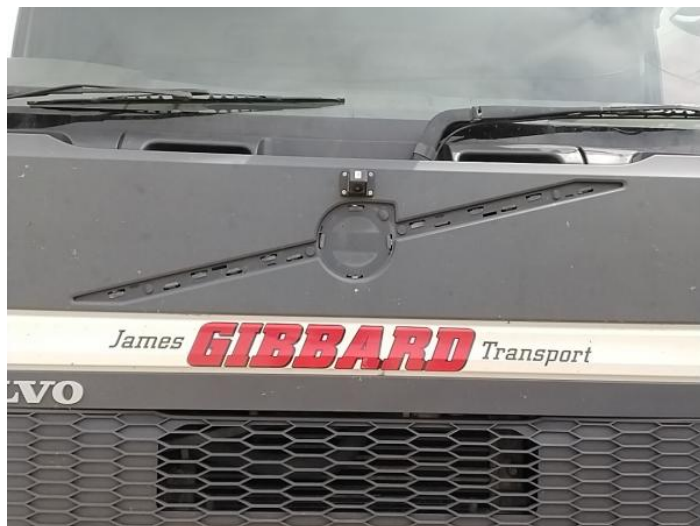
15: Badgedecal Front  
Missing  
Replace
