VEHICLE INSPECTION REPORT

AY18JYD

Mercedes-Benz Actros 2553

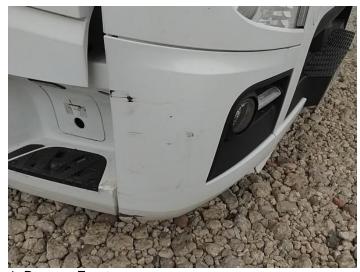
1: Bumper Front Scratched Over 100mm Thru Paint

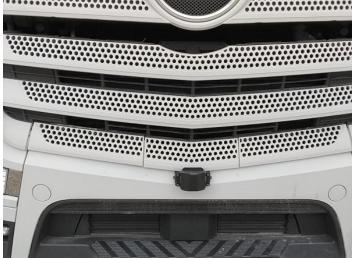
2: Bonnet Chipped Multiple Chips

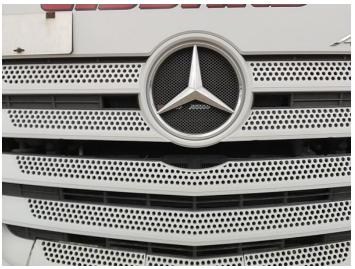
3: Bonnet Missing Replace

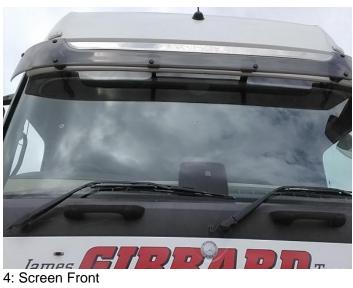
4: Screen From Chipped Over 10mm

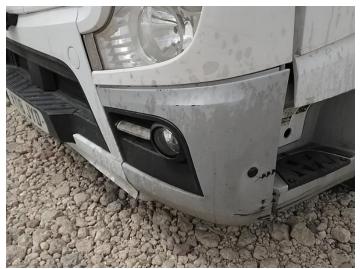
5: Bumper Front Poor Previous Repair Poor Paint

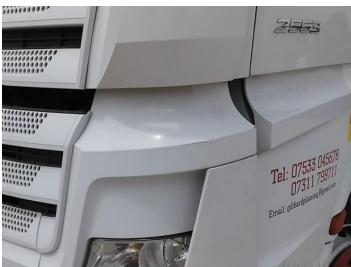
6: Wing nsf Scratched Over 25mm Thru Paint

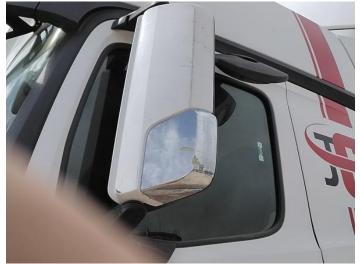
7: Door Mirror Assy nsf Scratched (Painted) Over 25mm Thru Paint

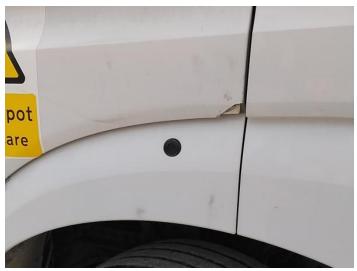
15: Door nsf Chipped Edge Chip

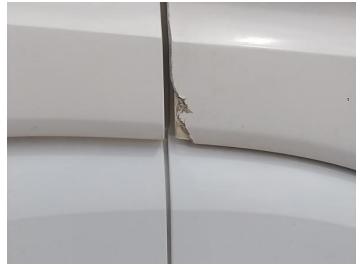
17: Door osf Chipped Over 5mm

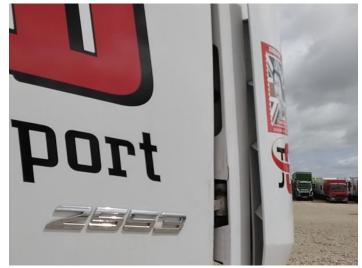
19: Wing osf Cracked Replace

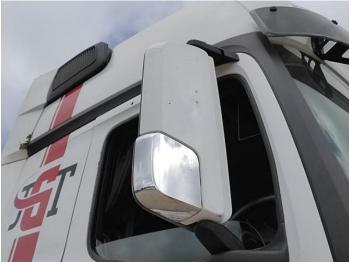
20: Door Mirror Assy osf Scratched (Painted) Over 25mm Thru Paint

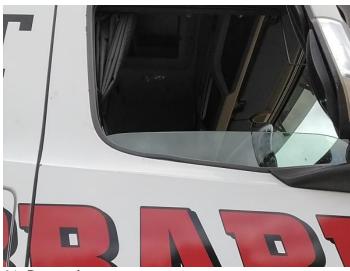
21: Door osf Scratched Over 25mm Thru Paint
