VEHICLE INSPECTION REPORT

Ford Transit 350 2.0 TDCi 130PS

Reg. date	30/09/2017	VIN	WF0XXXTTGXHB69873	CAP Below	£1,925.00
Year	2017	Body Style	Panel Van L3	Gearbox	MANUAL
Mileage	163,045 Miles	MOT Due	24/07/2025	Gears	6
	Warranted	CAP Clean	£3,025.00		
Fuel Type	Diesel	CAP Average	£2.550.00		
Colour	GREEN	<u></u>

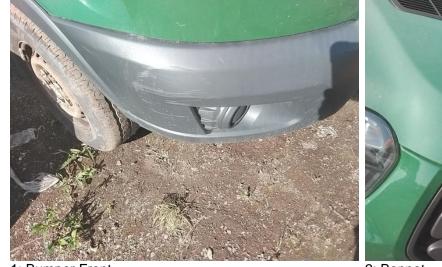
1: Bumper Front Scratched Over 100mm Thru Paint

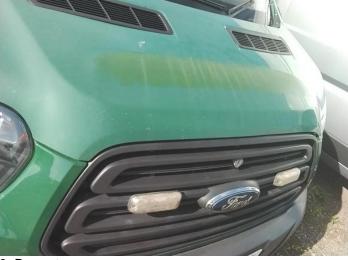
2: Bonnet Chipped Multiple Chips

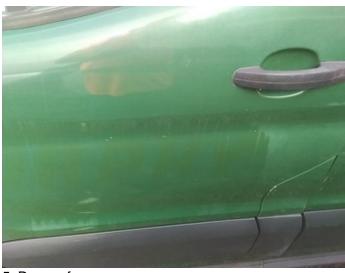
5: Door nsf Chipped Multiple Chips

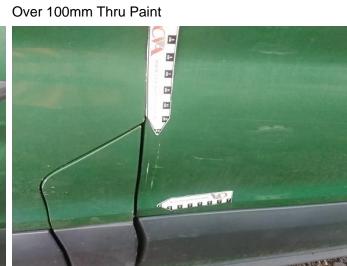
6: Qtr Panel nsr Dented With Paint Damage

Scratched

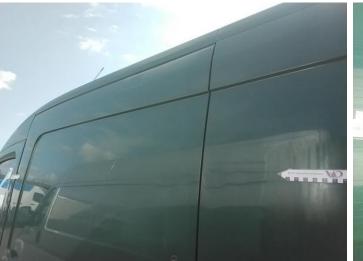
7: Qtr Panel nsr Scratched Over 25mm Thru Paint

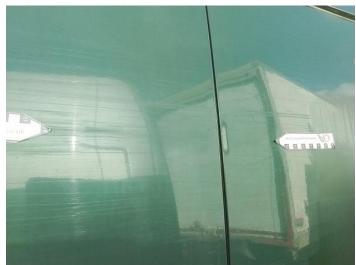
8: Qtr Panel nsr Dented Over 30mm

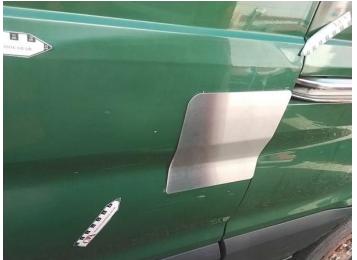
9: Qtr Panel nsr Dented Over 30mm

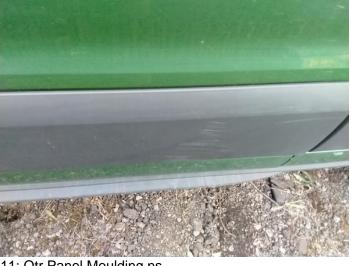
11: Qtr Panel Moulding ns Scuffed (Unpainted) Over 100mm

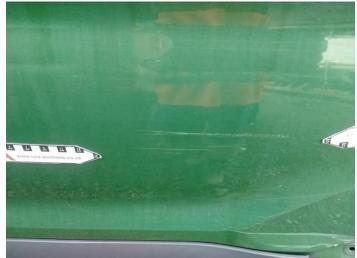
13: Qtr Panel nsr Scratched Over 25mm Thru Paint

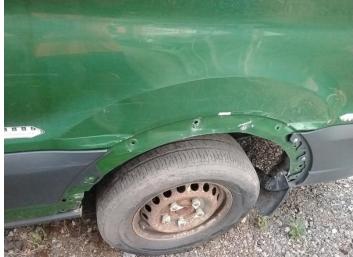
14: Qtr Panel nsr Dented With Paint Damage

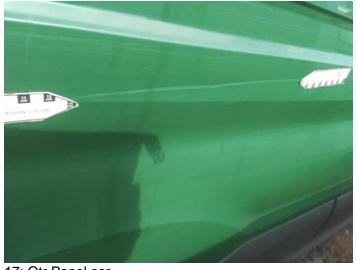
17: Qtr Panel osr Dented Over 30mm

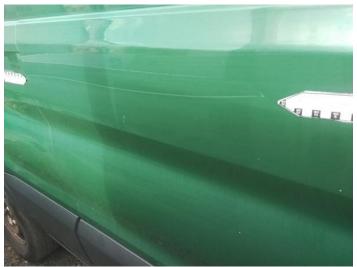
19: Qtr Panel osr Scratched Over 25mm Thru Paint

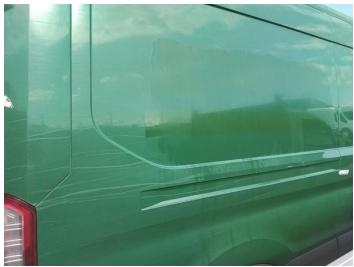
16: Qtr Panel osr Scratched Over 25mm Thru Paint

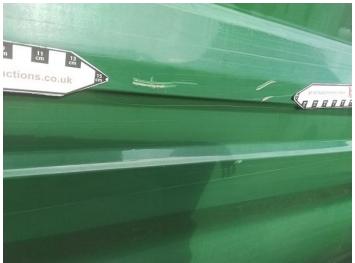
18: Qtr Panel osr Dented With Paint Damage

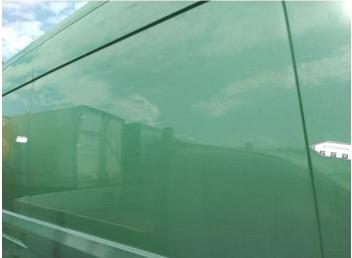
20: Qtr Panel osr Scratched Over 25mm Thru Paint

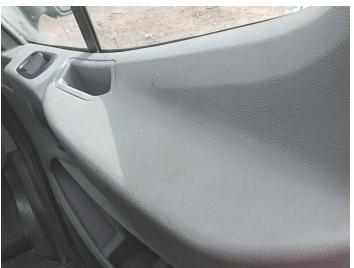
21: Door osf Chipped Multiple Chips

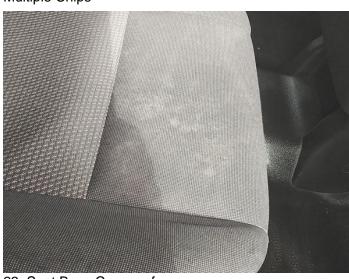
23: Seat Base Cover osf Soiled Heavy

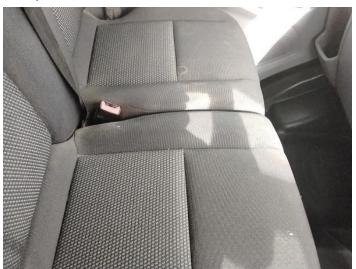
24: Seat Base Cover nsf Soiled Heavy

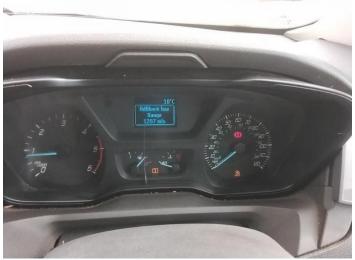
25: Dash Warning Lights Displayed No Action
