VEHICLE INSPECTION REPORT

DK69WHM

Isuzu GRAFTER N35.125

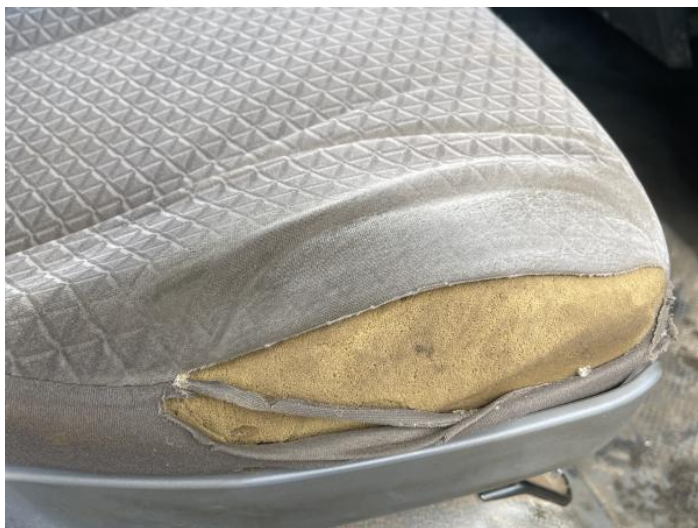
1: Seat Base Cover osf
Torn
Over 3mm

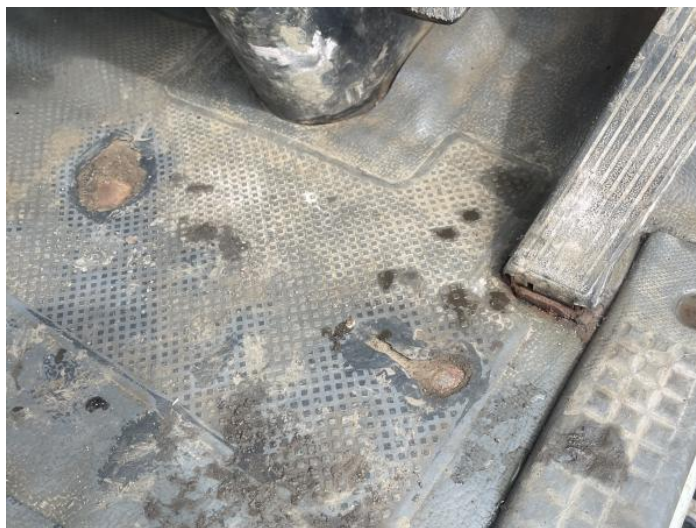
2: Carpets Front
Torn
Over 10mm

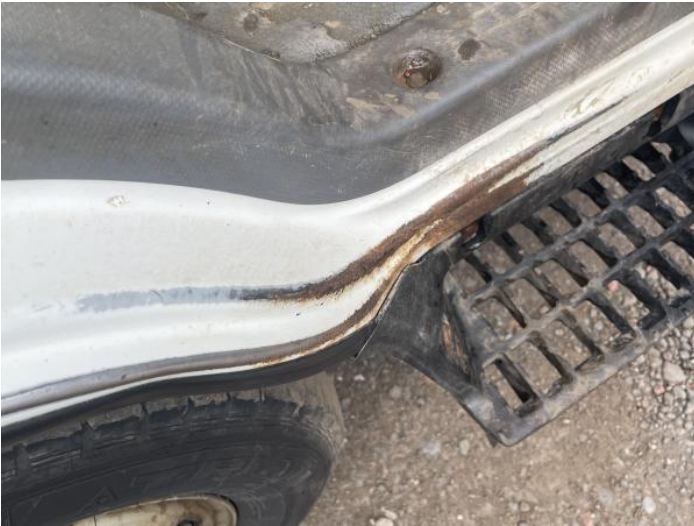
3: Sill os
Rusted
Over 5mm

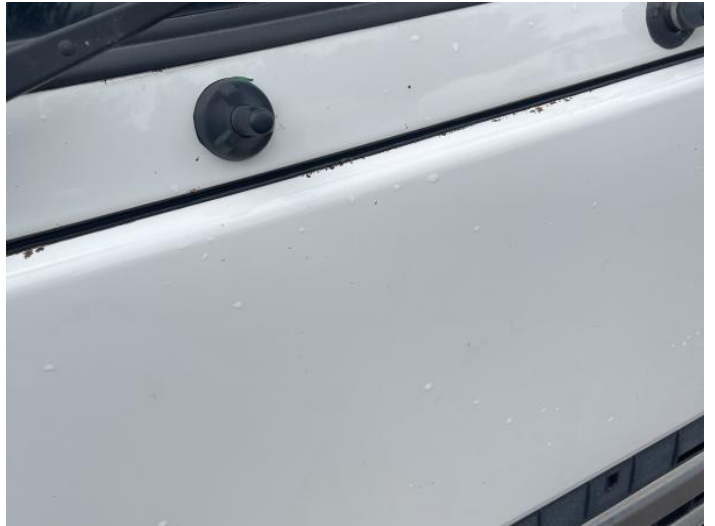
4: Bonnet
Rusted
Over 5mm

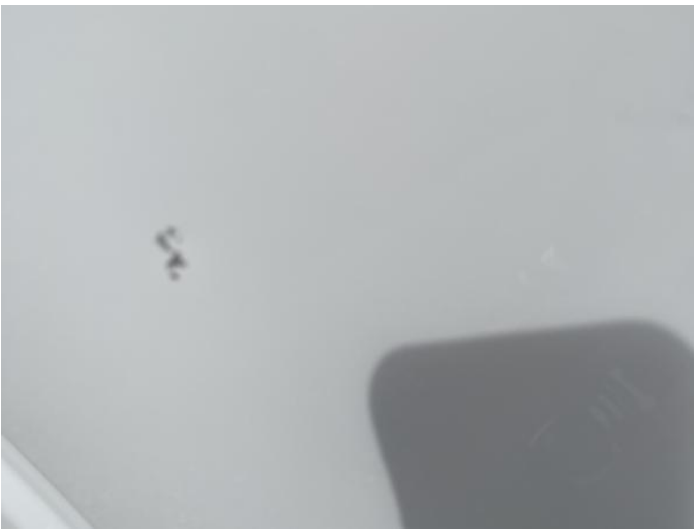
5: Door osf
Dented
With Paint Damage

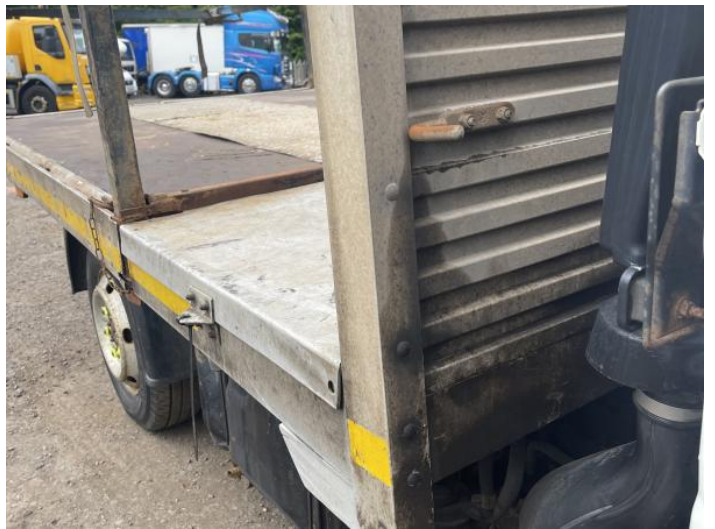
6: Qtr Panel osr
Rusted
Over 5mm

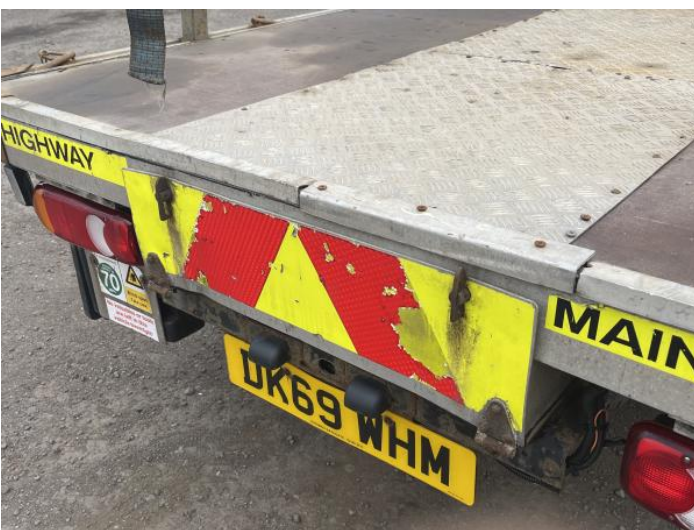
7: Tailgate
Dented
With Paint Damage

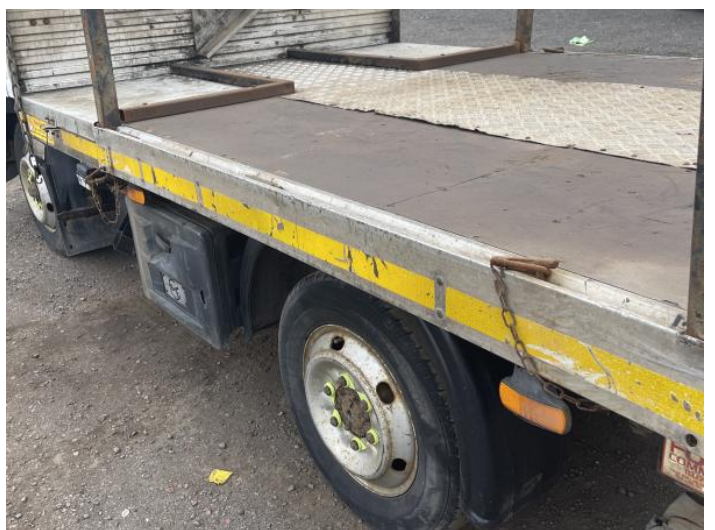
8: Qtr Panel nsr
Dented
With Paint Damage

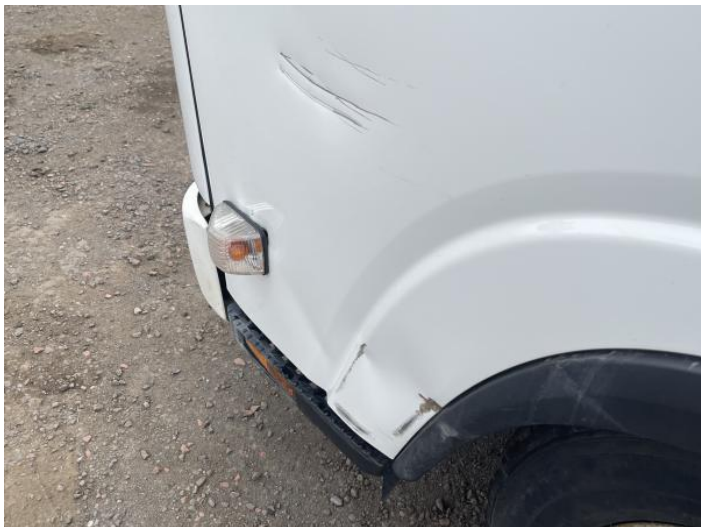
9: Door nsf
Dented
With Paint Damage
