# VEHICLE INSPECTION REPORT

**VX16AEE**

## Dennis Elite 6

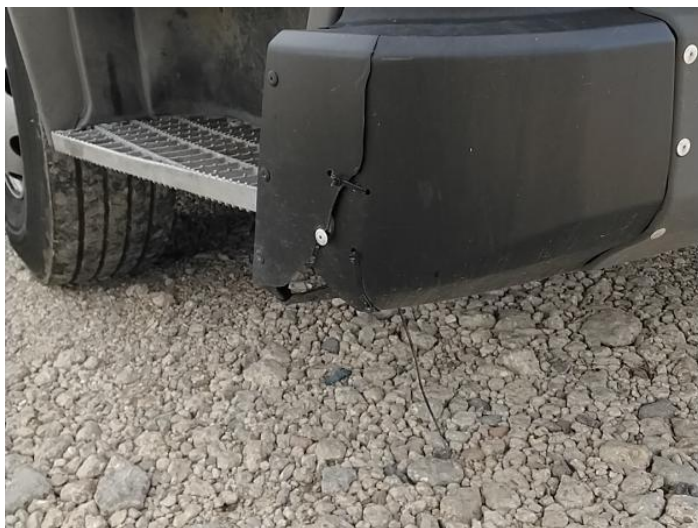
1: Bumper Front Moulding  
Broken  
Replace

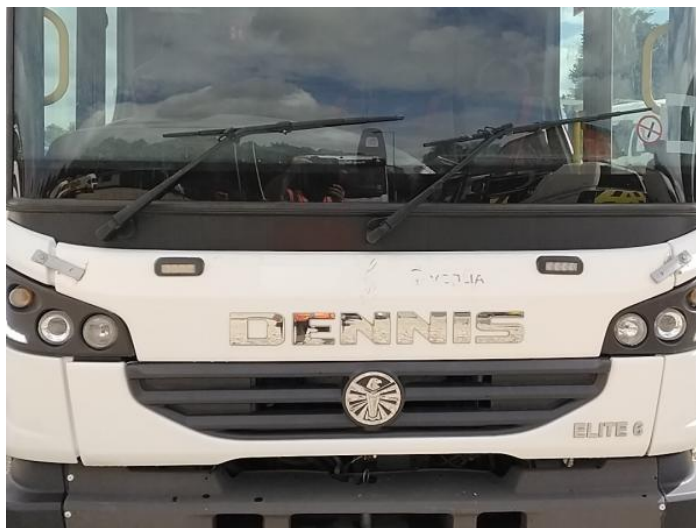
2: Bonnet  
Scratched  
UpTo 25mm Thru Paint

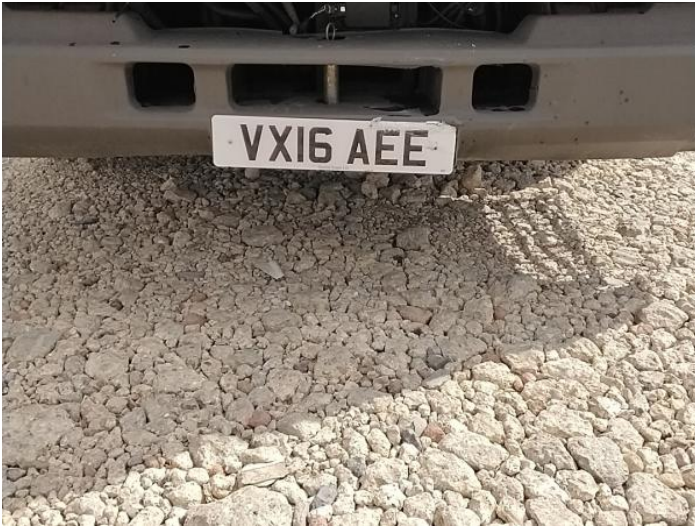
3: Bumper Front  
Cracked  
Over 25mm

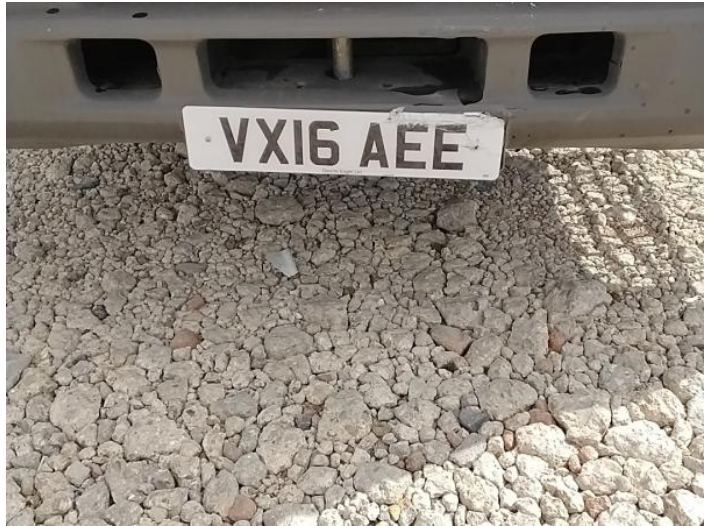
4: Number Plate Front  
Broken  
Replace

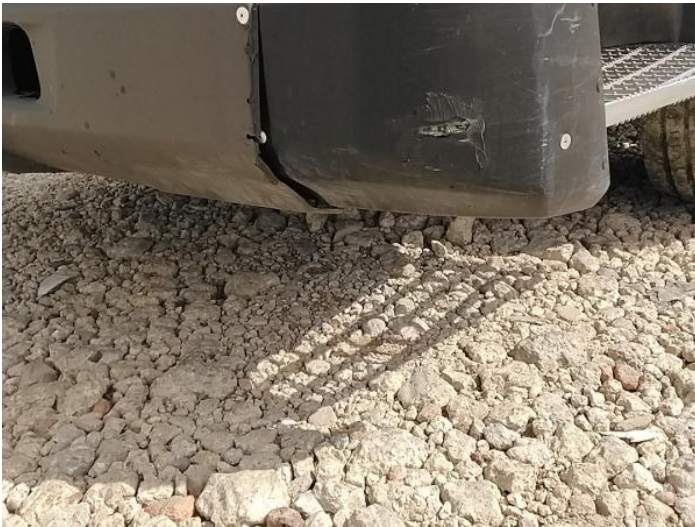
5: Bumper Front Moulding  
Broken  
Replace

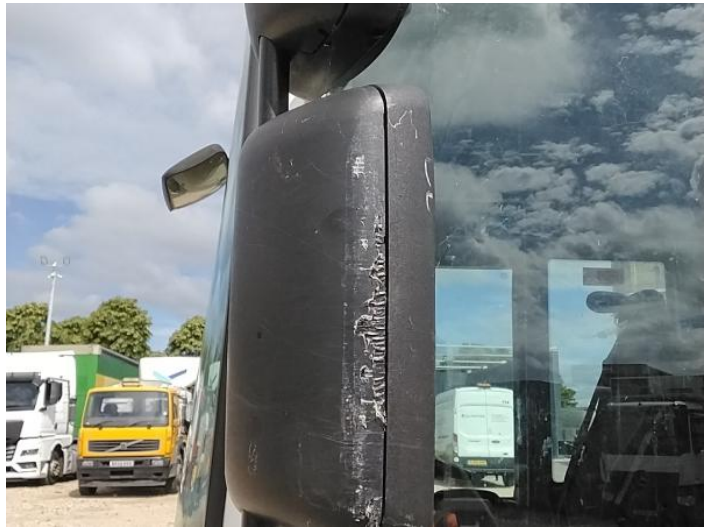
6: Door Mirror Assy nsf  
Scuffed (Unpainted)  
UpTo 100mm

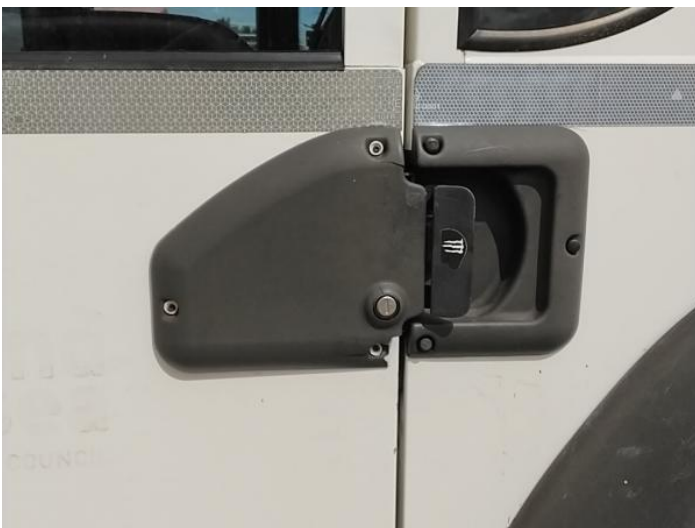
7: Handle Outer nsf  
Broken  
Replace

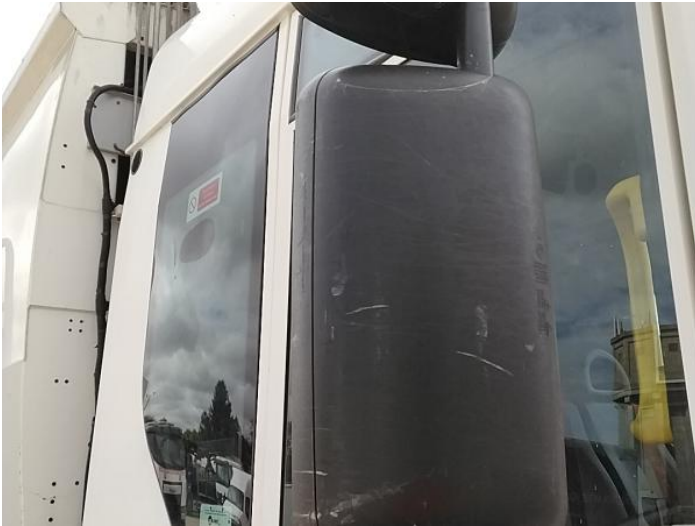
15: Door Mirror Assy osf  
Scuffed (Unpainted)  
UpTo 100mm

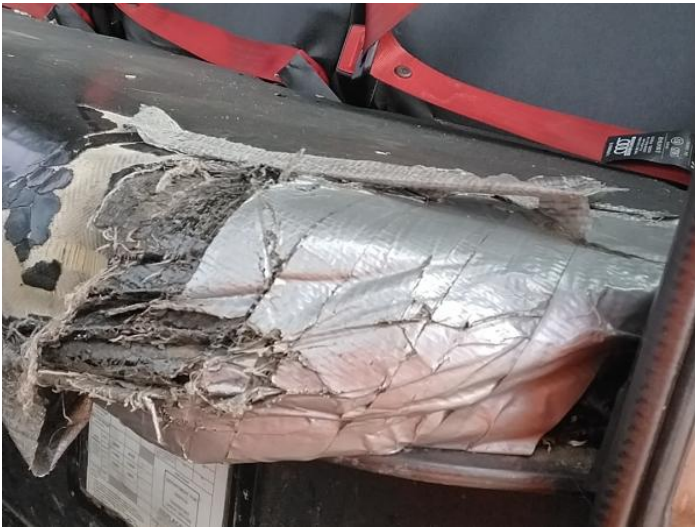
17: Seat Base Cover nsf  
Torn  
Over 3mm

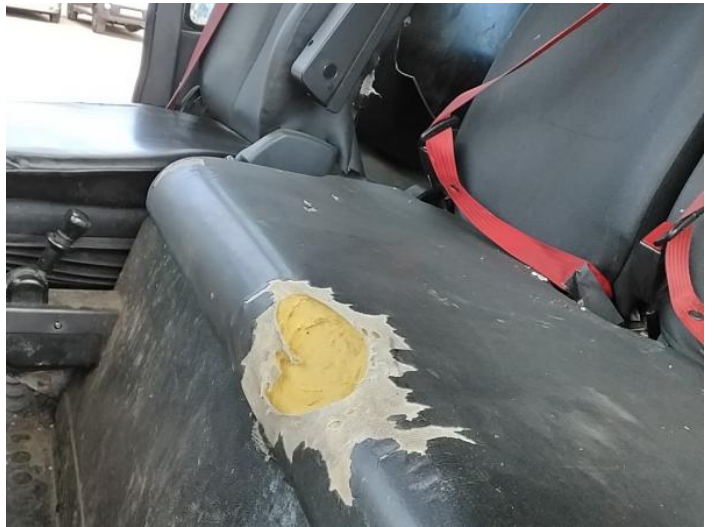
18: Seat Base Cover nsf  
Holed  
Over 3mm

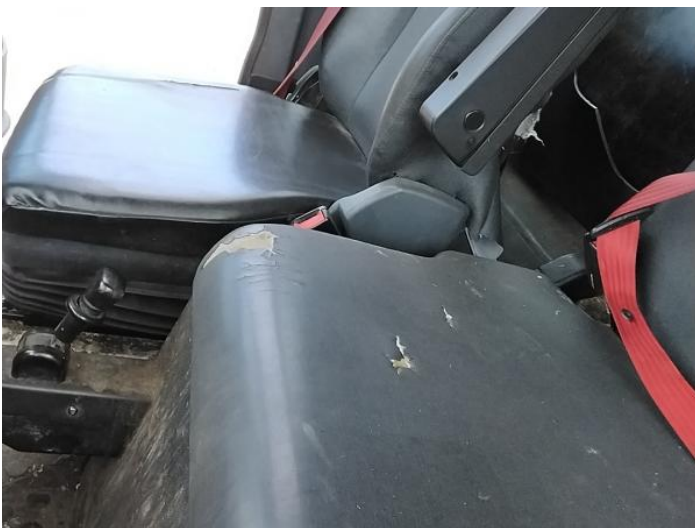
19: Seat Base Cover nsf  
Holed  
Over 3mm

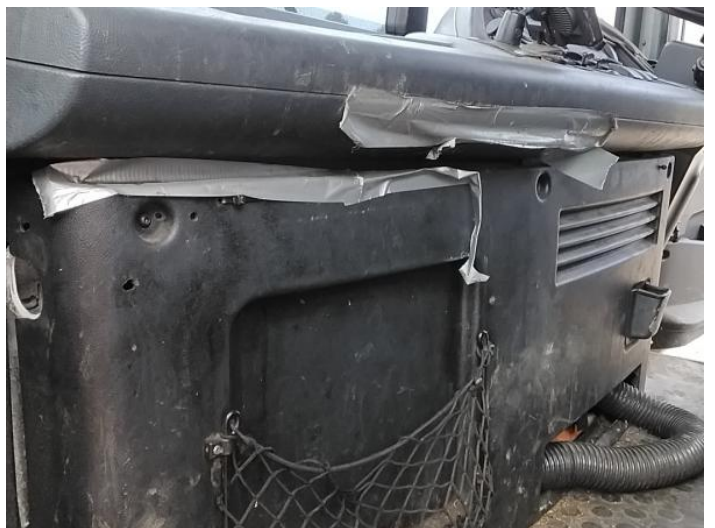
20: Fascia Panel  
Broken  
Replace

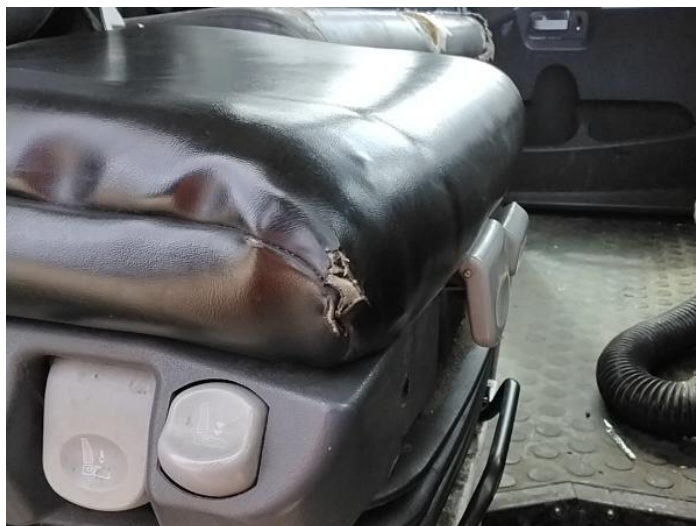
22: Seat Base Cover osf  
Holed  
Over 3mm

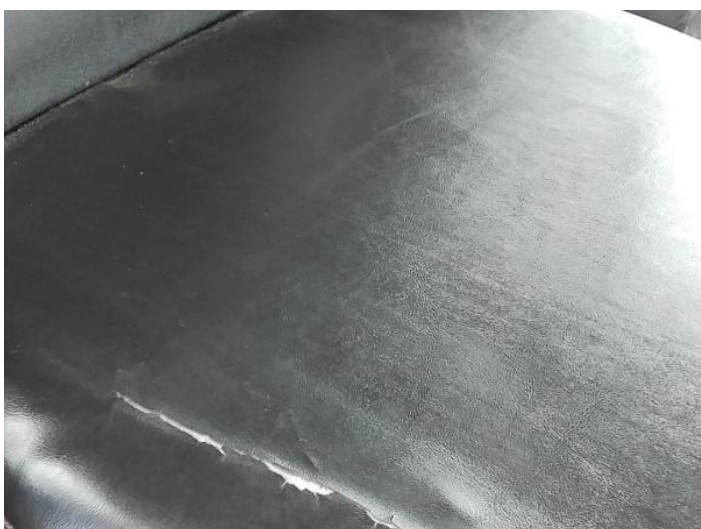
23: Seat Base Cover osf  
Torn  
Over 3mm
