VEHICLE INSPECTION REPORT

VX16AEC

Dennis Elite 6

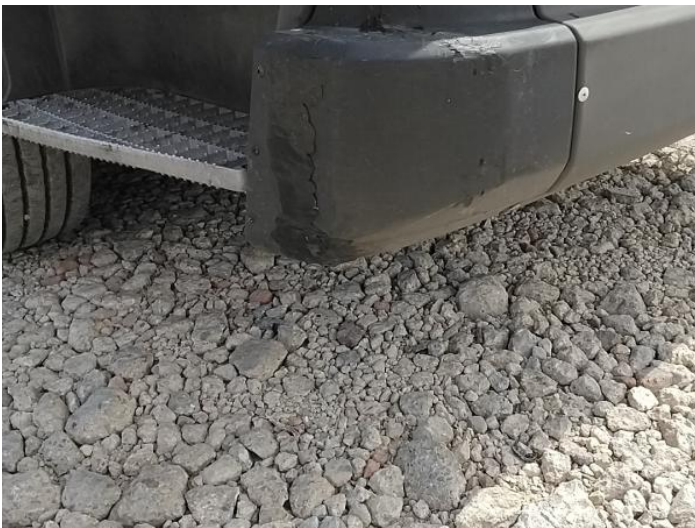
1: Bumper Front
Poor Previous Repair
Poor Paint

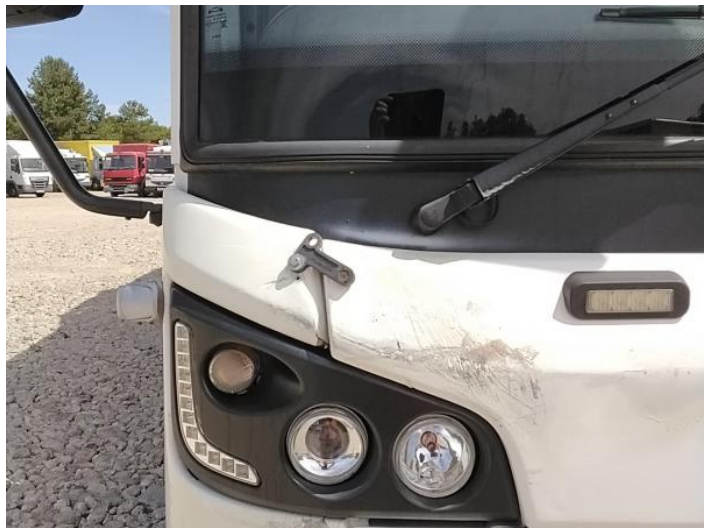
2: Moulding of Wing
Scratched (Painted)
Over 25mm Thru Paint

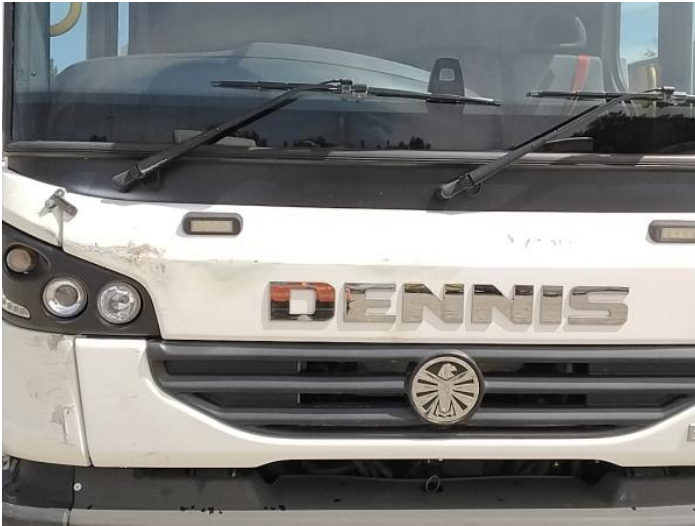
3: Bonnet
Poor Previous Repair
Poor Colour

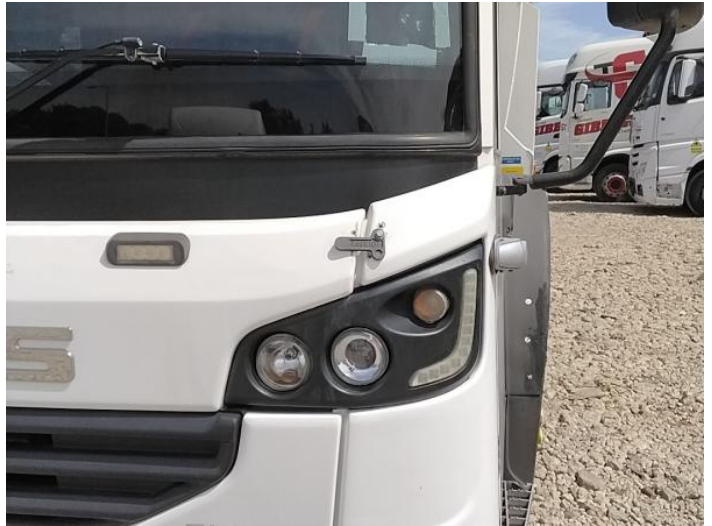
4: Bonnet
Poor Previous Repair
Poor Paint

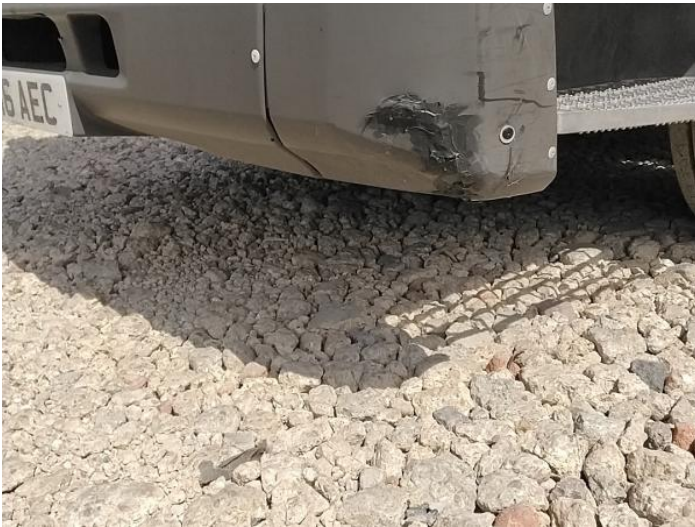
5: Bumper Front
Poor Previous Repair
Poor Paint

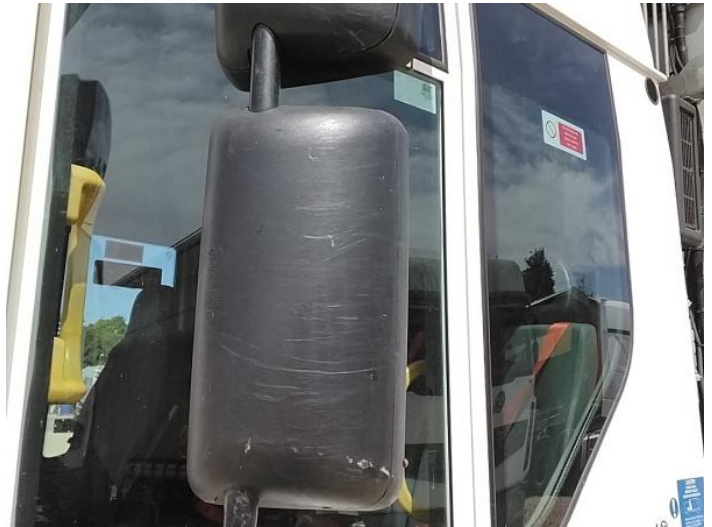
6: Door Mirror Assy nsf
Scuffed (Unpainted)
Over 100mm

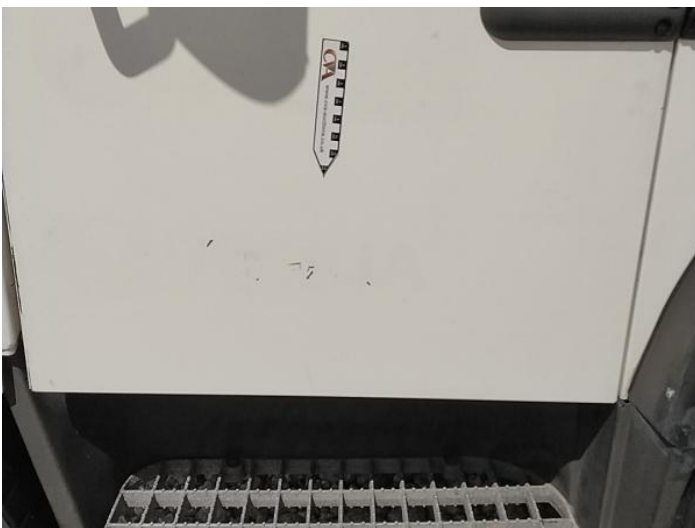
7: Door nsf
Scratched
Over 25mm Thru Paint

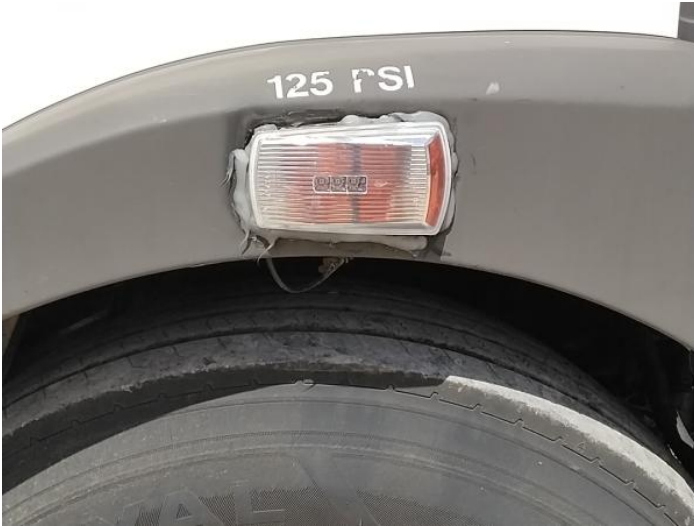
9: Flasher Side Repeater ns
Broken
Replace

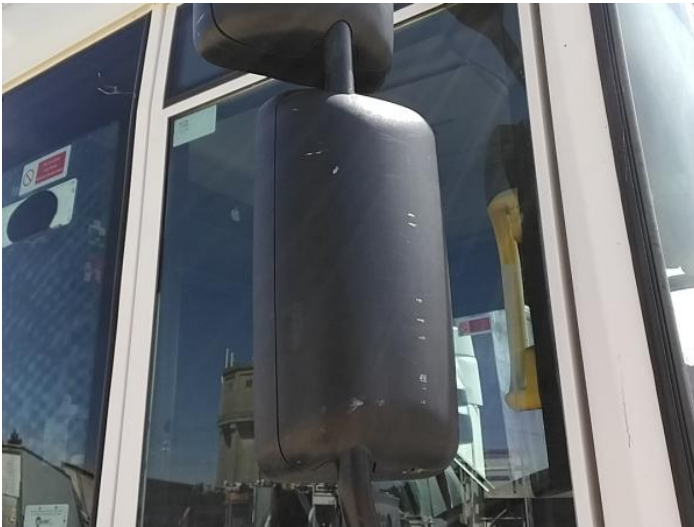
11: Door Mirror Assy osf
Scuffed (Unpainted)
Over 100mm

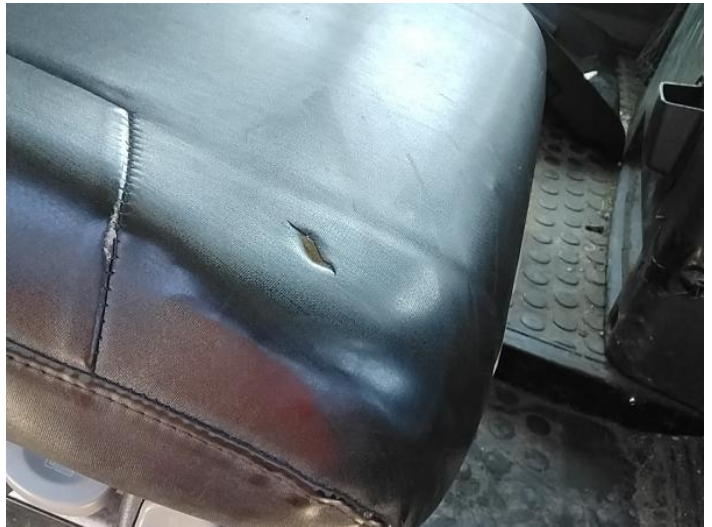
12: Seat Base Cover osf
Torn
Over 3mm

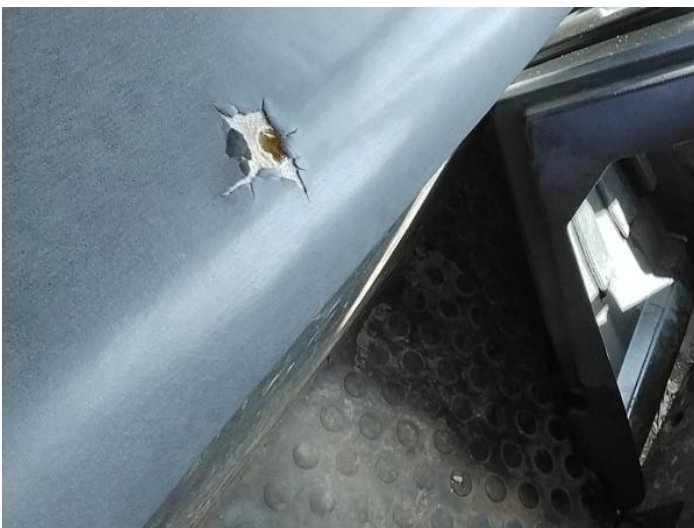
13: Seat Base Cover nsf
Holed
Over 3mm

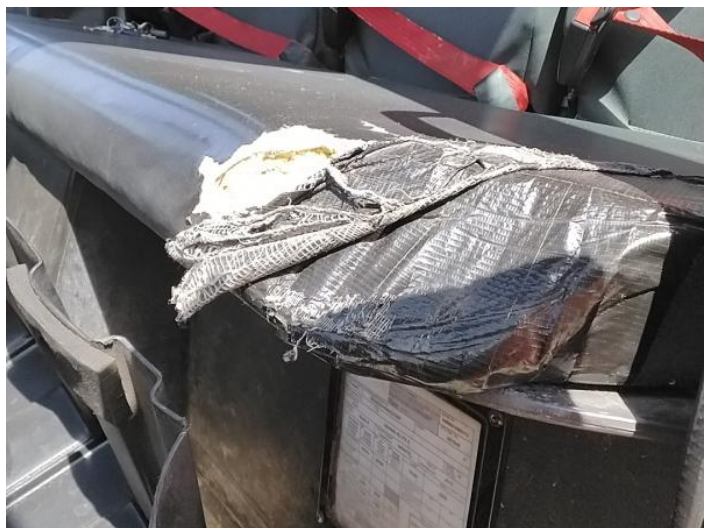
14: Seat Base Cover nsf
Holed
Over 3mm

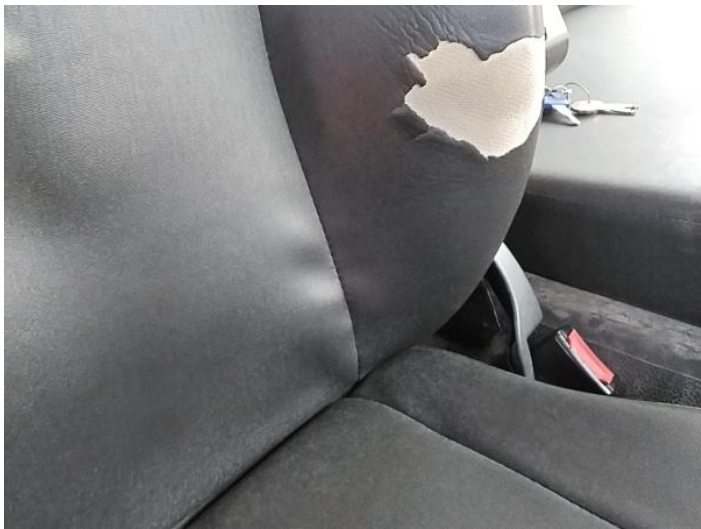
15: Seat Back Cover osf
Torn
Over 3mm
