VEHICLE INSPECTION REPORT

PF65LNC

Daf LF 220

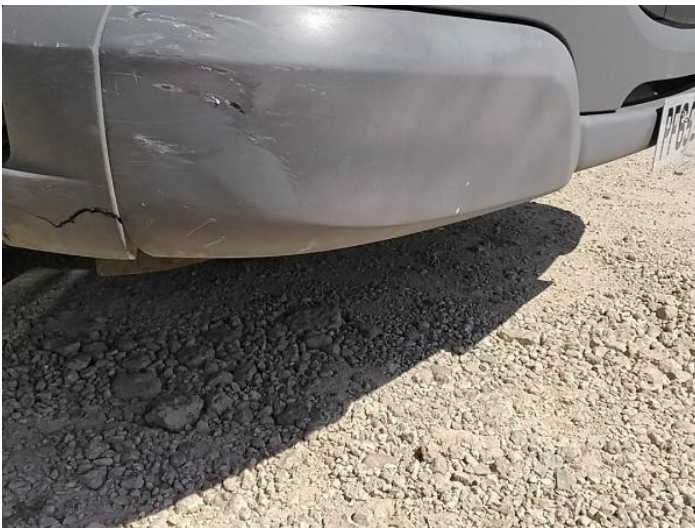
1: Bumper Front
Scratched
25 to 100mm Thru Paint

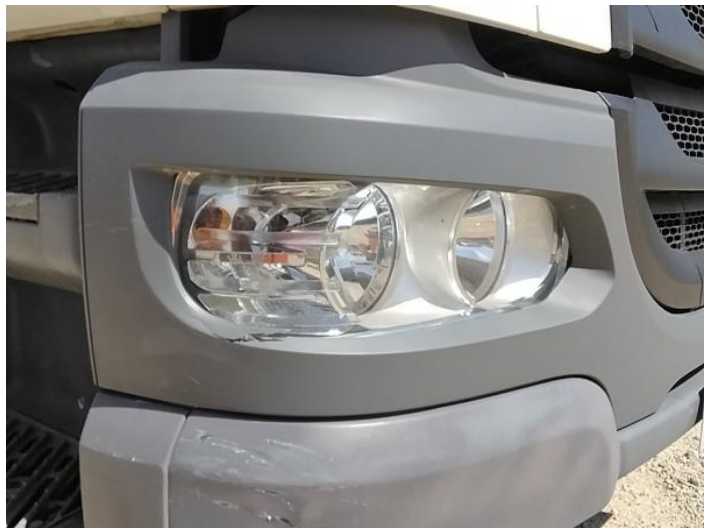
2: Fog Lamp Surround is
Broken
Replace

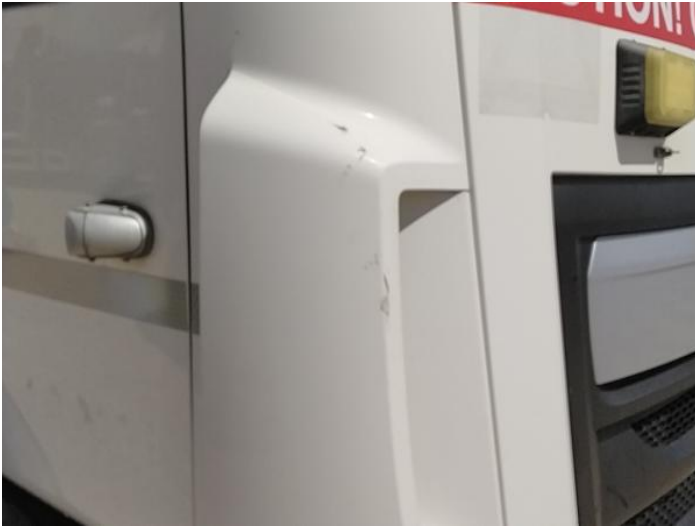
3: Wing osf
Scratched
UpTo 25mm Thru Paint

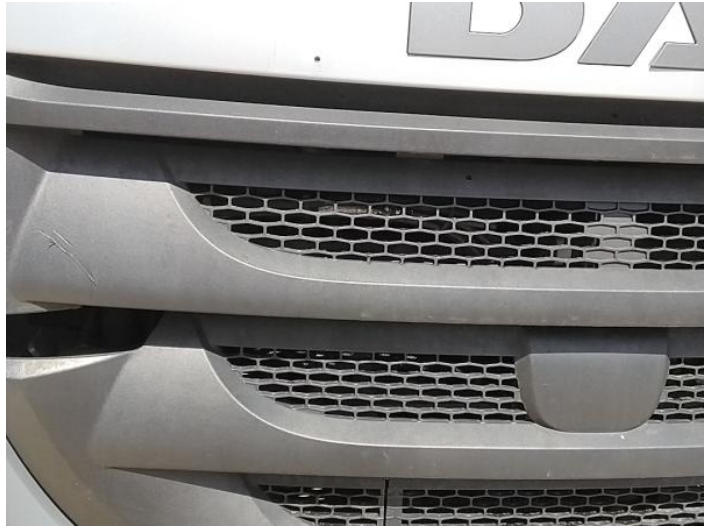
4: Grille Front
Scuffed (Unpainted)
UpTo 100mm

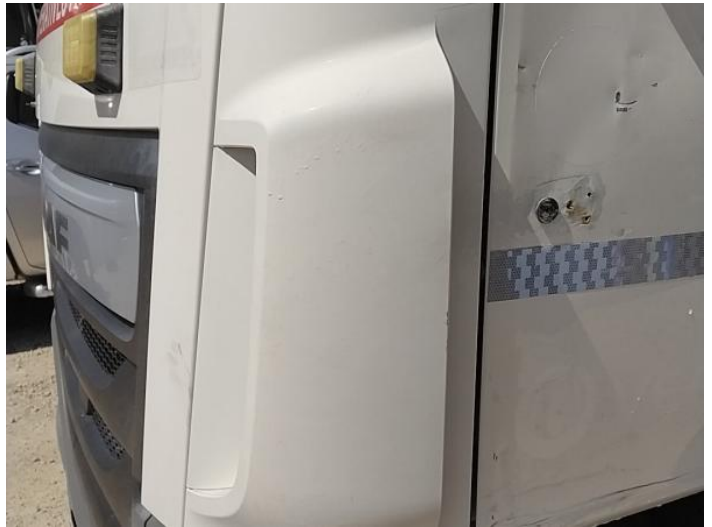
6: Wing nsf
Poor Previous Repair
Poor Paint

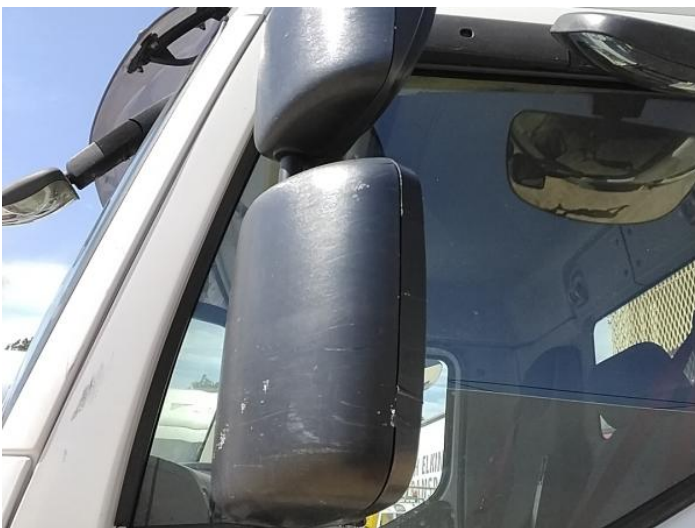
7: Door Mirror Assy nsf
Broken
Replace

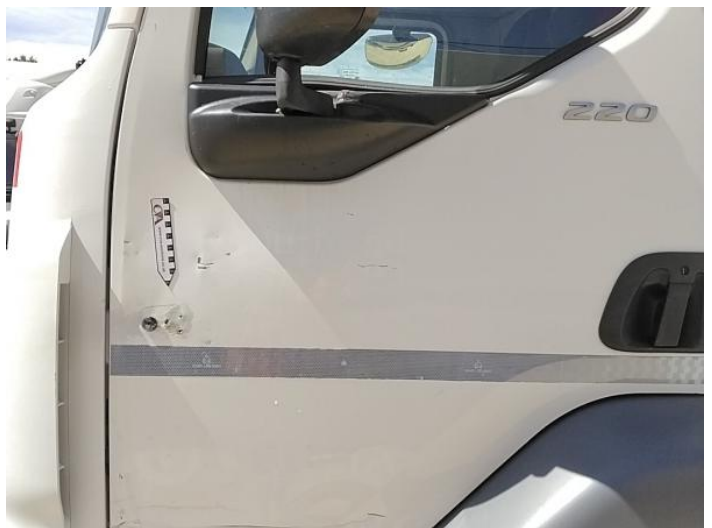
8: Door nsf
Dented
Over 30% Of Panel

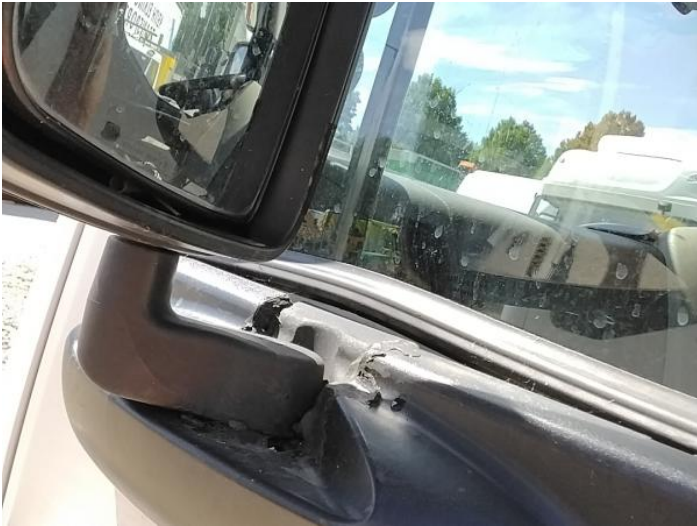
9: Door Mirror Assy nsf
Broken
Replace

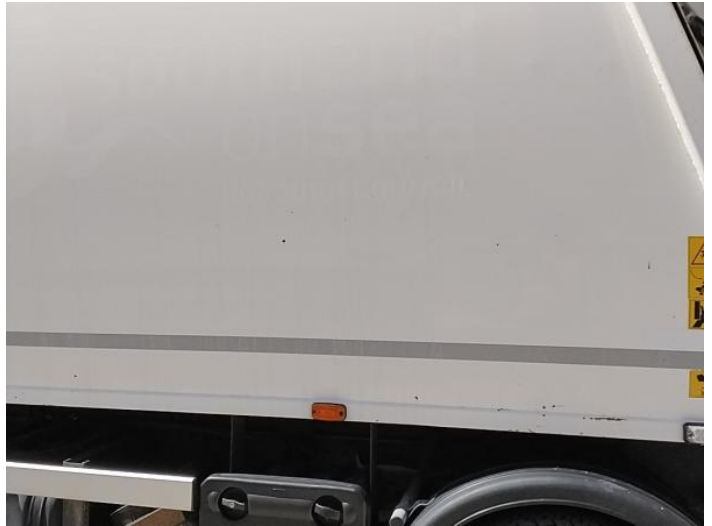
10: Qtr Panel nsr
Chipped
Multiple Chips

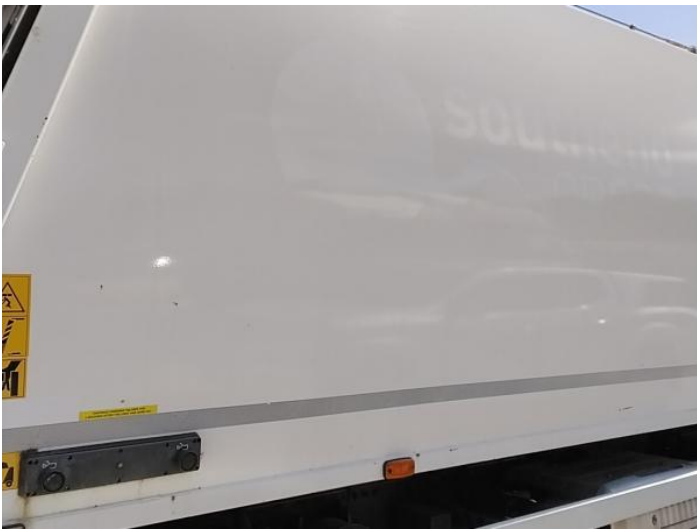
11: Qtr Panel osr
Chipped
Multiple Chips

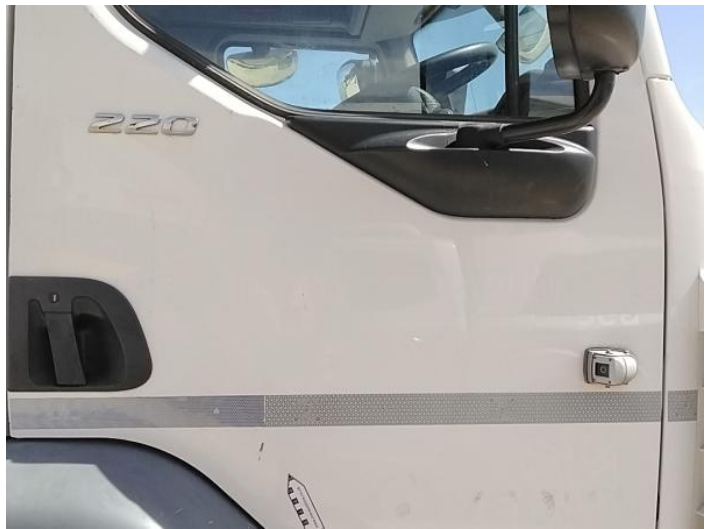
12: Door osf
Scratched
Over 25mm Thru Paint

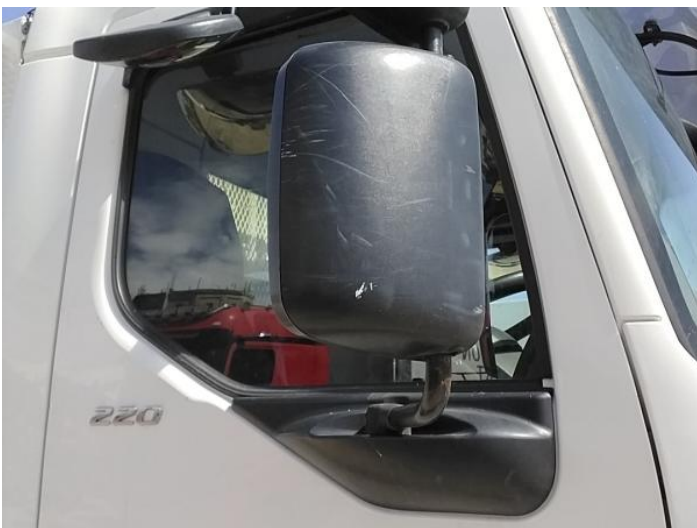
13: Door Mirror Assy osf
Scuffed (Unpainted)
Over 100mm

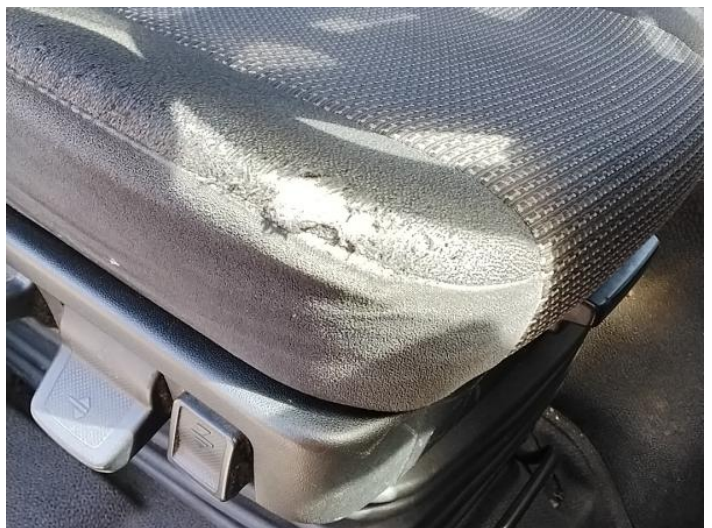
14: Seat Base Cover osf
Torn
Over 3mm

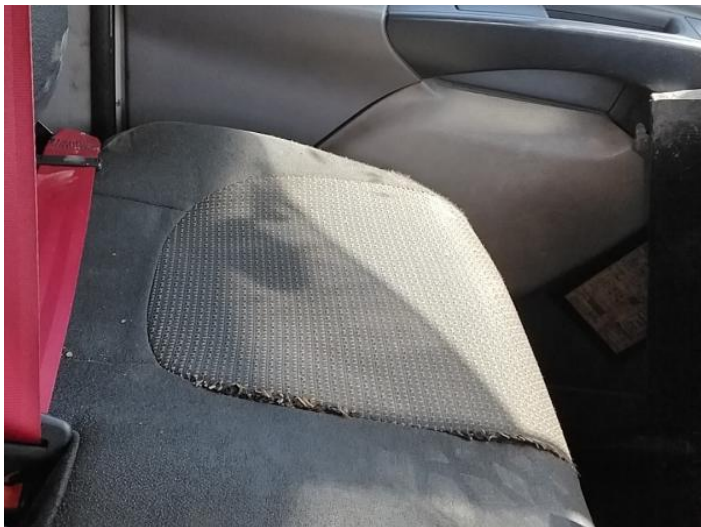
15: Seat Base Cover nsf
Scuffed
Over 25mm
