# **VEHICLE INSPECTION REPORT**

**DP69AXS**

### Vauxhall Vivaro 2700 1.5d 120PS H1 Dynamic

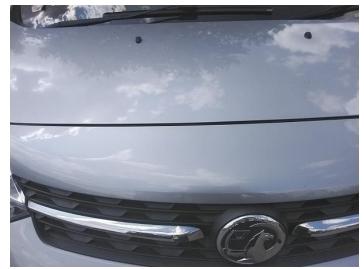
1: Bonnet Chipped Multiple Chips

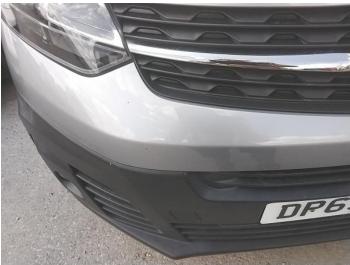
2: Panel Front Chipped Multiple Chips

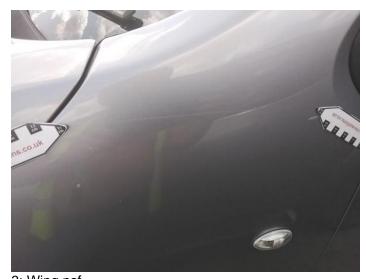
3: Wing nsf Scratched Over 25mm Not Thru Paint

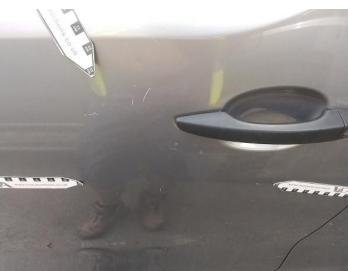
4: Door nsf Scratched Over 25mm Thru Paint

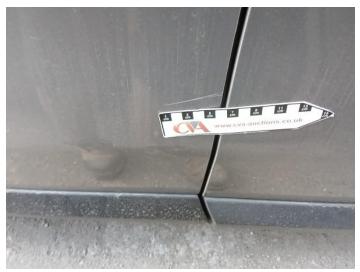
5: Door nsf Scratched Over 25mm Thru Paint

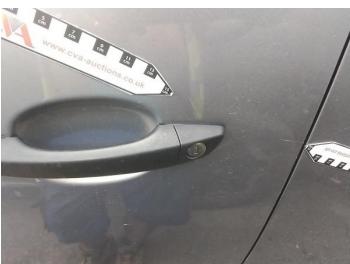
6: Door nsf Scratched Over 25mm Thru Paint

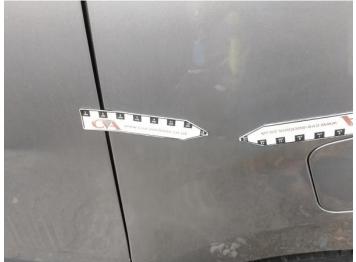
7: Qtr Panel nsr Dented Over 30mm

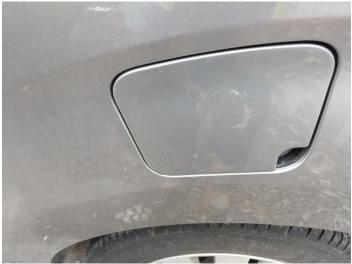
8: Fuel Flap Scratched Over 25mm Thru Paint

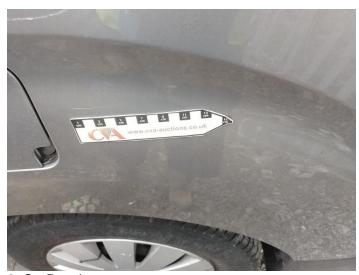
9: Qtr Panel nsr Scratched Over 25mm Thru Paint

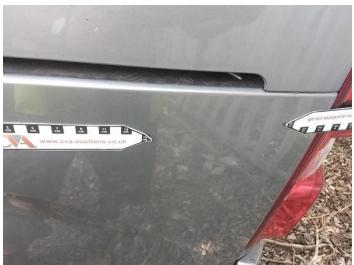
10: Qtr Panel nsr Scratched Over 25mm Thru Paint

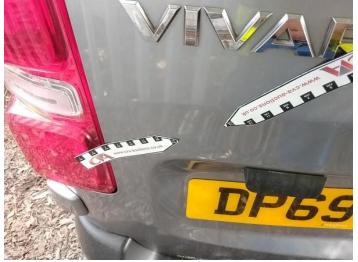
11: Door nsr Dented Over 30mm

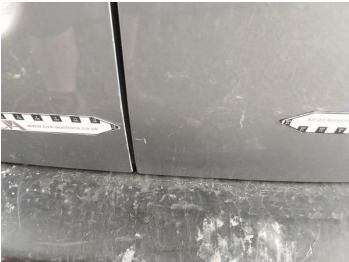
12: Door osr Scratched Over 25mm Thru Paint

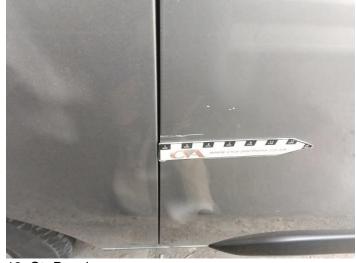
13: Qtr Panel osr Scratched Over 25mm Thru Paint

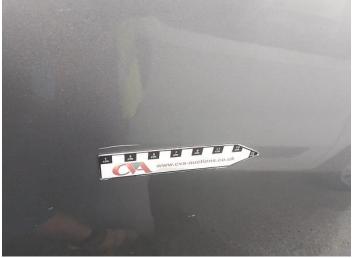
14: Qtr Panel osr Scratched Over 25mm Thru Paint

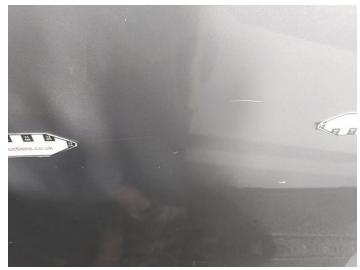
15: Qtr Panel osr Scratched Over 25mm Thru Paint

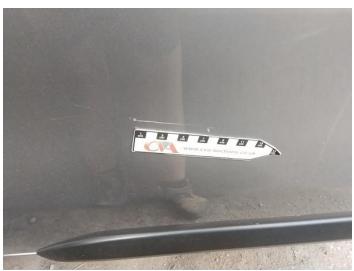
16: Qtr Panel osr Scratched Over 25mm Thru Paint

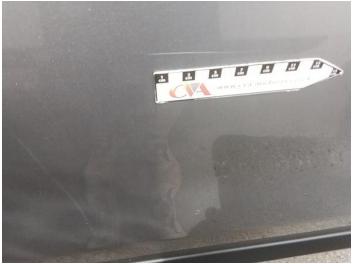
17: Qtr Panel osr Scratched Over 25mm Thru Paint

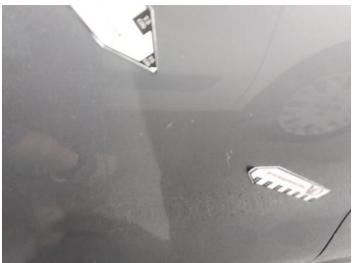
18: Qtr Panel osr Scratched Over 25mm Thru Paint

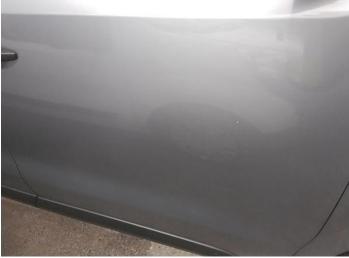
20: Door osf Chipped Multiple Chips

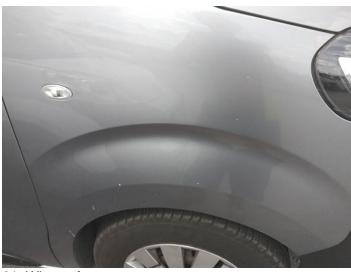
21: Wing osf Chipped Multiple Chips
