VEHICLE INSPECTION REPORT

YK70EFX

Mercedes-Benz Sprinter 315 CDI

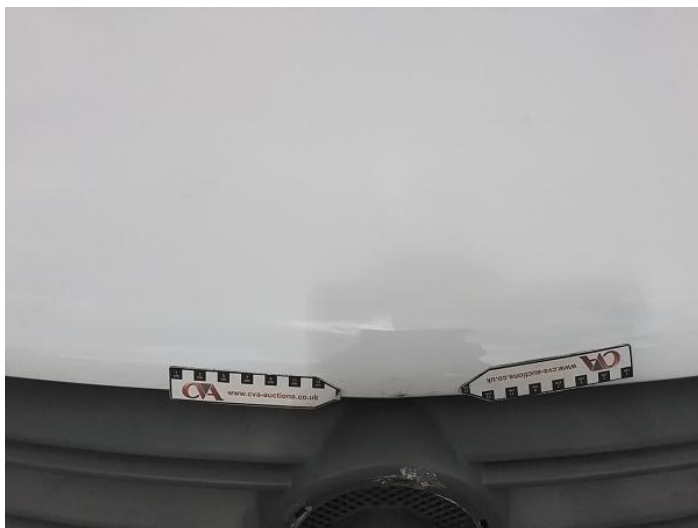
1: Bonnet
Dented
With Paint Damage

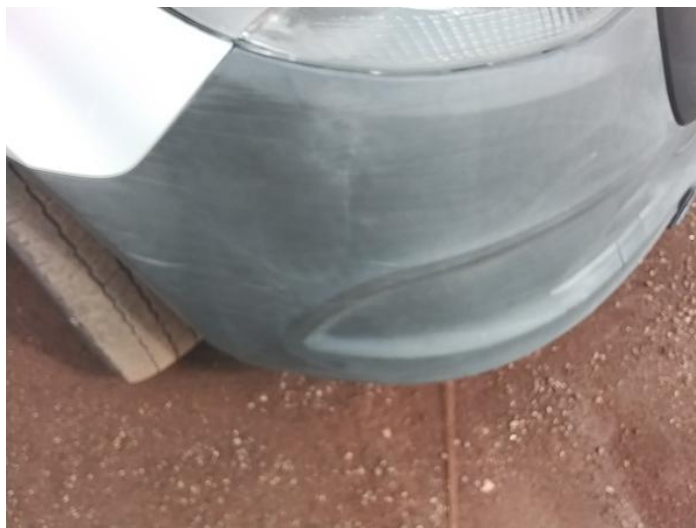
2: Bumper Front
Scratched
Over 100mm Thru Paint

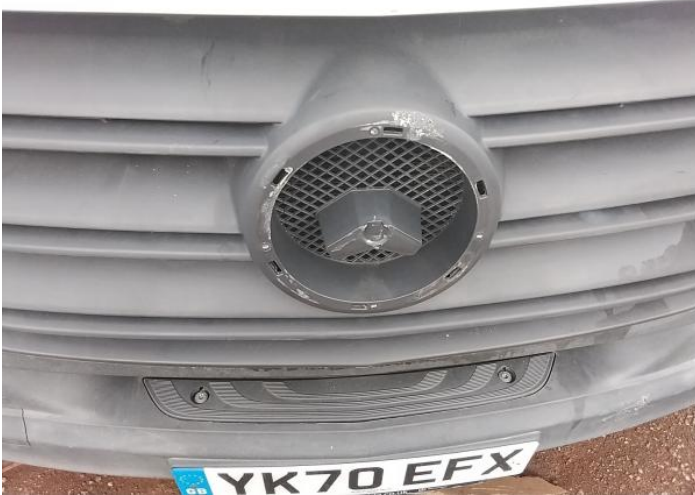
3: Badgedecal Front
Missing
Replace

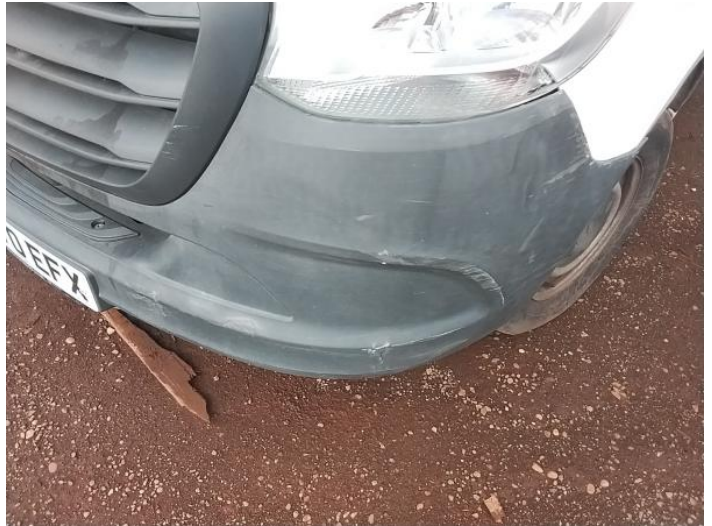
4: Bumper Front
Scratched
Over 100mm Thru Paint

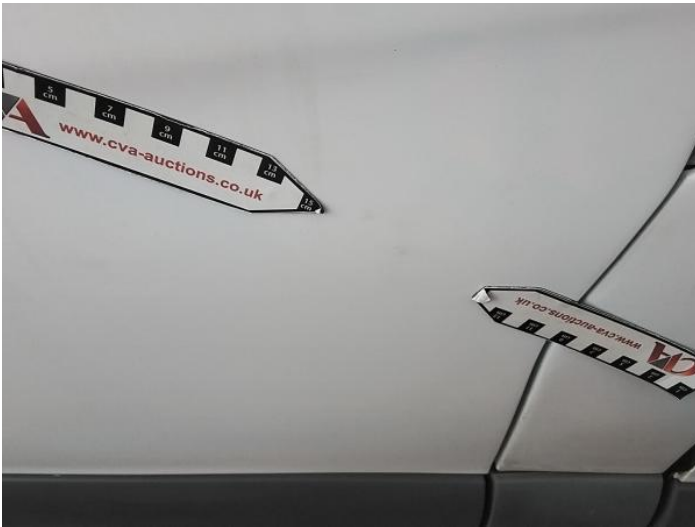
5: Door nsf
Dented
Over 30mm

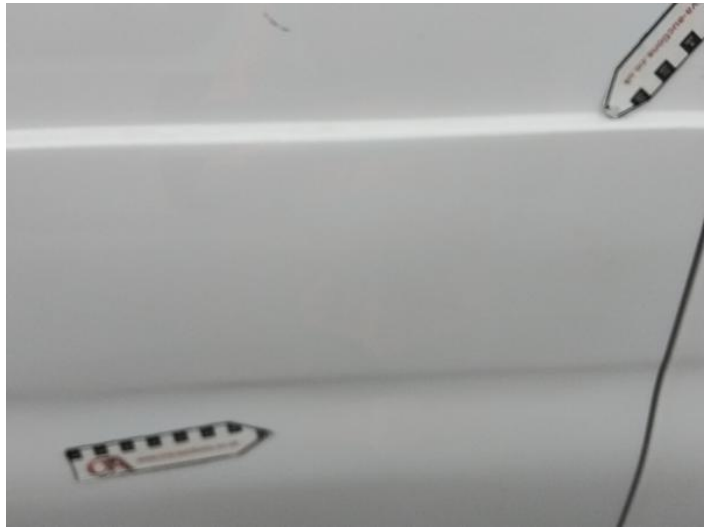
6: Qtr Panel nsr
Dented
Over 30mm

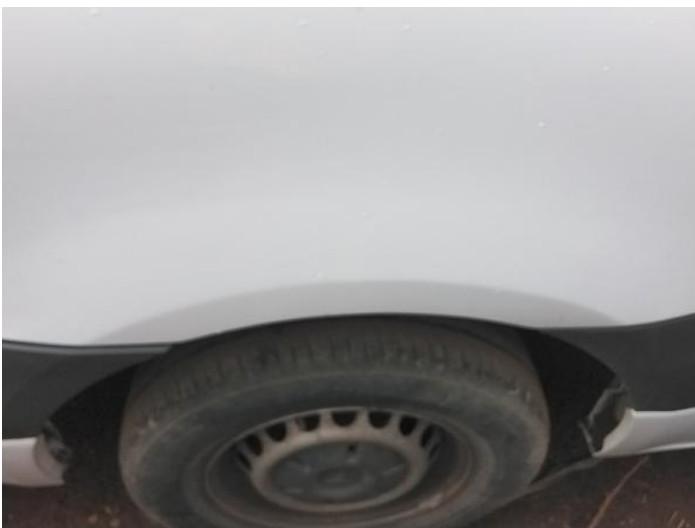
7: Qtr Panel nsr
Poor Previous Repair
Poor Colour

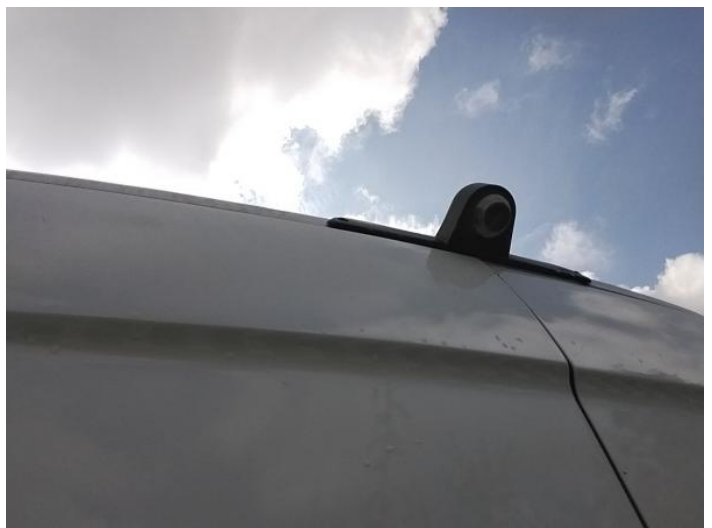
8: Door nsr
Dented
Over 30mm

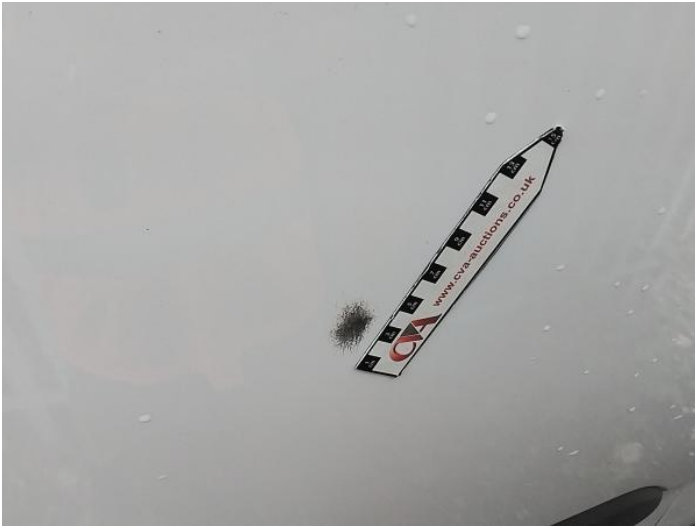
9: Door nsr
Scratched
Over 25mm Thru Paint

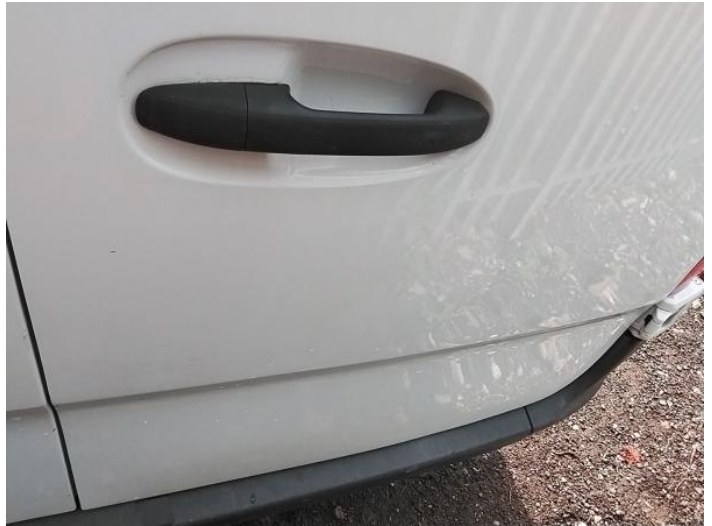
10: Door osr
Poor Previous Repair
Poor Colour

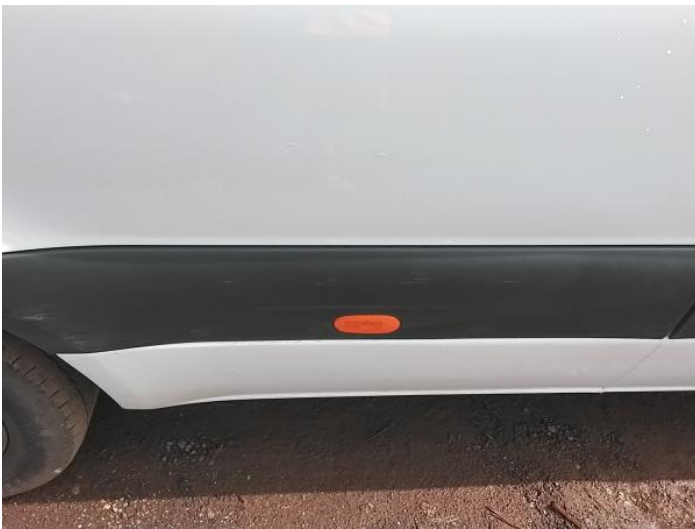
11: Qtr Panel Moulding os
Scuffed (Unpainted)
Over 100mm

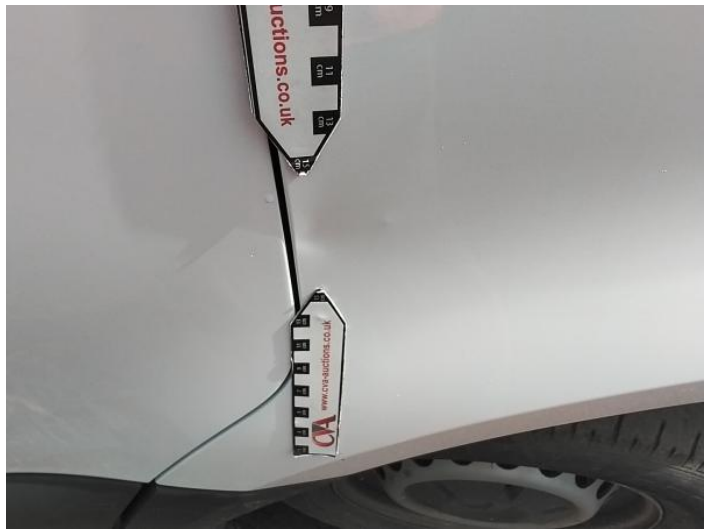
12: Wing osf
Dented
Over 30mm

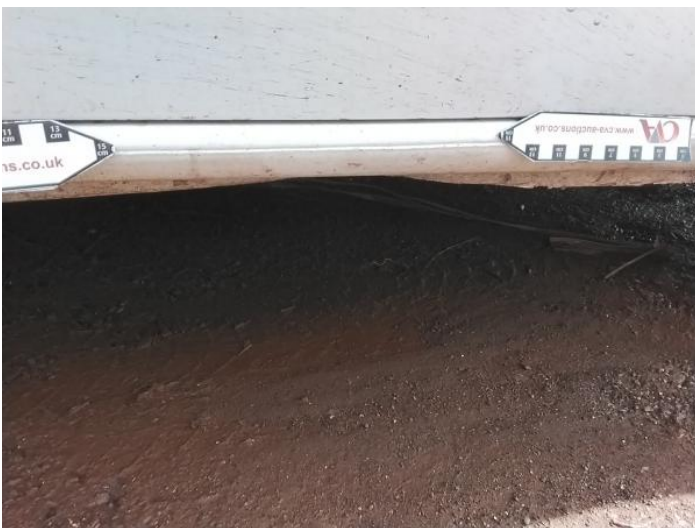
13: Sill os
Dented
With Paint Damage

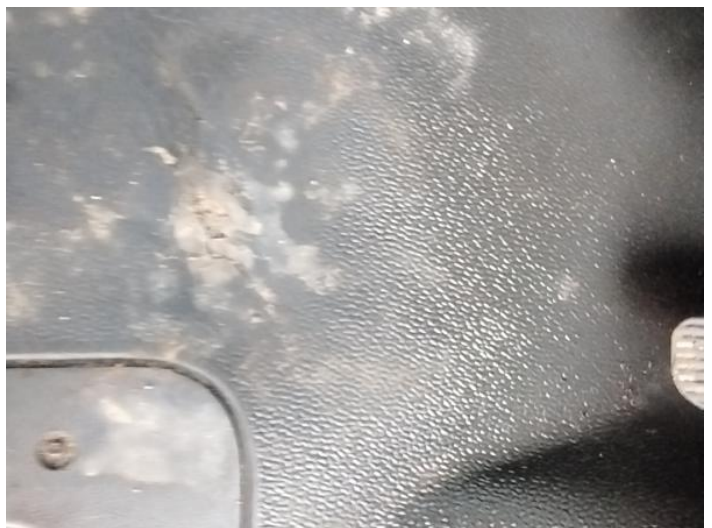
14: Carpets Front
Holed
Over 3mm

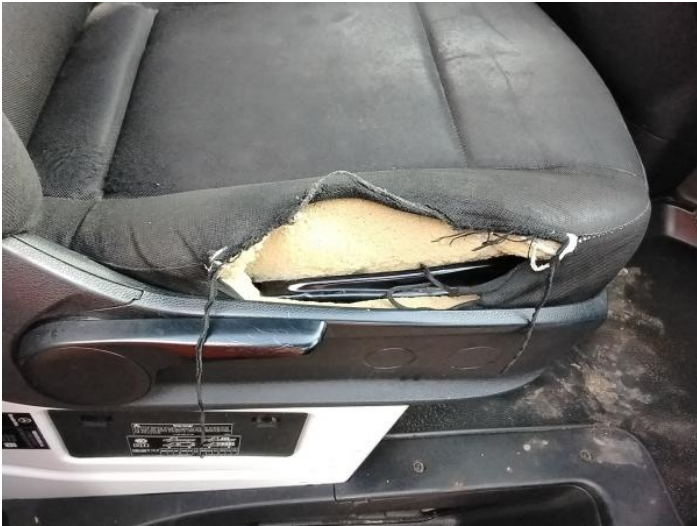
15: Seat Base Cover osf
Torn
Over 3mm

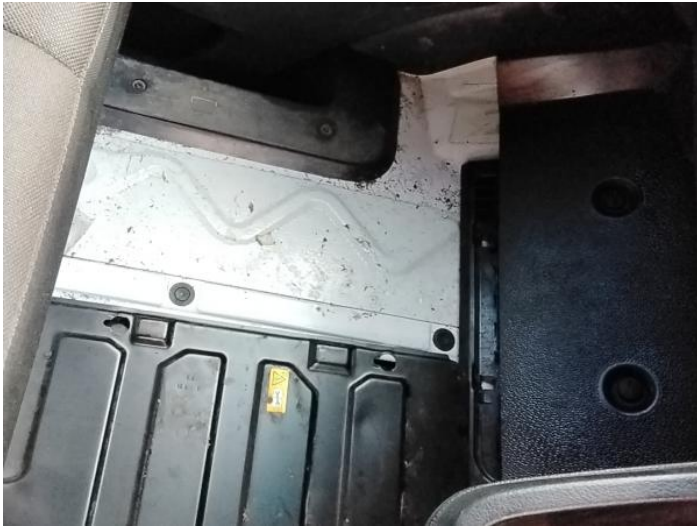
16: Carpets Front
Missing
Replace

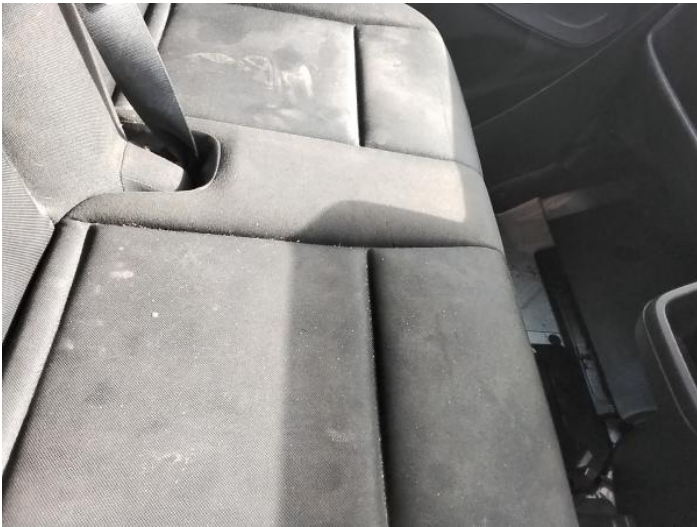
17: Seat Base Cover nsf
Soiled
Heavy

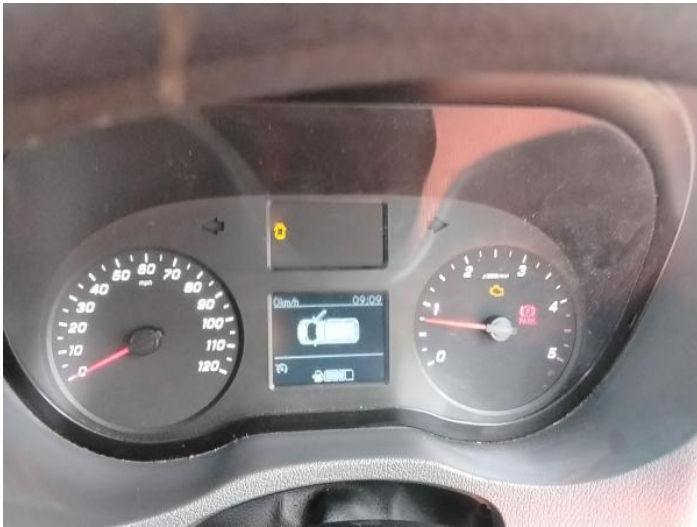
WARNING LIGHT ON DASH AD-BLUE, SIDE LOAD DOOR

18: Dash Warning Lights
Displayed
No Action
