VEHICLE INSPECTION REPORT

FJ14DCX

Fiat Ducato 35 2.3 MULTIJET 130PS

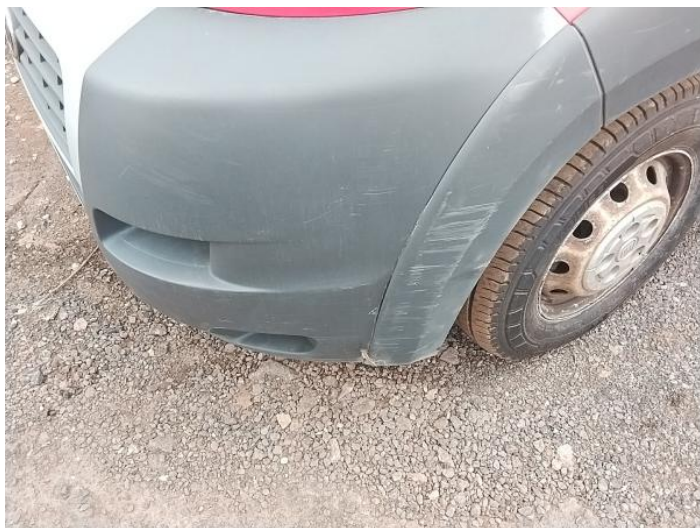
1: Bumper Front Moulding
Scuffed (Unpainted)
Over 100mm

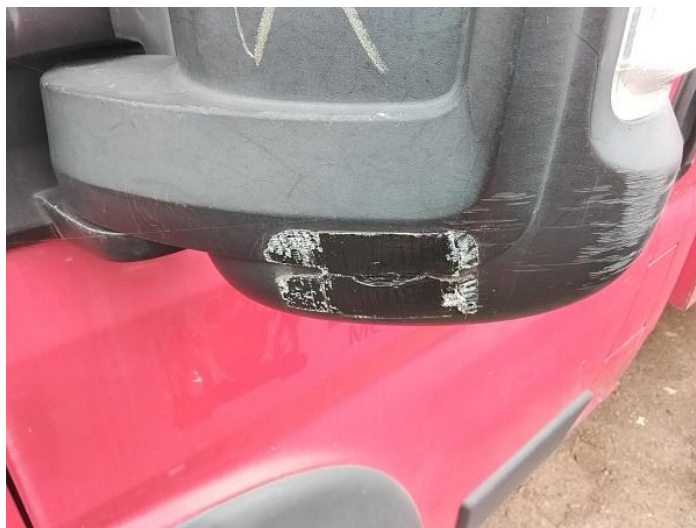
2: Door Mirror Assy nsf
Broken
Replace

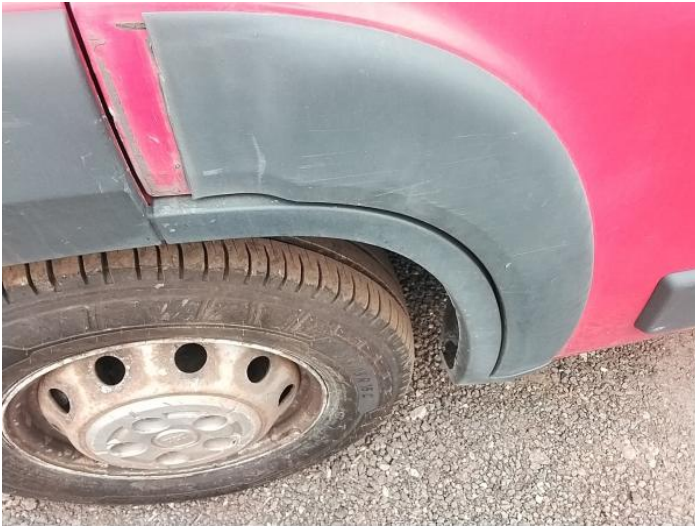
3: Door Moulding nsf
Scuffed (Unpainted)
Over 100mm

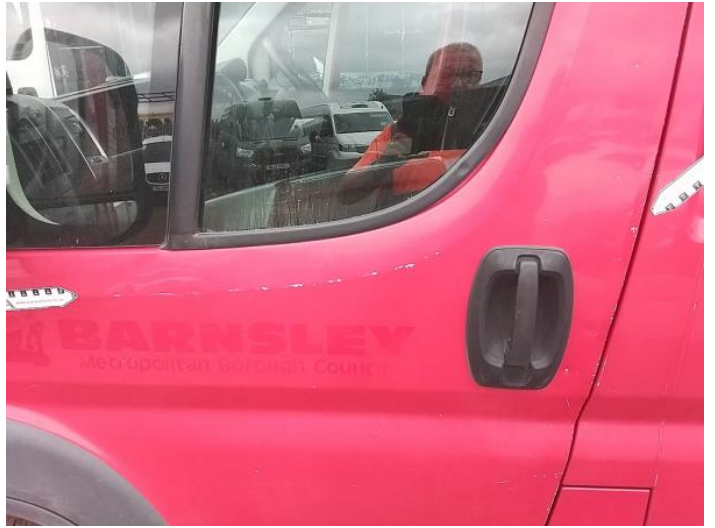
4: Door nsf
Scratched
Over 25mm Thru Paint

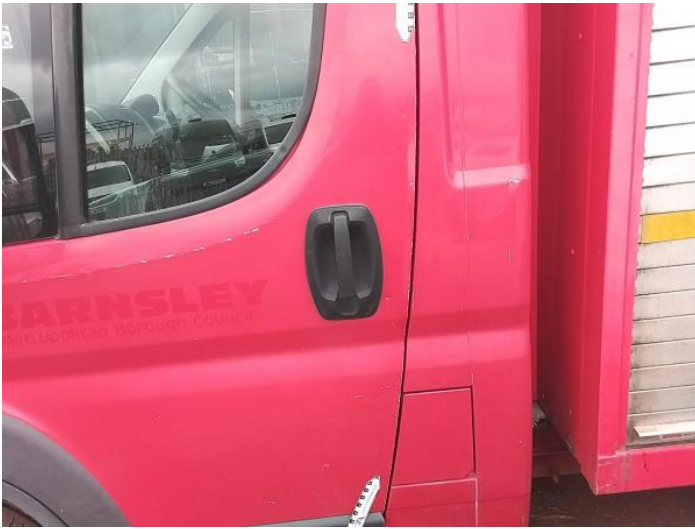
5: Door nsf
Scratched
Over 25mm Thru Paint

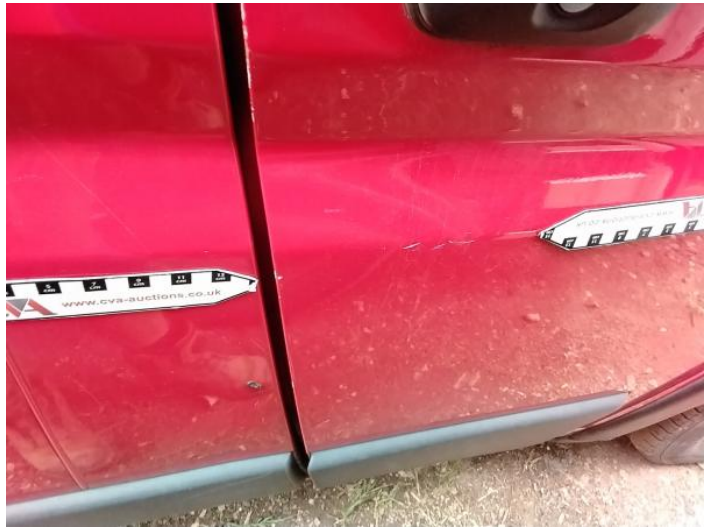
6: Door osf
Scratched
Over 25mm Thru Paint

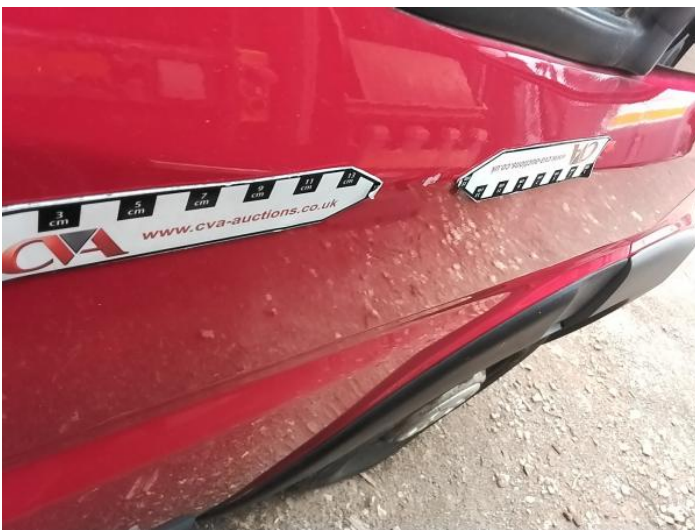
7: Door osf
Dented
With Paint Damage

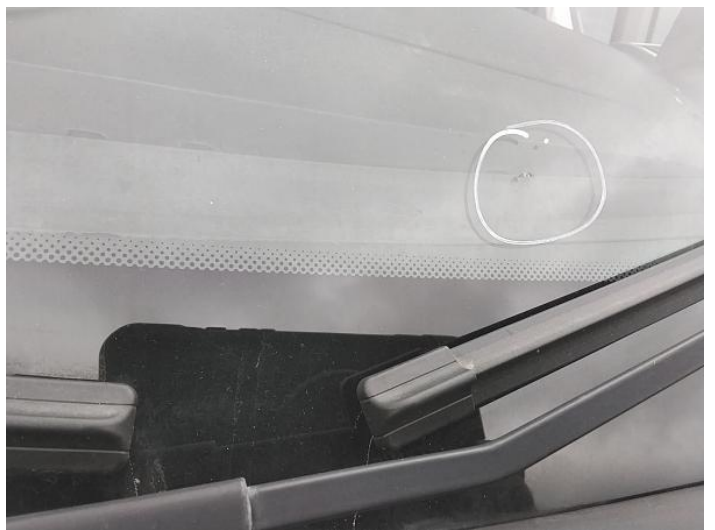
8: Screen Front
Chipped
UpTo 10mm

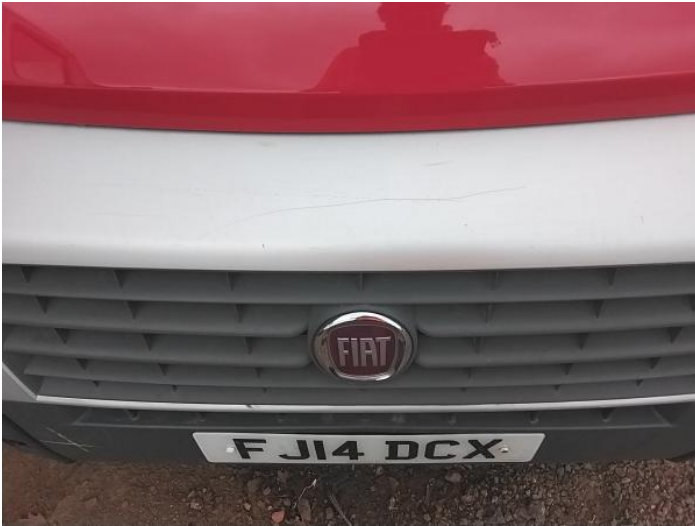
9: Panel Front
Scratched
Over 25mm Thru Paint

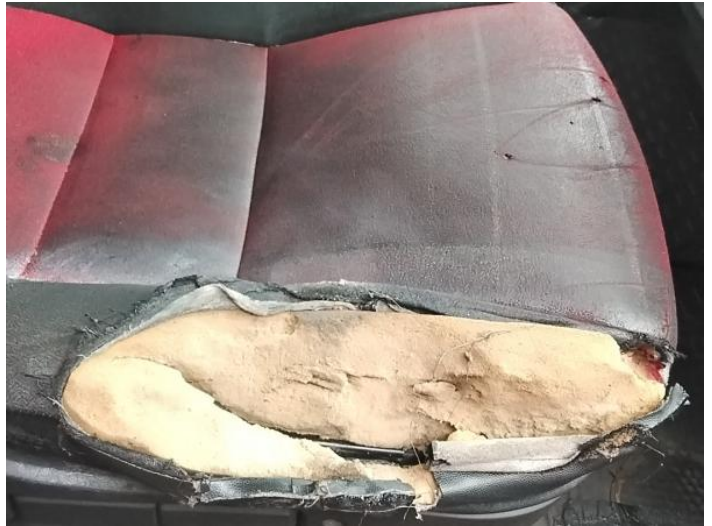
10: Seat Base Cover osf
Holed
Over 3mm

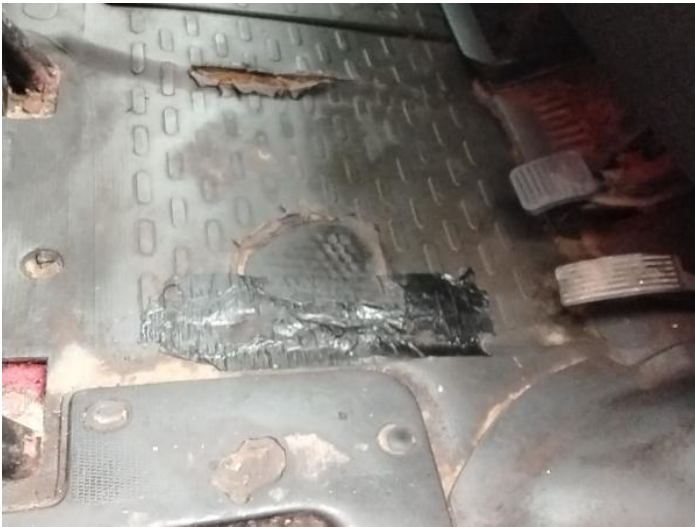
11: Carpets Front
Holed
Over 3mm

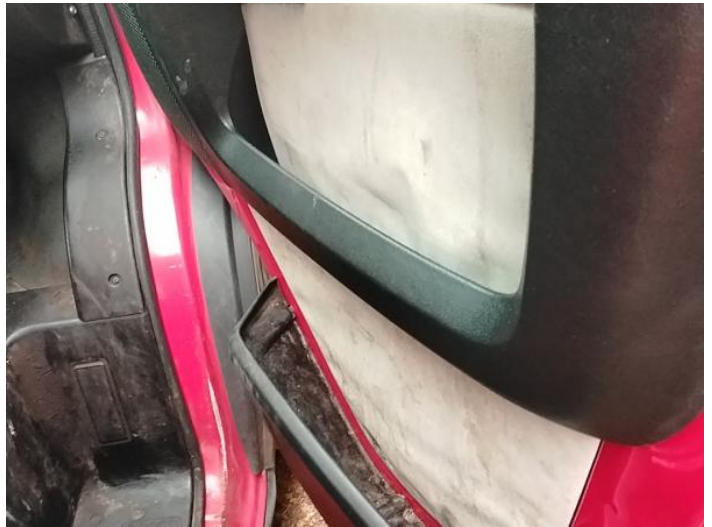
12: Door Pad osf
Soiled
Heavy

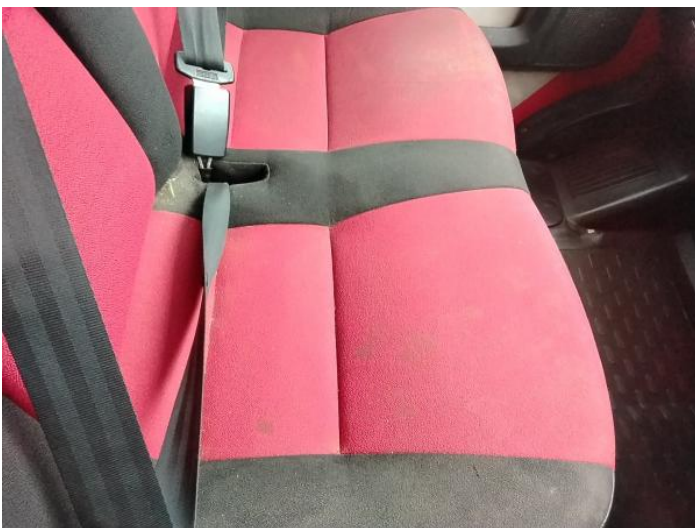
13: Seat Base Cover nsf
Soiled
Heavy

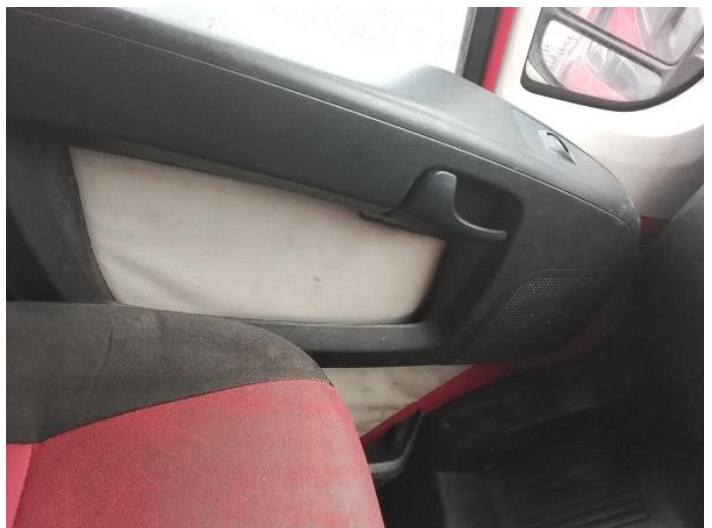
14: Door Pad nsf
Soiled
Heavy
