VEHICLE INSPECTION REPORT

DF64GSV

Mercedes-Benz Antos 1824

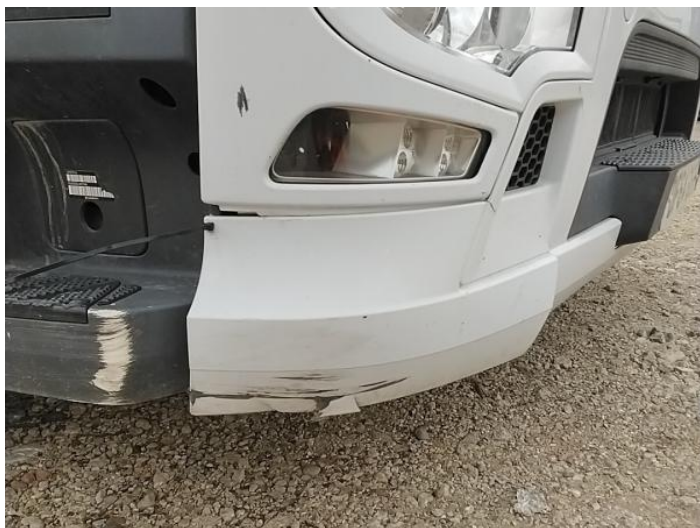
1: Bumper Front
Cracked
Over 25mm

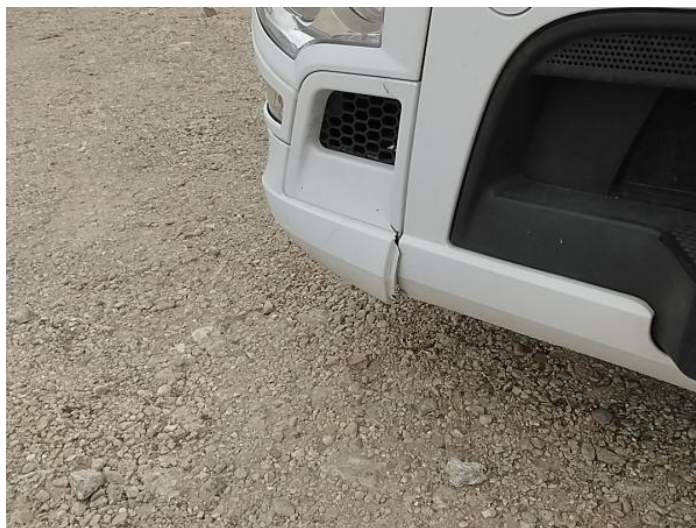
2: Bumper Front
Cracked
Over 25mm

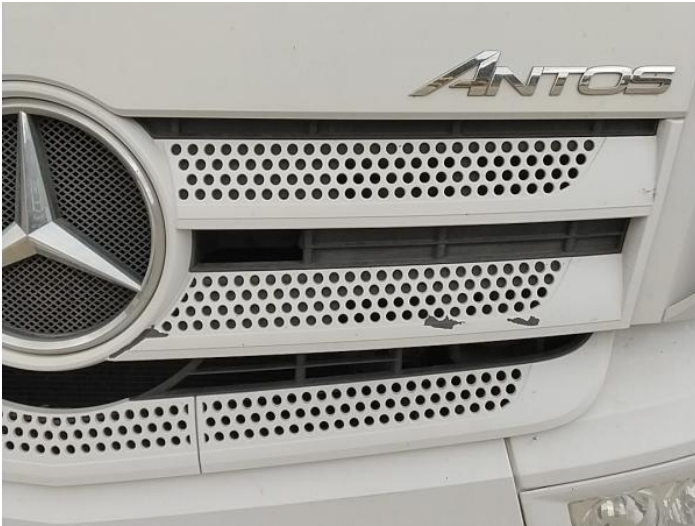
3: Bonnet
Scratched
Over 25mm Thru Paint

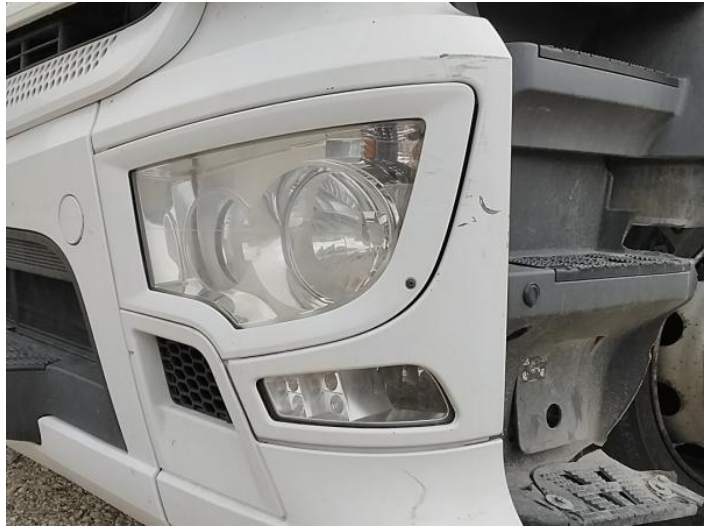
4: Bumper Front
Cracked
Over 25mm

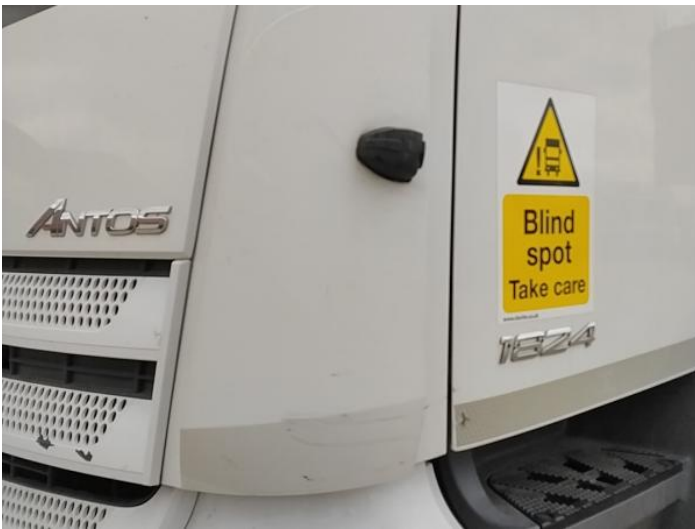
5: Wing nsf
Scratched
Over 25mm Thru Paint

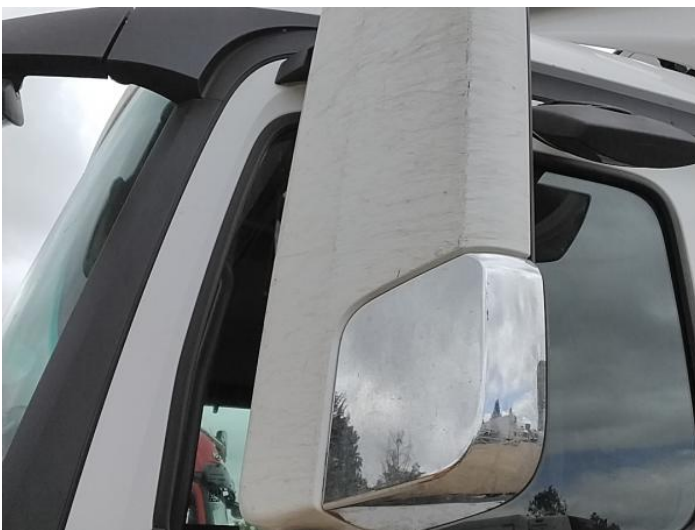
7: Door Mirror Assy nsf
Scratched (Painted)
Over 25mm Thru Paint

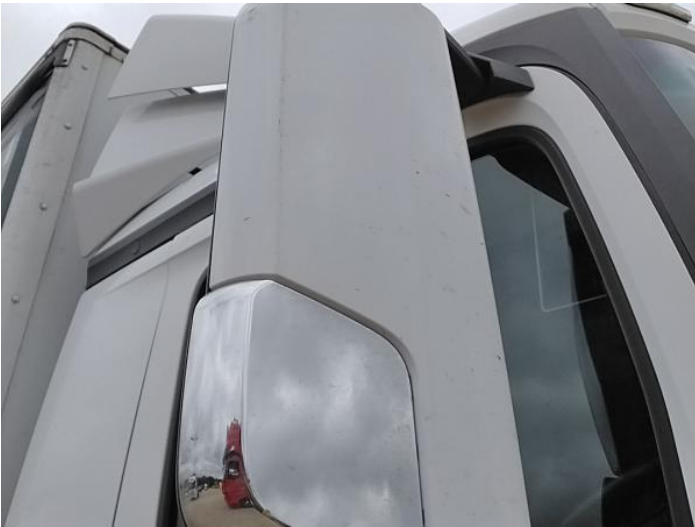
12: Door Mirror Assy osf
Scratched (Painted)
Over 25mm Thru Paint
