VEHICLE INSPECTION REPORT

SN20YFT

Man TGM 26.320

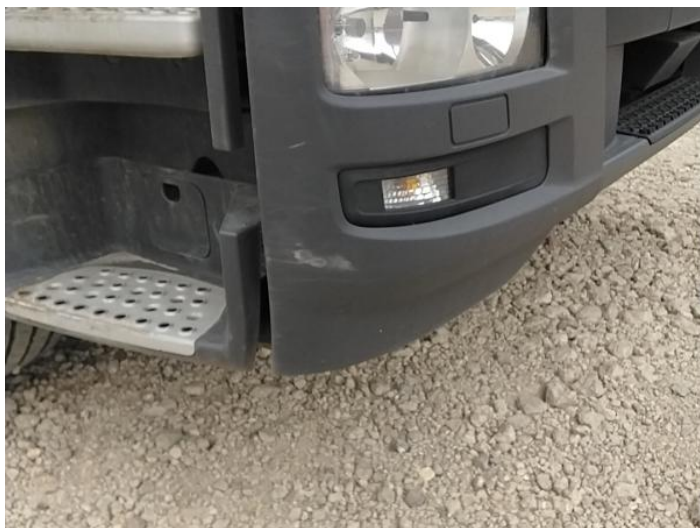
1: Bumper Front
Scratched
Over 25mm Not Thru Paint

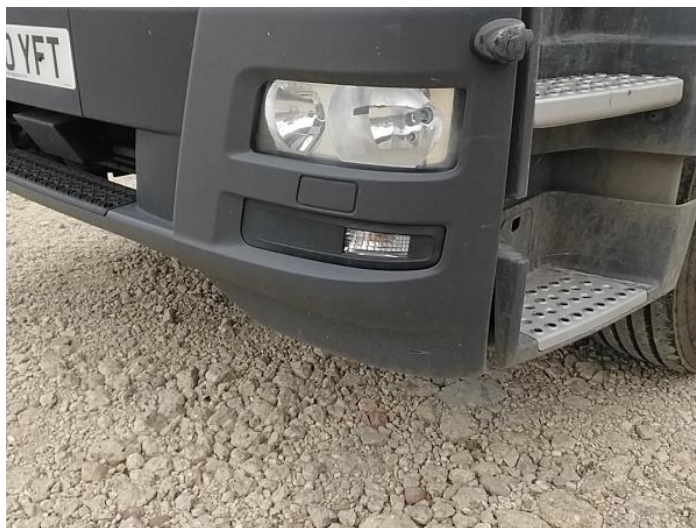
2: Bumper Front
Scratched
Over 25mm Not Thru Paint

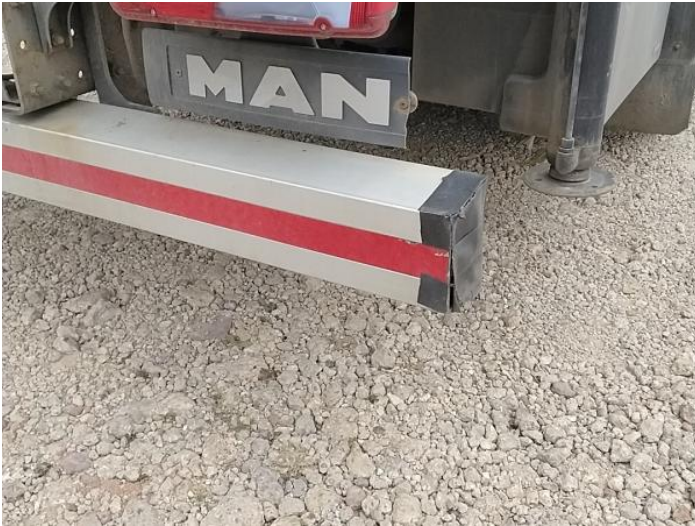
3: Bumper Rear
Missing
Replace

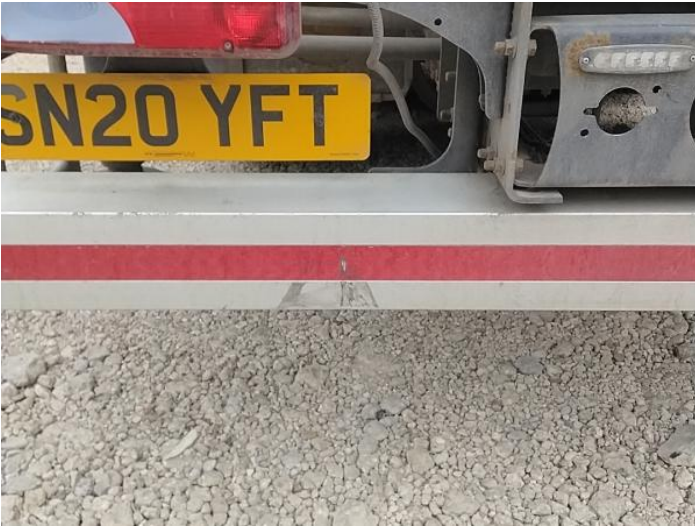
4: Bumper Rear
Scratched
Over 25mm Not Thru Paint

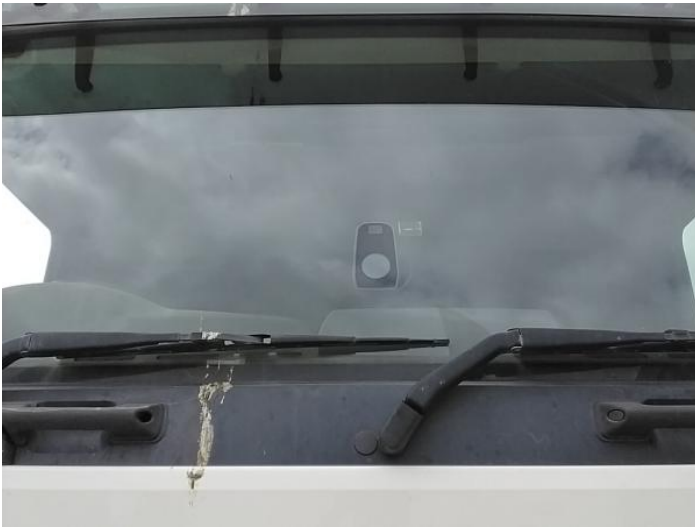
5: Screen Front
Chipped
Over 10mm
