VEHICLE INSPECTION REPORT

EJ20VLU

Mercedes-Benz Sprinter 314 CDI

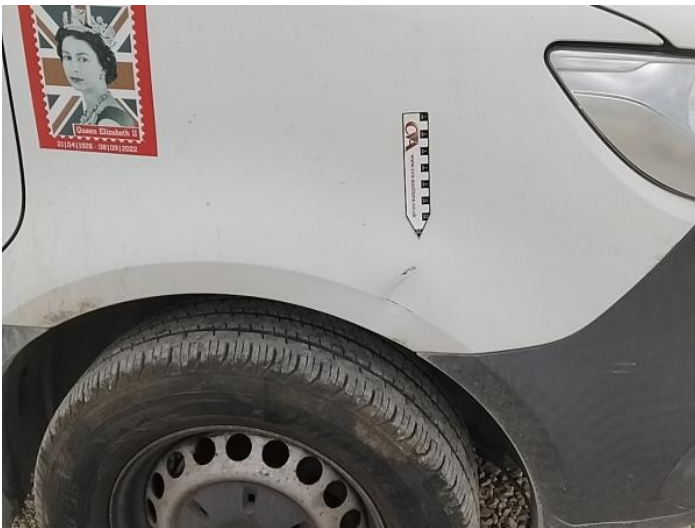
1: Wing osf
Dented
With Paint Damage

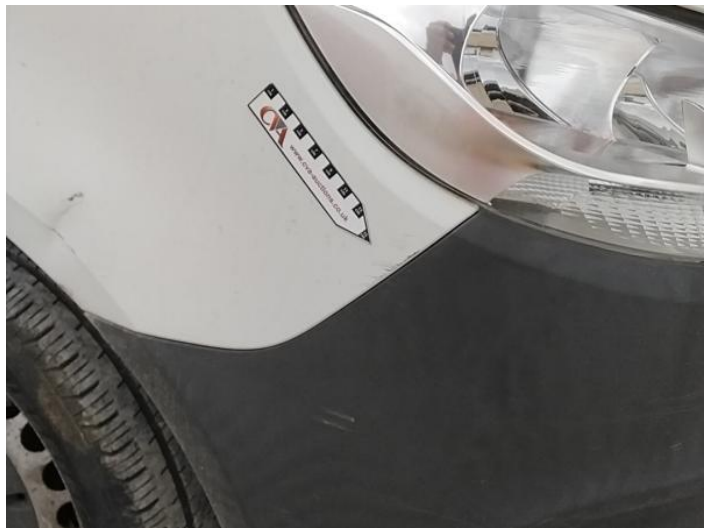
2: Wing osf
Scratched
Over 25mm Thru Paint

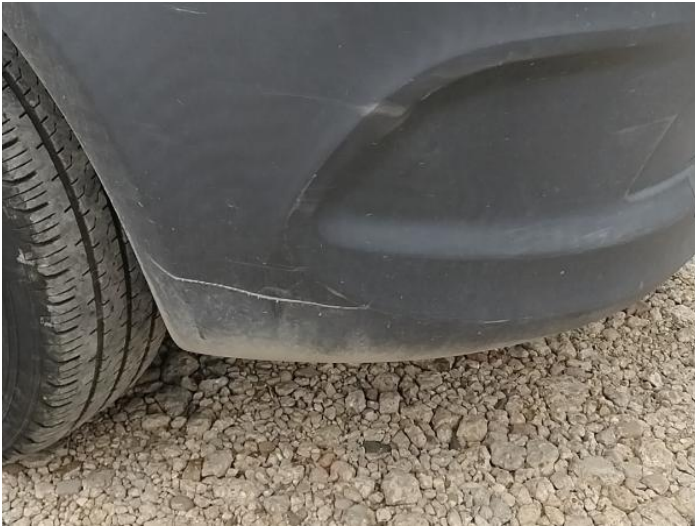
3: Bumper Front
Scratched
Over 100mm Thru Paint

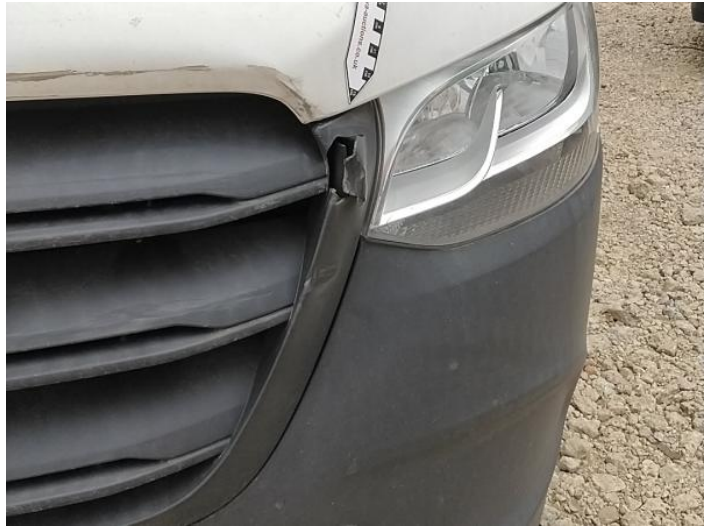
4: Grille Front
Broken
Replace

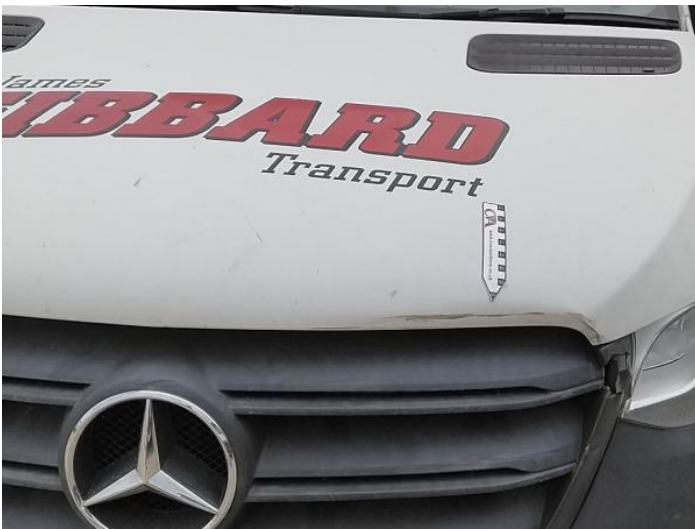
5: Bonnet
Dented
With Paint Damage

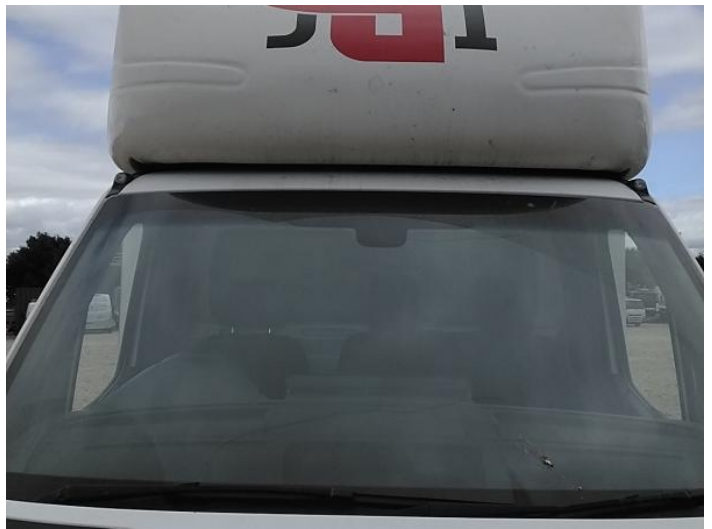
6: Screen Front
Cracked
Replace

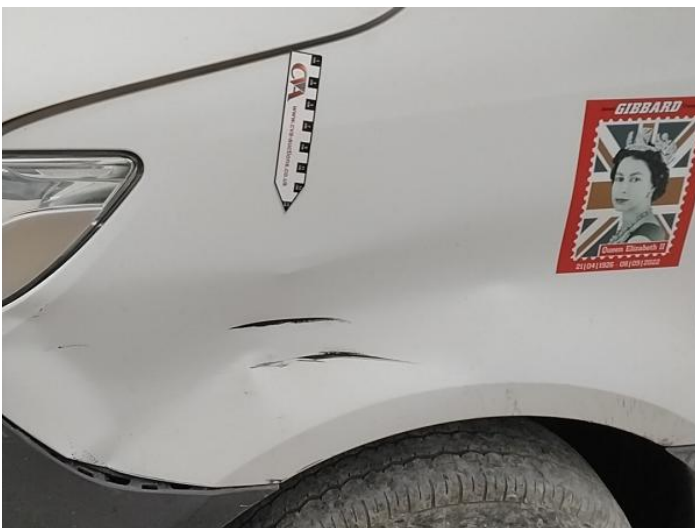
7: Wing nsf
Dented
With Paint Damage

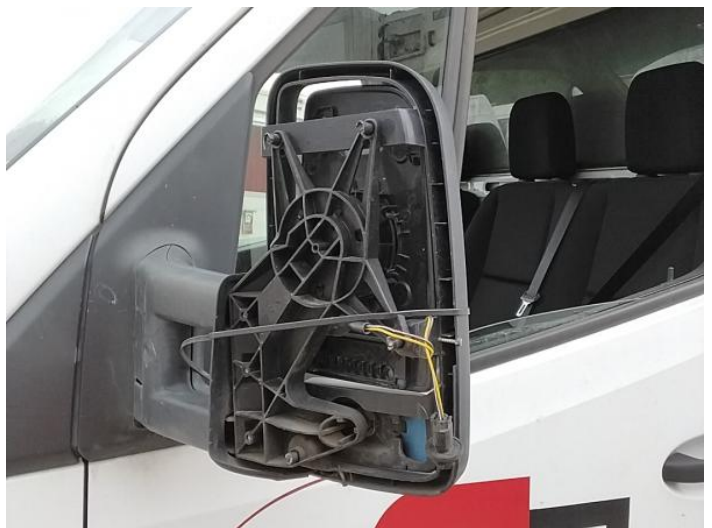
8: Door Mirror Assy nsf
Missing
Replace

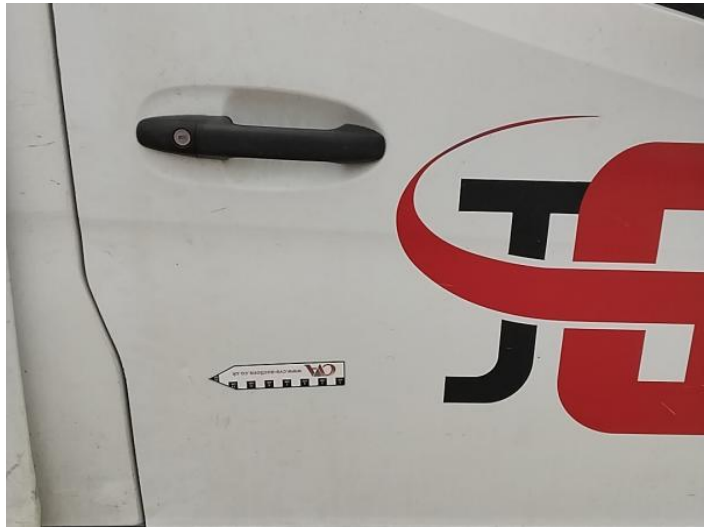
12: Door osf
Dented
Over 2 UpTo 10mm

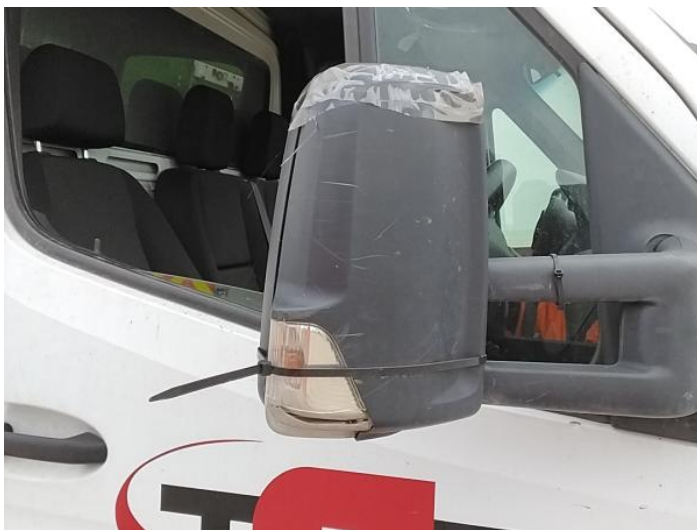
13: Door Mirror Assy osf
Broken
Replace

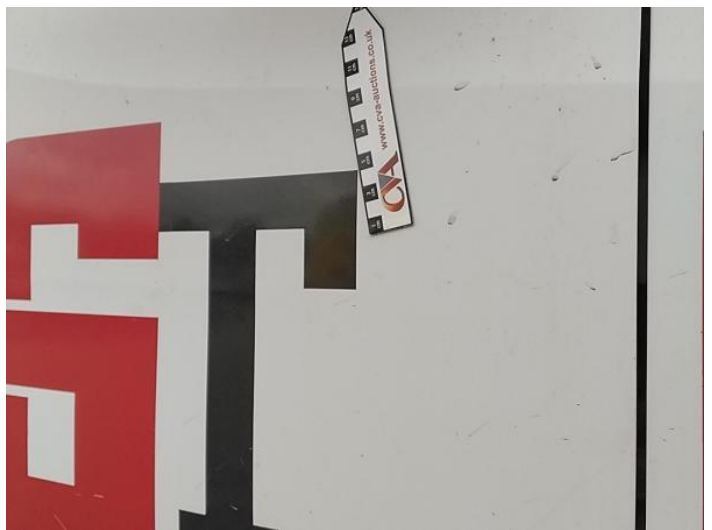
14: Door osf
Dented
With Paint Damage

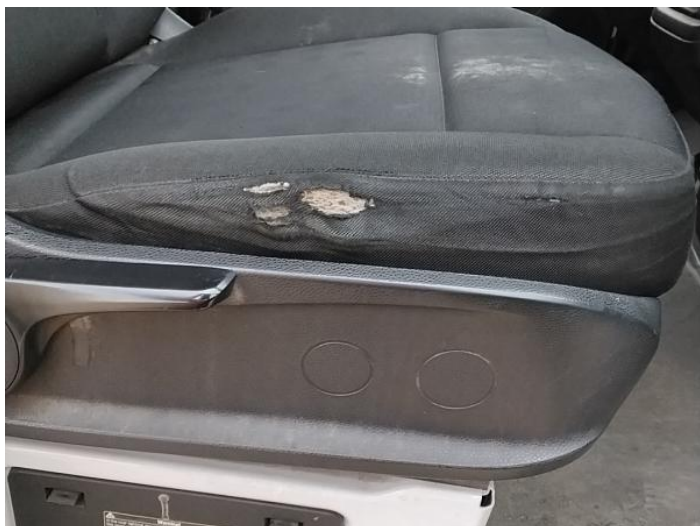
15: Seat Base Cover osf
Torn
Over 3mm
