VEHICLE INSPECTION REPORT

AY18JYE

Mercedes-Benz Actros 2553

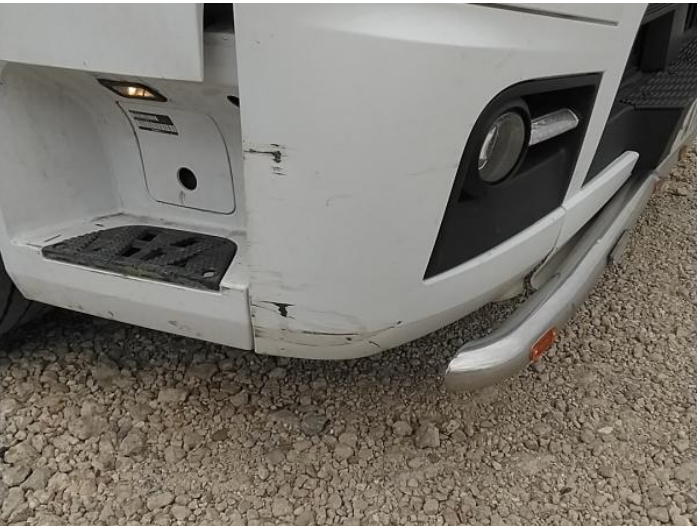
1: Bumper Front
Scratched
Over 100mm Thru Paint

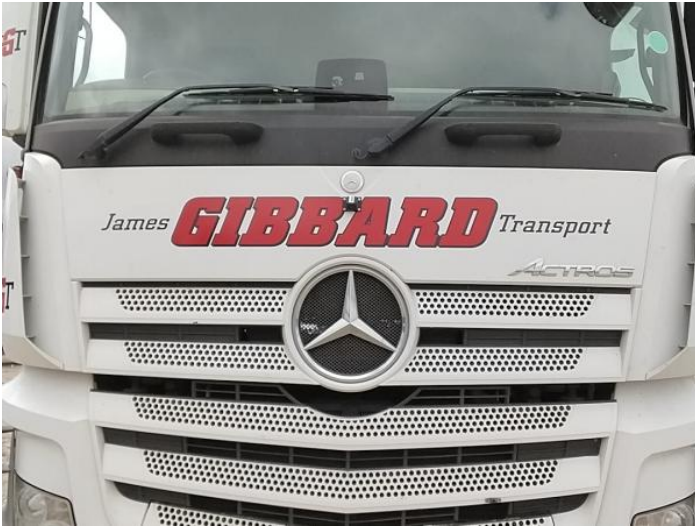
3: Bonnet
Chipped
Multiple Chips

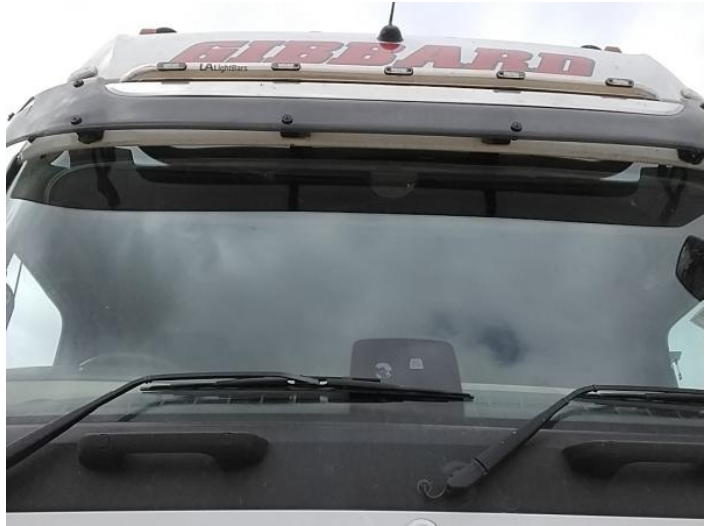
4: Screen Front
Chipped
Over 10mm

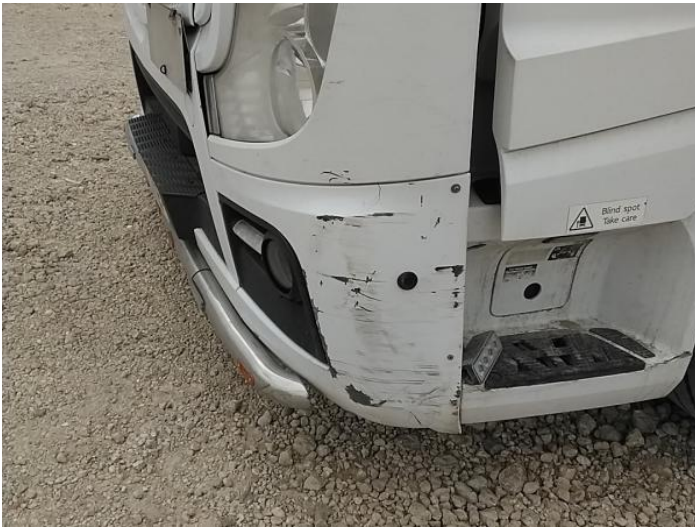
5: Bumper Front
Cracked
Over 25mm

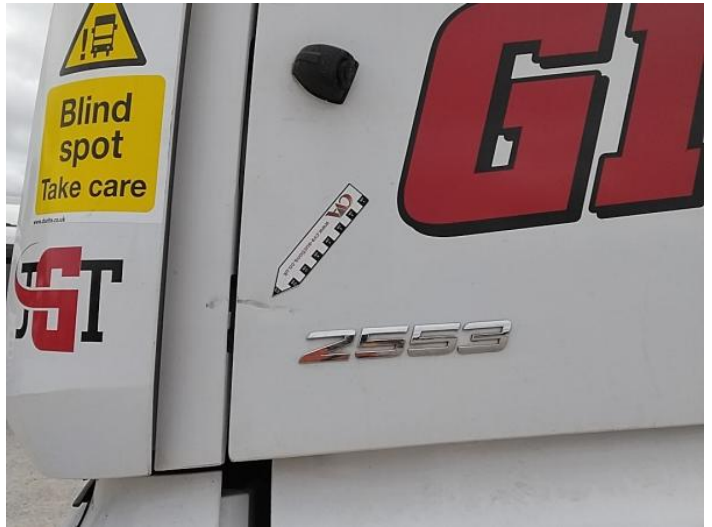
6: Door nsf
Dented
Over 30mm

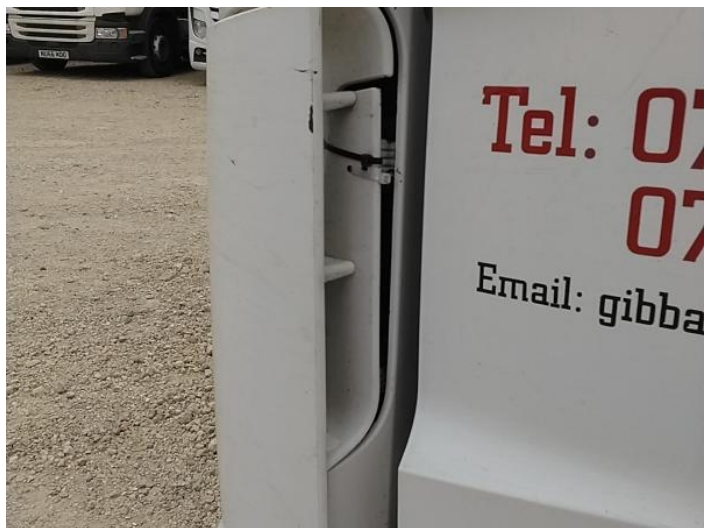
8: Wing nsf
Poor Previous Repair
Poor Paint

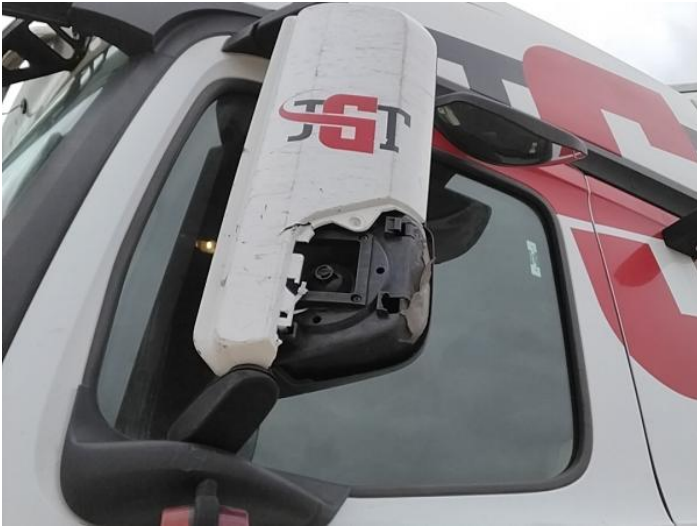
9: Door Mirror Assy nsf
Broken
Replace

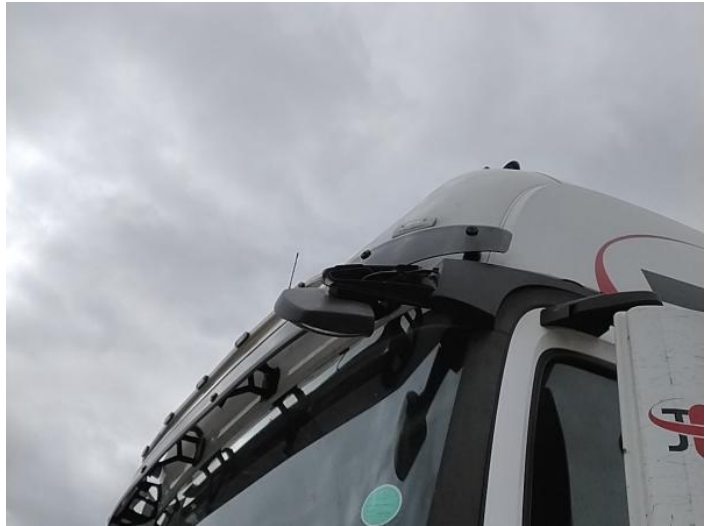
10: Door Mirror Assy nsf
Missing
Replace

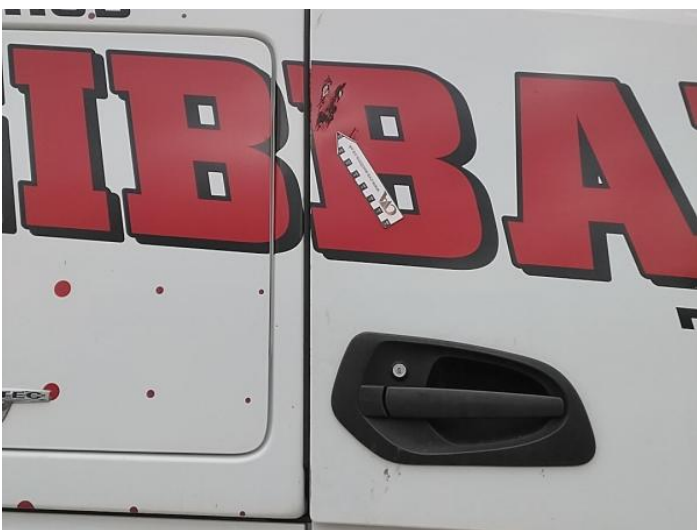
13: Door osf
Dented
With Paint Damage
