VEHICLE INSPECTION REPORT

DG16DSV

Man TGS 26.320

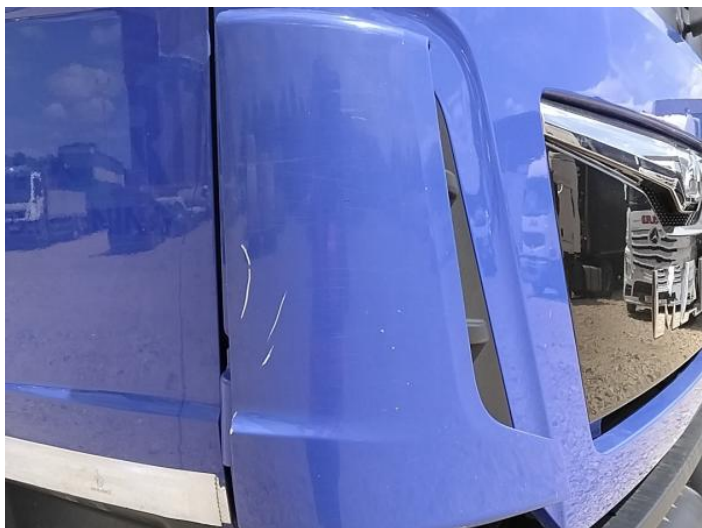
1: Wing osf
Scratched
Over 25mm Thru Paint

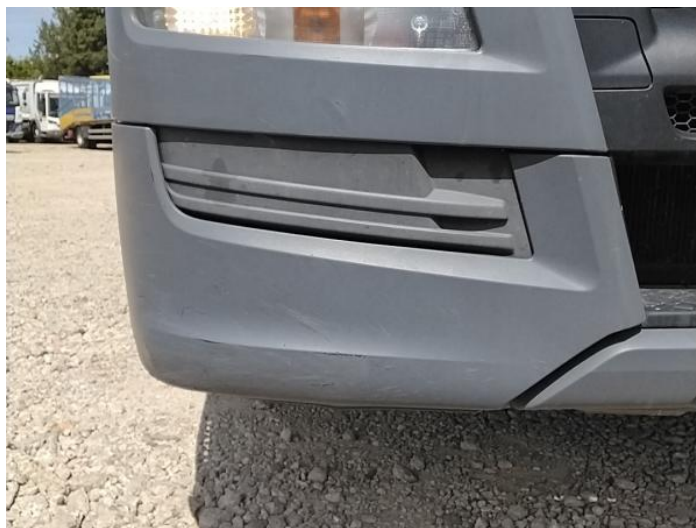
2: Bumper Front
Scratched
Over 100mm Thru Paint

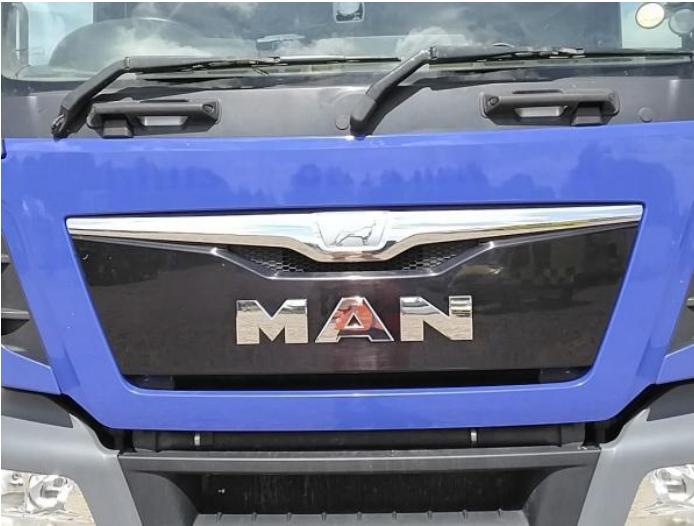
3: Bonnet
Chipped
Multiple Chips

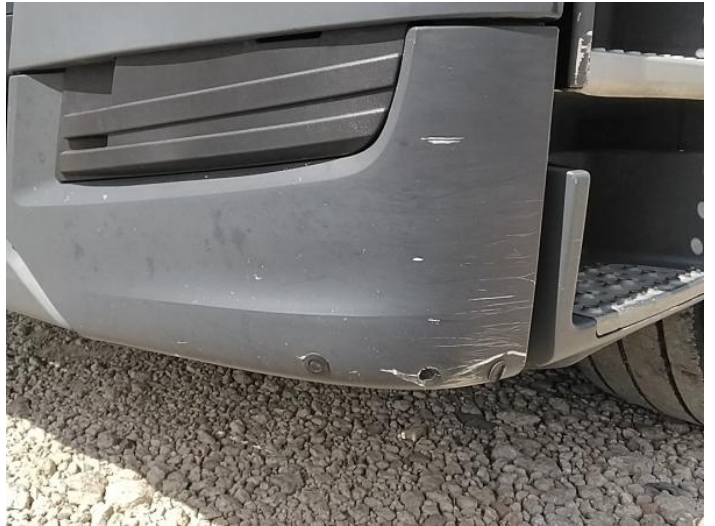
4: Bumper Front
Scratched
Over 100mm Thru Paint

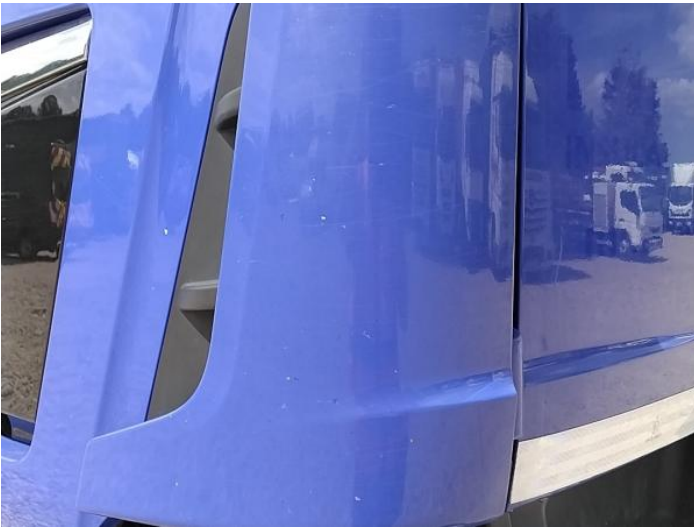
5: Wing nsf
Chipped
Multiple Chips

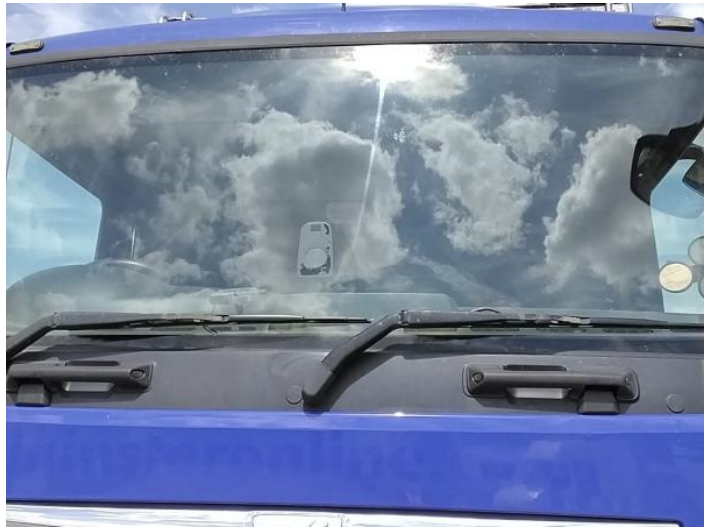
6: Screen Front
Chipped
UpTo 10mm

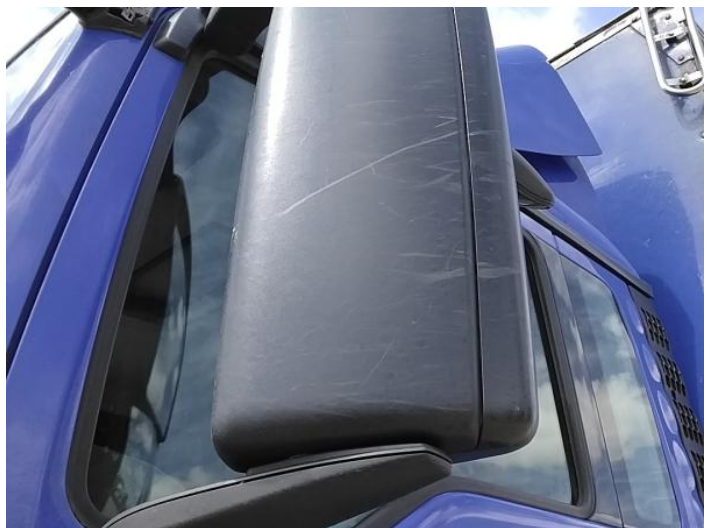
8: Door Mirror Assy nsf
Scuffed (Unpainted)
Over 100mm

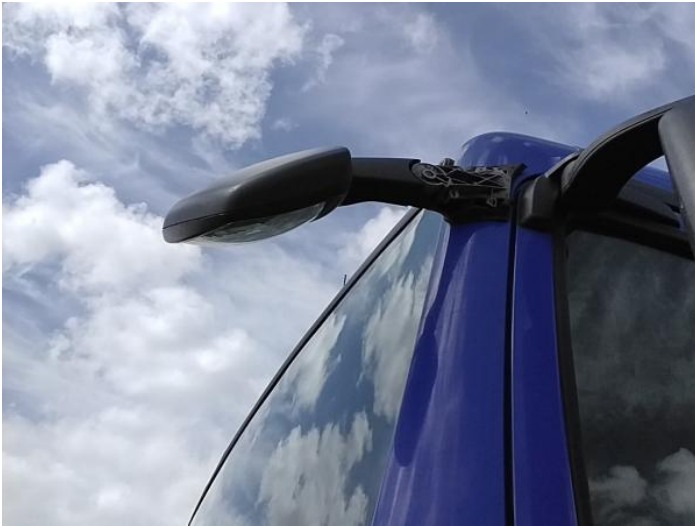
9: Door Mirror Assy nsf
Missing
Replace

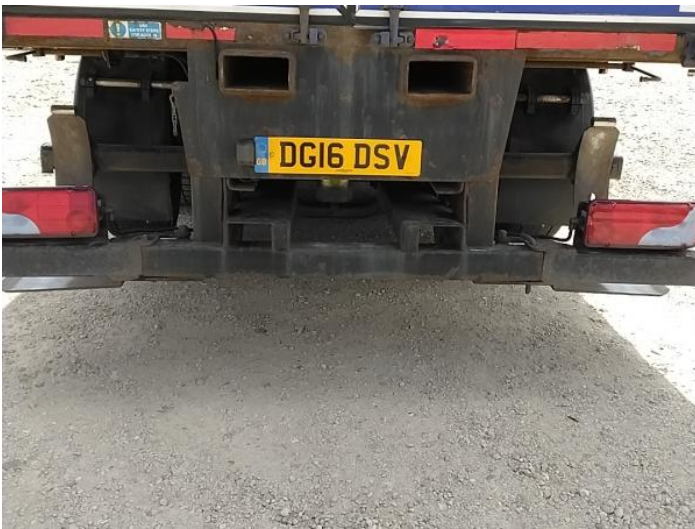
11: Bumper Rear
Rusted
Over 5mm

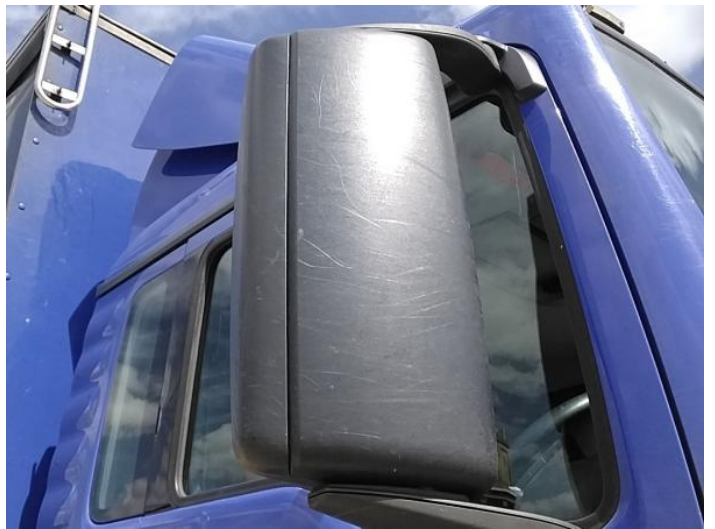
12: Door Mirror Assy osf
Scuffed (Unpainted)
Over 100mm

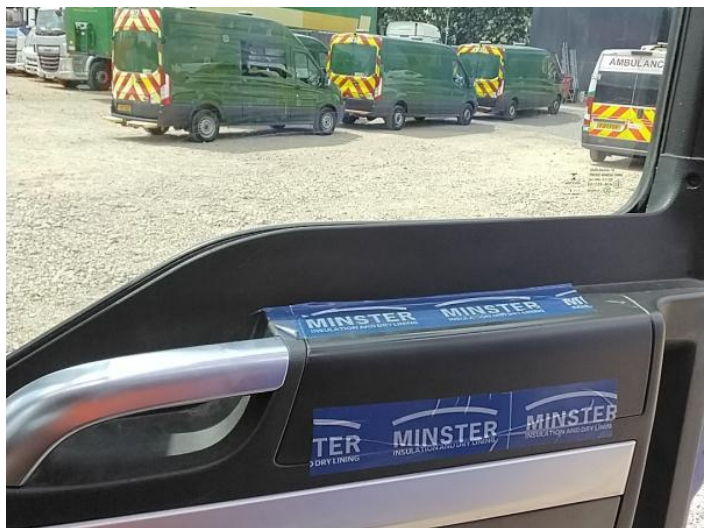
14: Door Pad osf
Broken
Replace

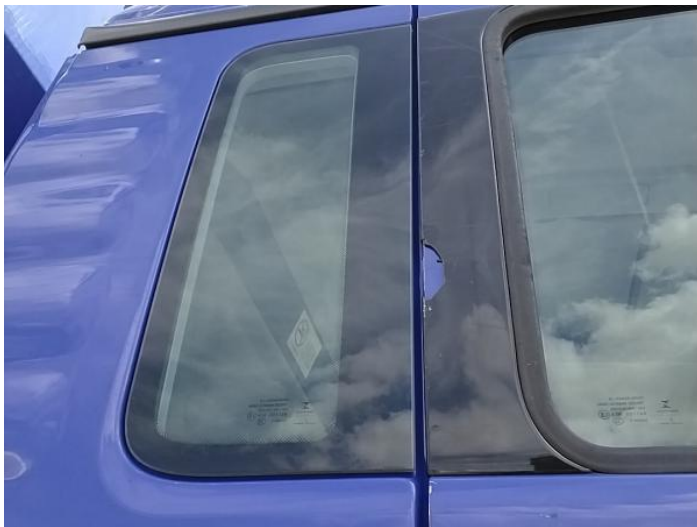
15: Door Moulding osf
Broken
Replace

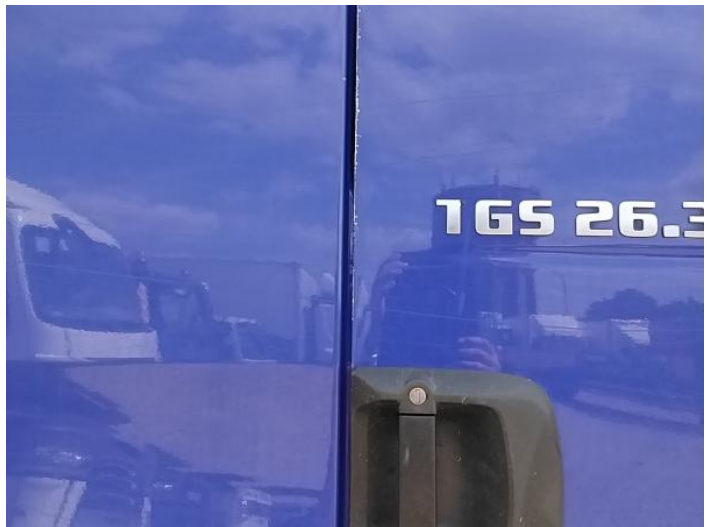
16: Door osf
Chipped
Edge Chip
