VEHICLE INSPECTION REPORT

RK70FMG

Daf LF 180

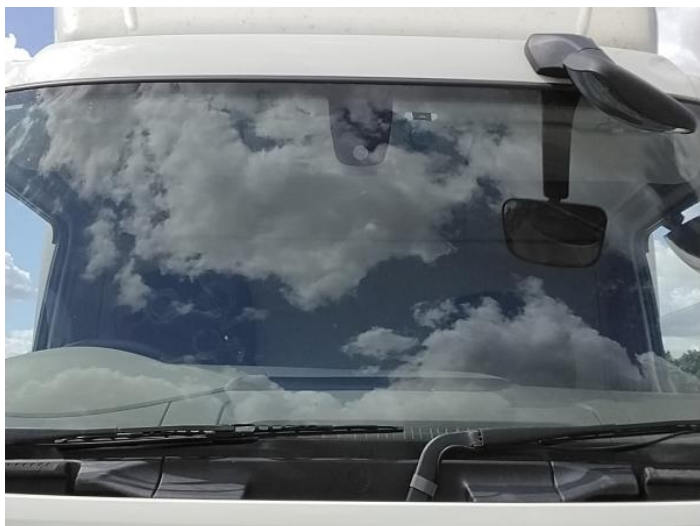
1: Screen Front
Chipped
UpTo 10mm

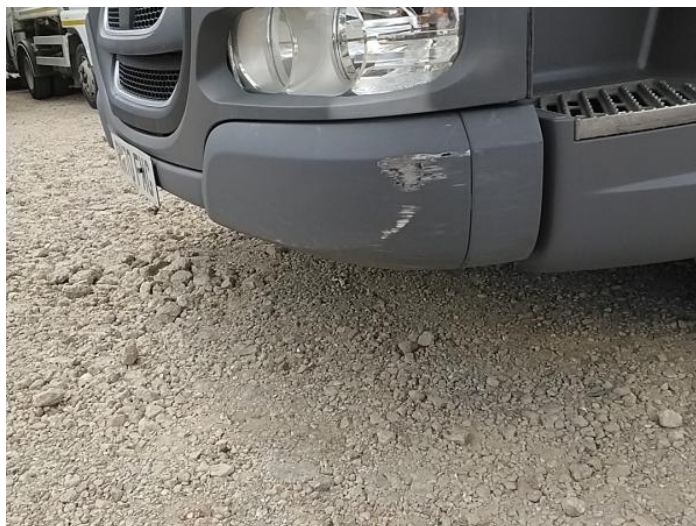
2: Bumper Front
Scratched
25 to 100mm Thru Paint

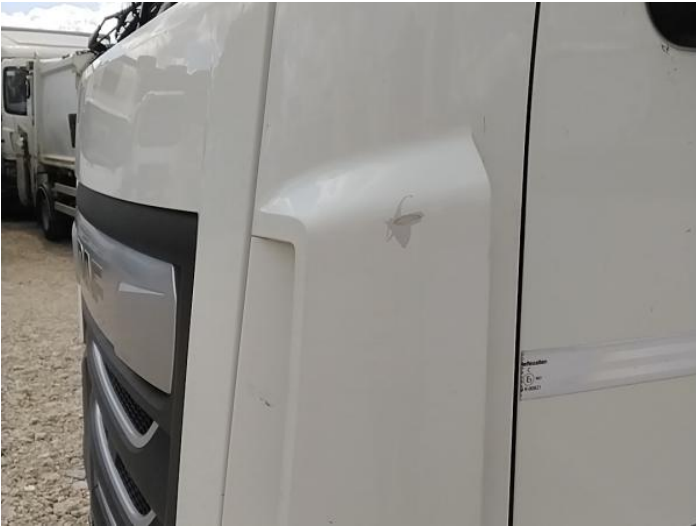
3: Moulding nsf Wing
 Scratched (Painted)
 UpTo 25mm Thru Paint

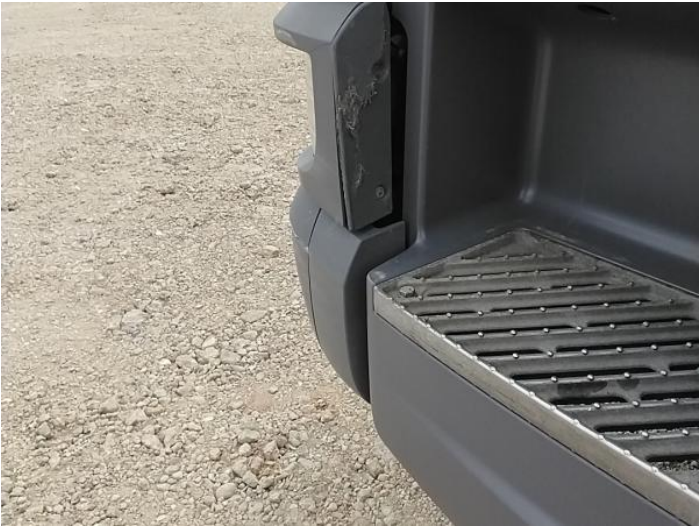
4: Fog Lamp Surround ns
 Broken
 Replace

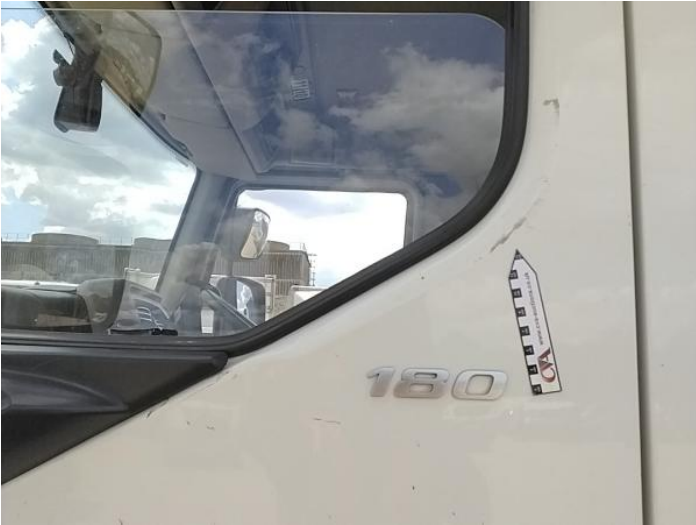
5: Door nsf
 Scratched
 Over 25mm Thru Paint

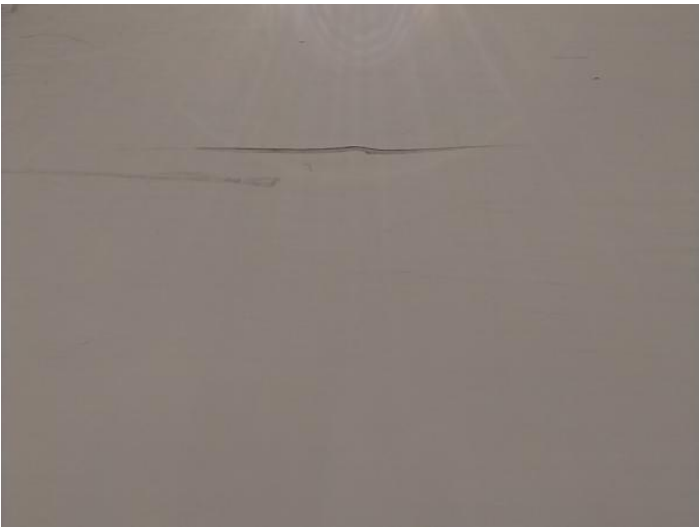
8: Qtr Panel nsr
 Scratched
 Over 25mm Thru Paint

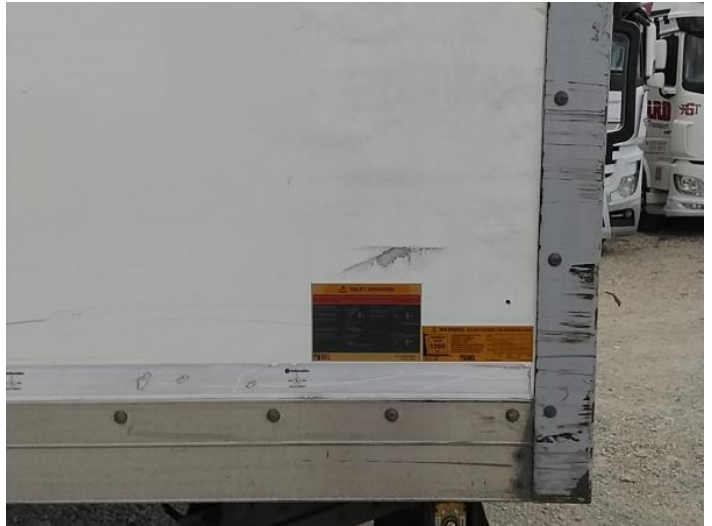
10: Qtr Panel nsr
Scratched
Over 25mm Thru Paint

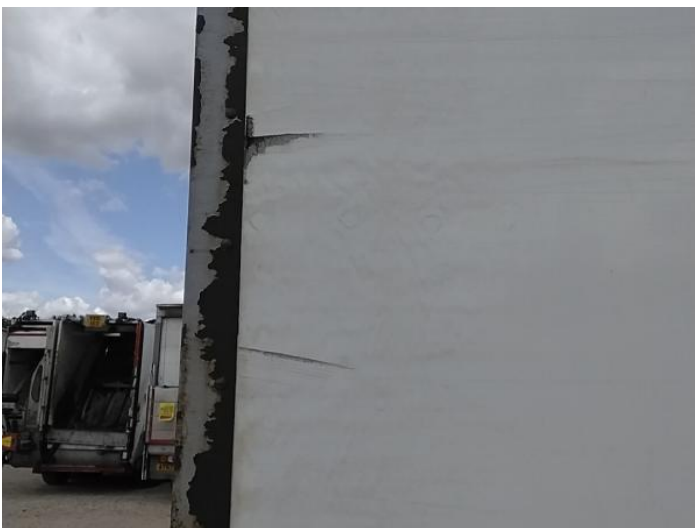
13: Qtr Panel osr
Scratched
UpTo 25mm Thru Paint

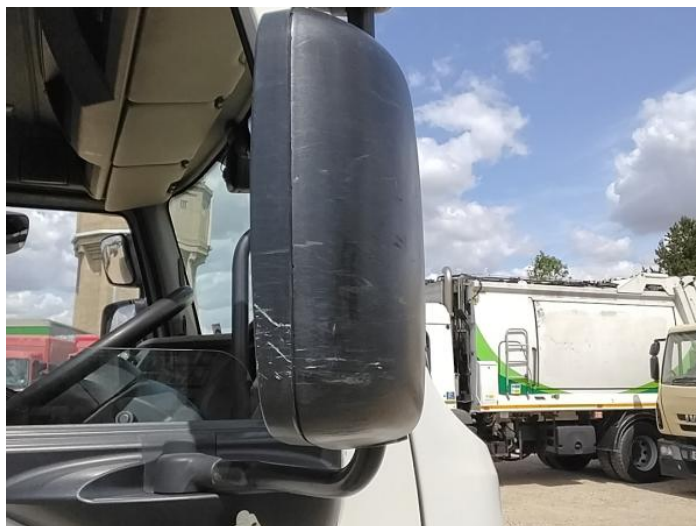
16: Door Mirror Assy osf
Scuffed (Unpainted)
UpTo 100mm

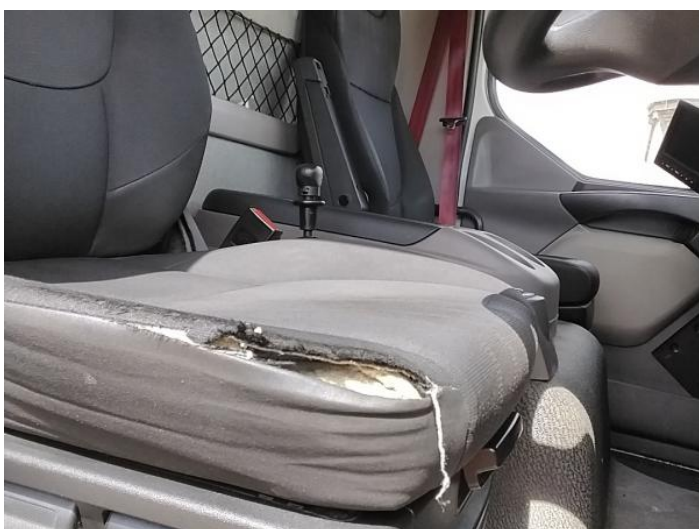
17: Seat Base Cover osf
Torn
Over 3mm
