VEHICLE INSPECTION REPORT

LN20YGT

Isuzu Forward N75.190

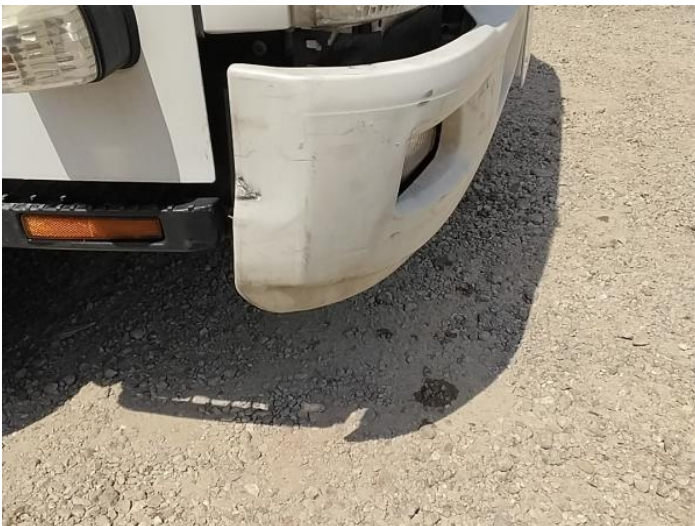
1: Bumper Front
Dented
Between 10mm + 30mm

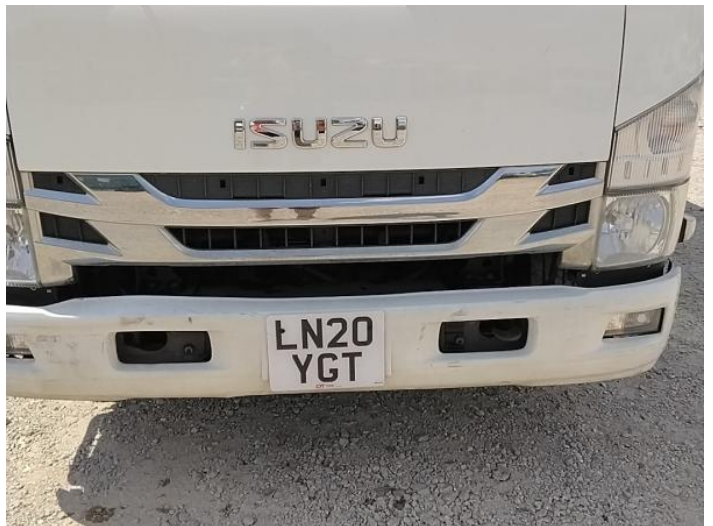
2: Bumper Front
Scratched
Over 25mm Not Thru Paint

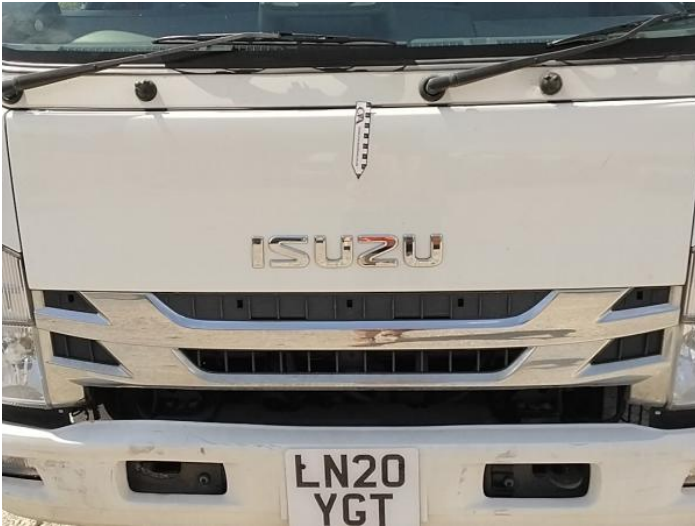
3: Bonnet
Chipped
Multiple Chips

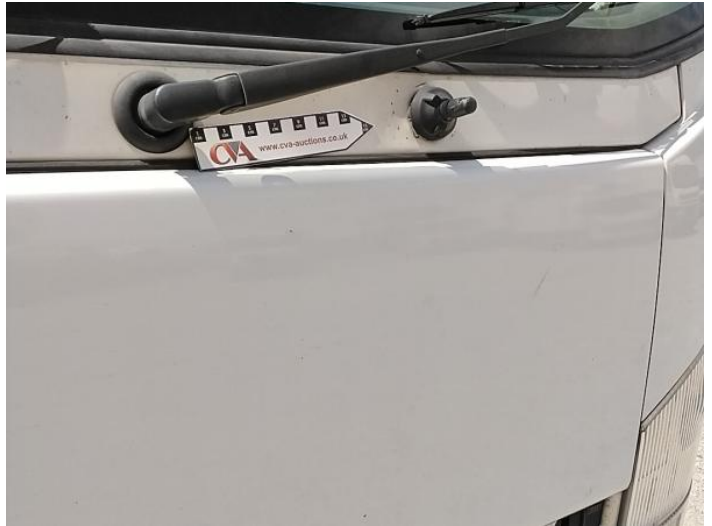
4: Panel Front
Dented
With Paint Damage

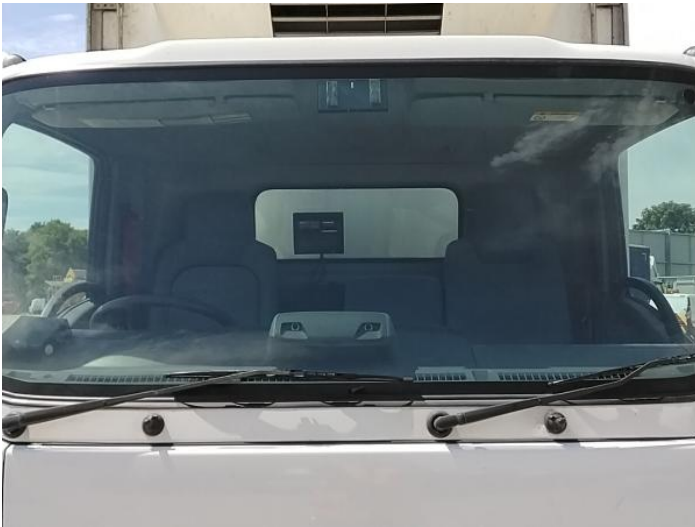
5: Screen Front
Chipped
UpTo 10mm

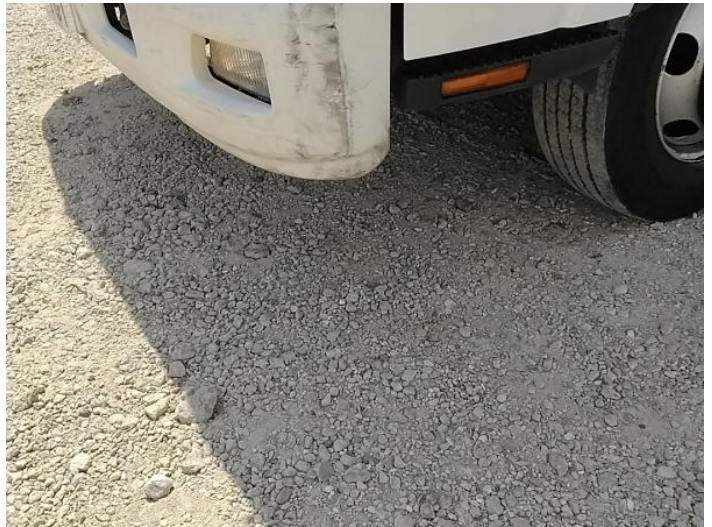
6: Bumper Front
Scratched
Over 25mm Not Thru Paint

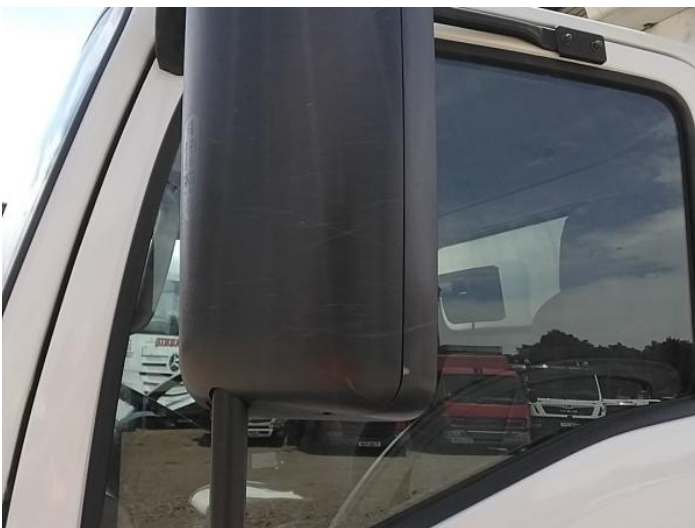
7: Door Mirror Assy nsf
Scuffed (Unpainted)
UpTo 100mm

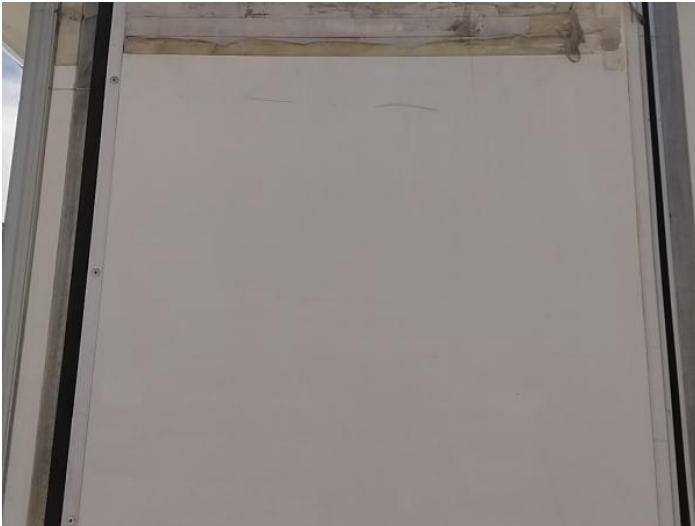
9: Door nsr
Poor Previous Repair
Poor Paint

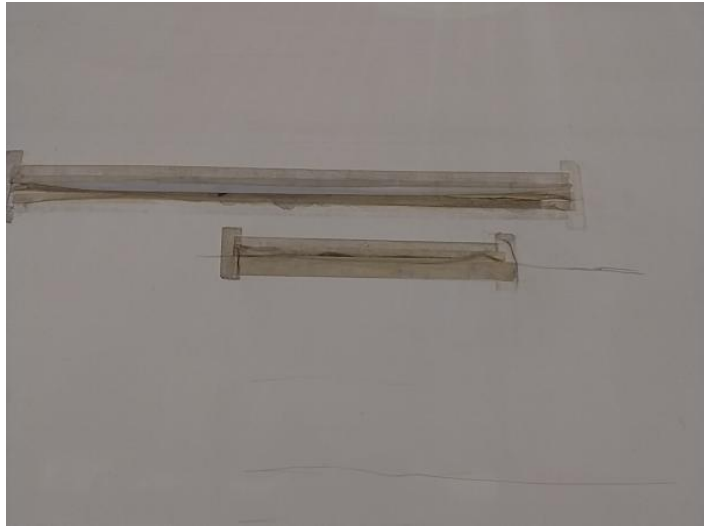
10: Qtr Panel nsr
Poor Previous Repair
Poor Colour

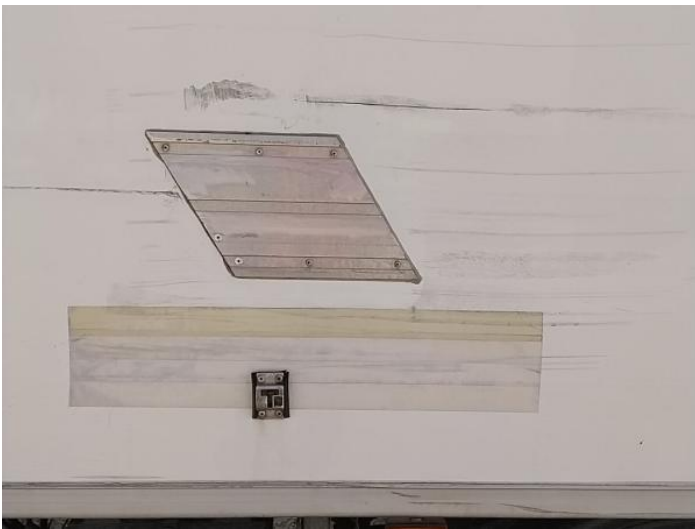
11: Qtr Panel nsr
Poor Previous Repair
Poor Paint

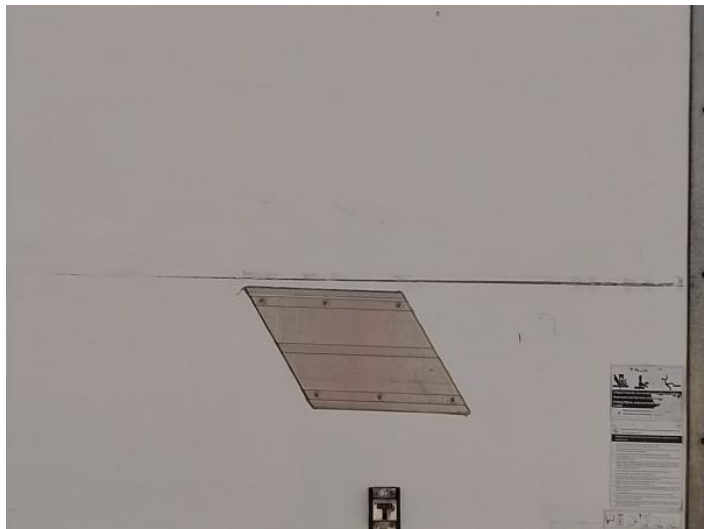
12: Qtr Panel nsr
Scratched
Over 25mm Not Thru Paint

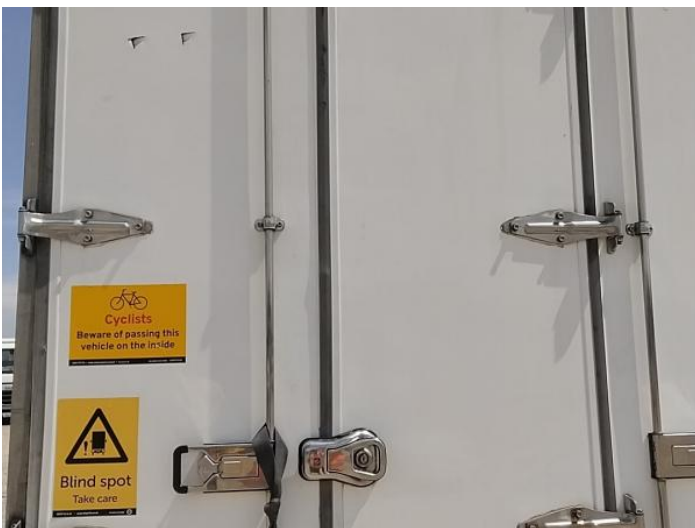
13: Door nsr
Hole
Over 10mm

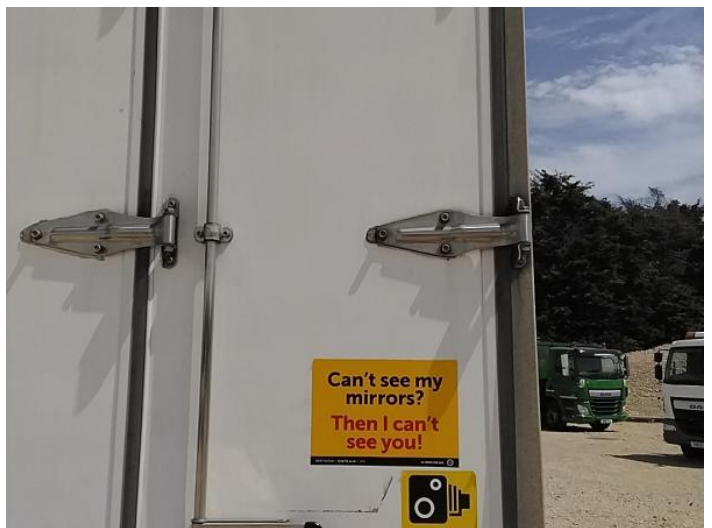
14: Door osr
Hole
Over 10mm

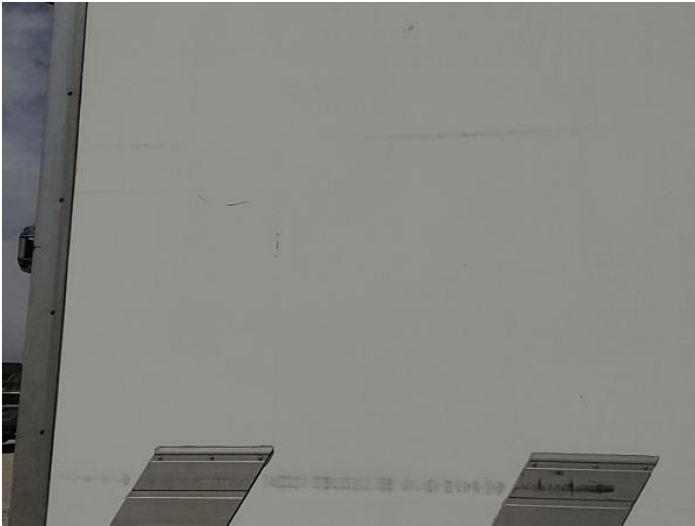
15: Qtr Panel osr
Scratched
Over 25mm Not Thru Paint

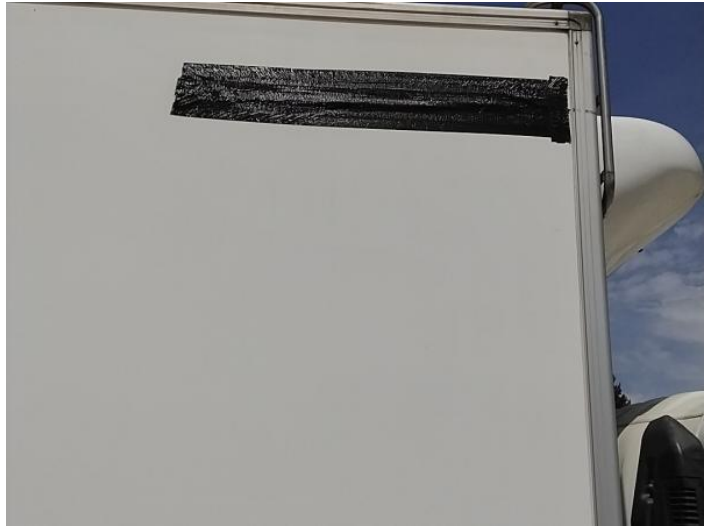
16: Qtr Panel osr
Poor Previous Repair
Poor Paint

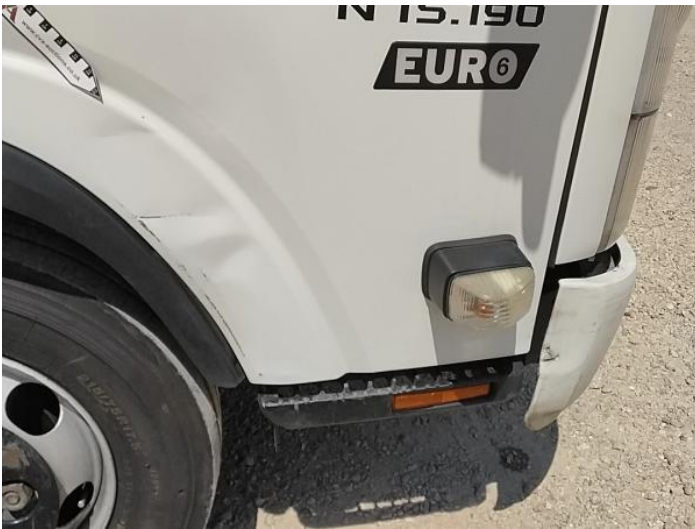
17: Door osf
Dented
With Paint Damage

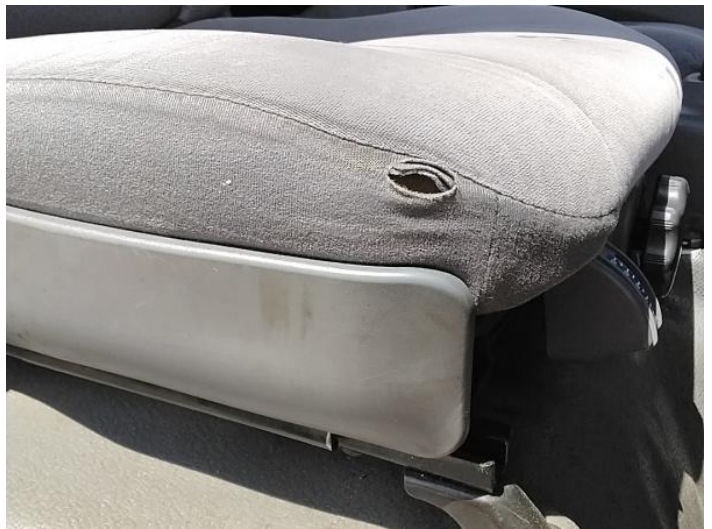
18: Seat Base Cover osf
Holed
Over 3mm
