# VEHICLE INSPECTION REPORT

**DK18HXG**

## Daf LF 180

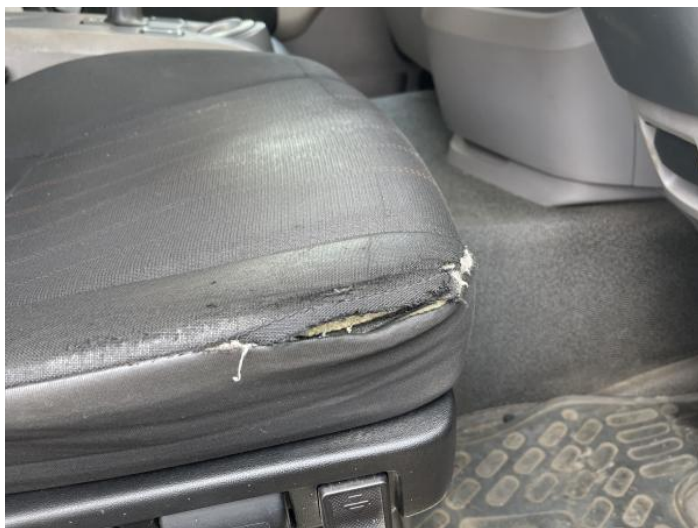
1: Seat Base Cover osf  
Torn  
Over 3mm

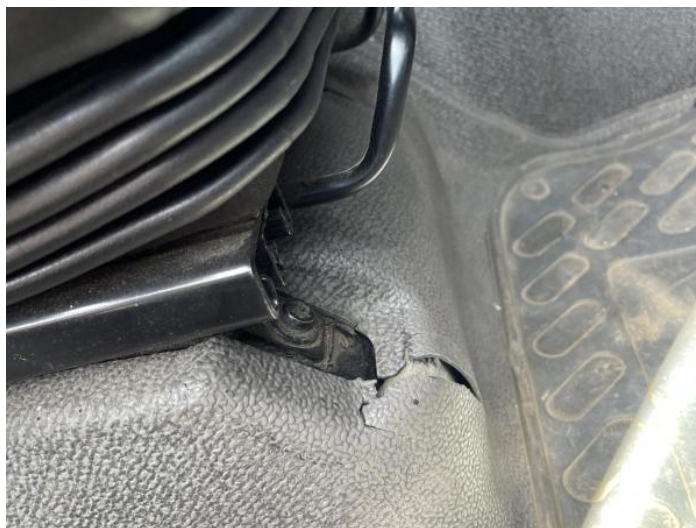
2: Carpets Front  
Torn  
Over 10mm

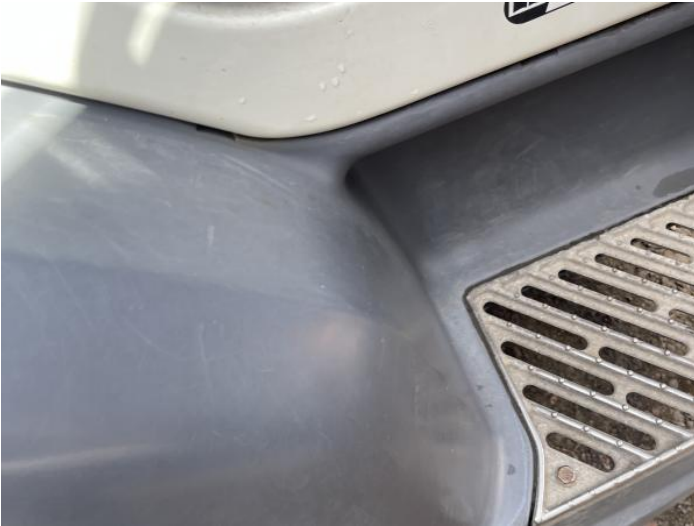
3: Door Moulding osf  
Scuffed (Unpainted)  
Over 100mm

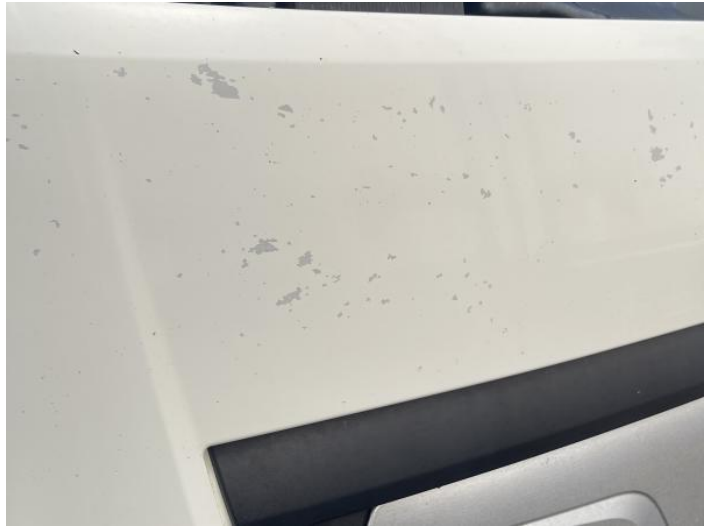
4: Bonnet  
Scratched  
Over 25mm Thru Paint

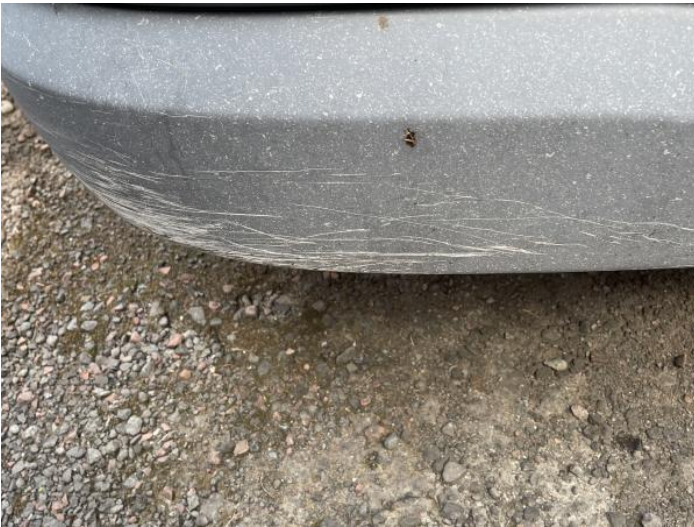
5: Bumper Front Moulding  
Scuffed (Unpainted)  
Over 100mm

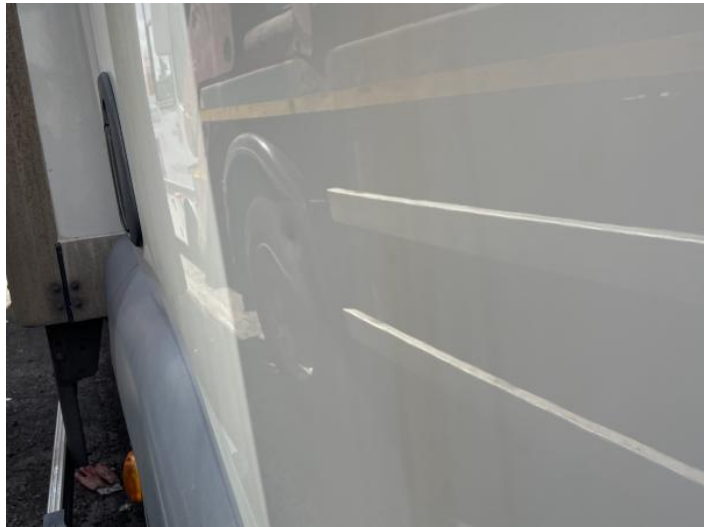
6: Door osf  
Dented  
With Paint Damage

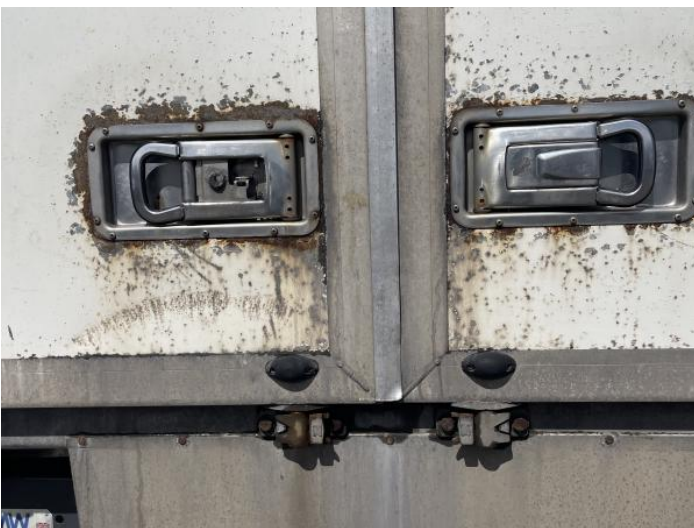
7: Tailgate  
Rusted  
Over 5mm

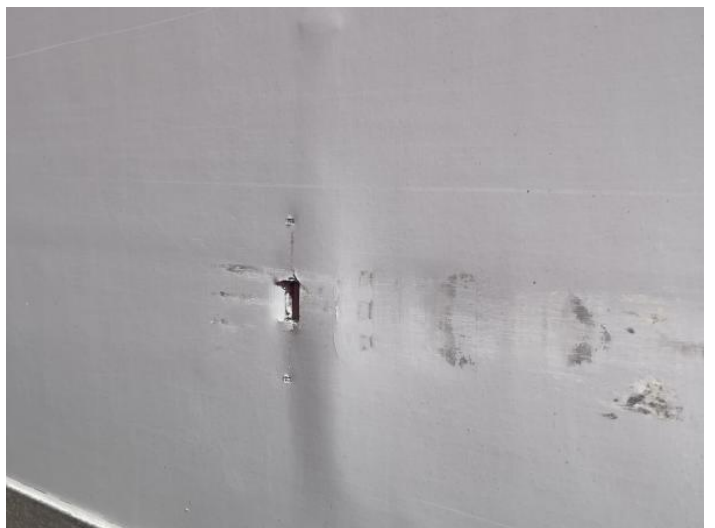
8: Qtr Panel nsr  
Hole  
UpTo 10mm

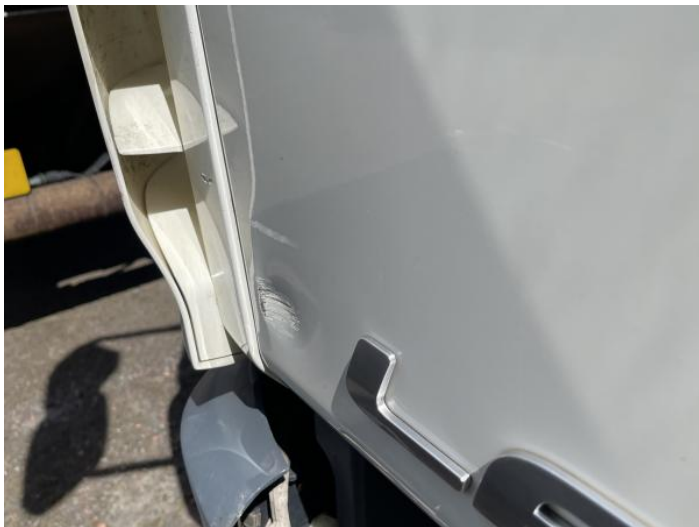
9: Door osf  
Dented  
Over 30mm

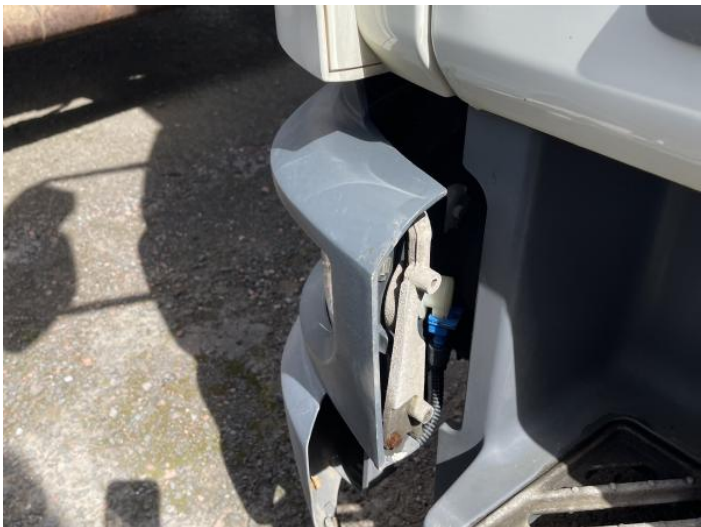
10: Door Moulding nsf  
Missing  
Replace

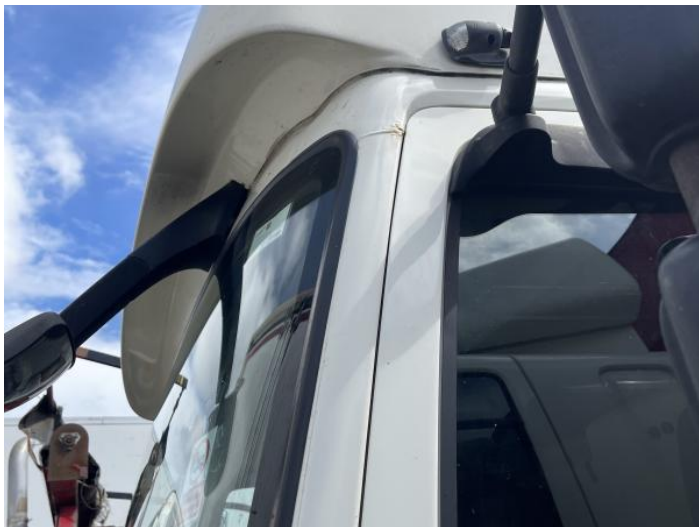
11: A Post ns  
Rusted  
Over 5mm
