VEHICLE INSPECTION REPORT

C376749

Cartwright BOX DOUBLE DECK

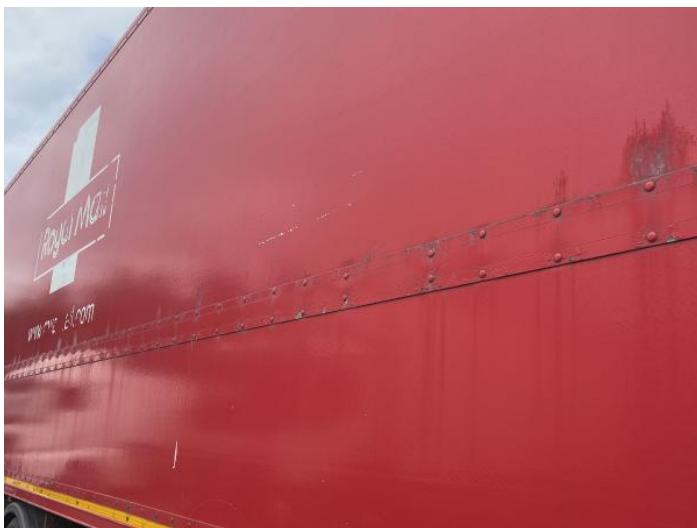
1: Qtr Panel osr
Dented
With Paint Damage

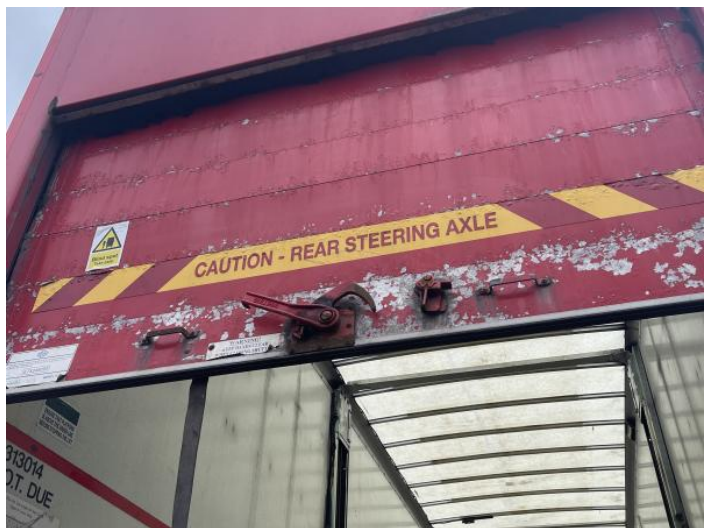
2: Tailgate
Rusted
Over 5mm

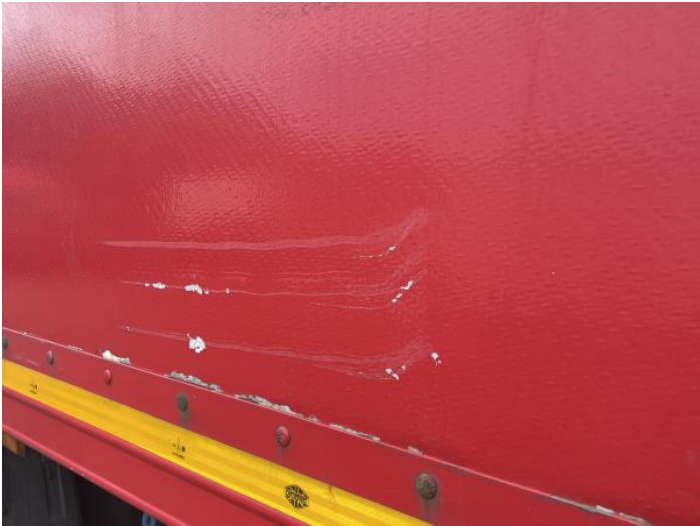
3: Qtr Panel nsr
Dented
With Paint Damage

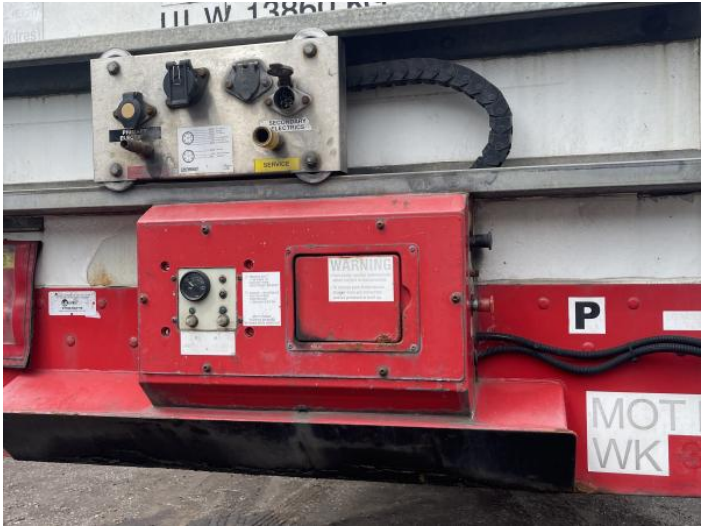
4: Bonnet
Rusted
Over 5mm
