VEHICLE INSPECTION REPORT

NX70CYZ

Mercedes-Benz Atego 824

Inspection

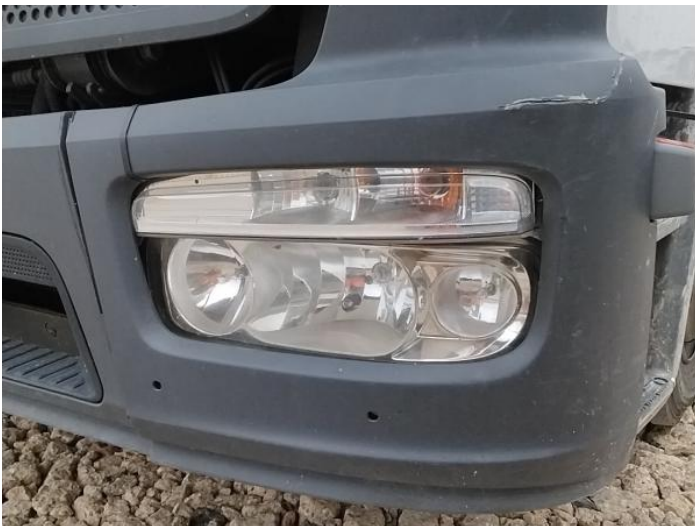
1: Fog Lamp Surrounds
Broken
Replace

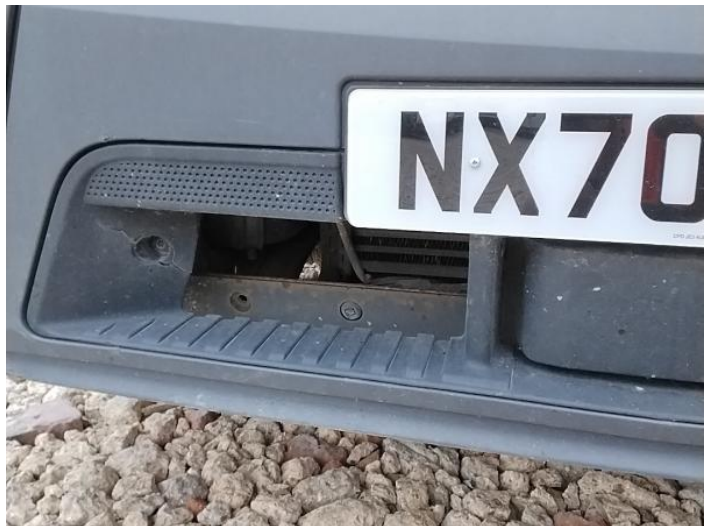
2: Grille Front
Broken
Replace

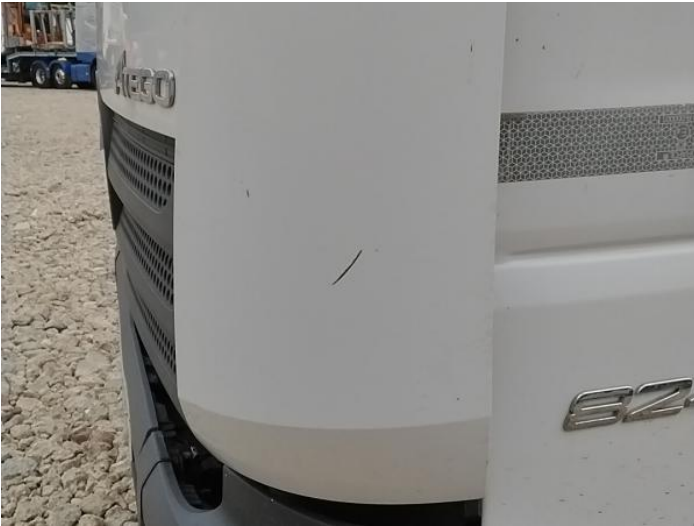
3: Moulding nsf Wing
Scratched (Painted)
UpTo 25mm Thru Paint

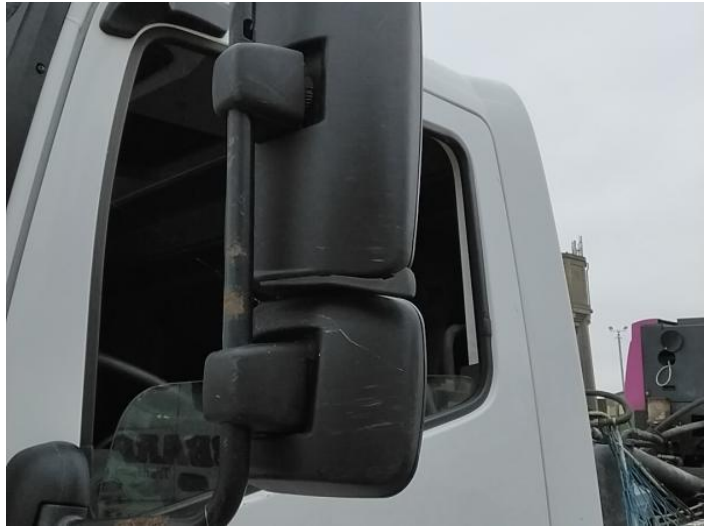
4: Door Mirror Assy nsf
Scuffed (Unpainted)
UpTo 100mm

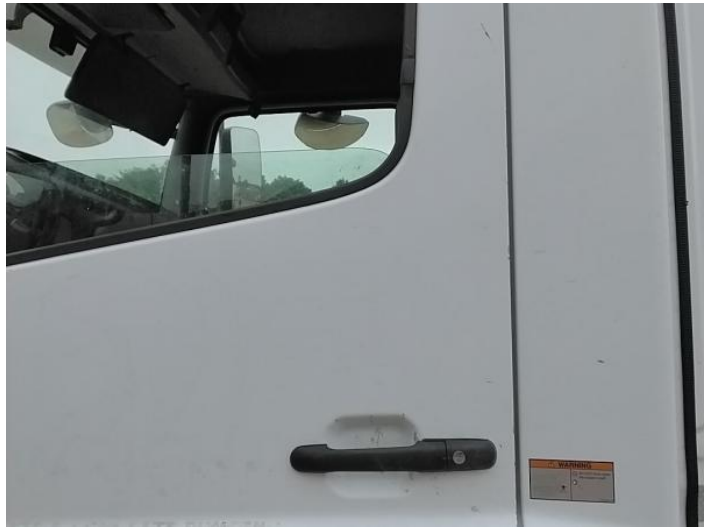
6: Door nsf
Scratched
Over 25mm Thru Paint

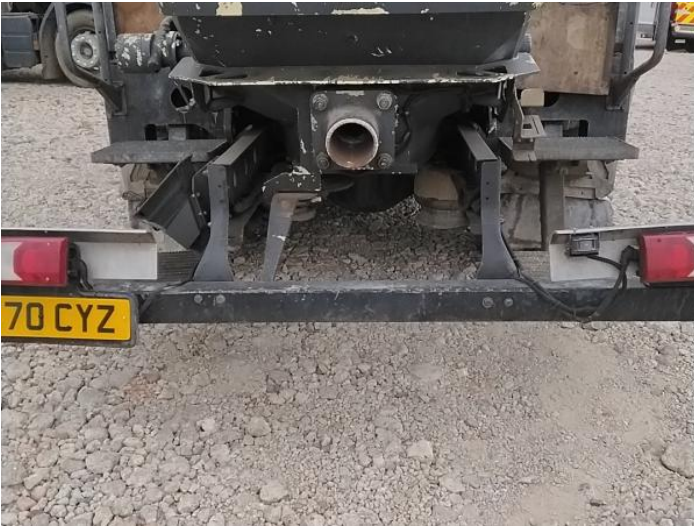
9: Bumper Rear
Rusted
Over 5mm

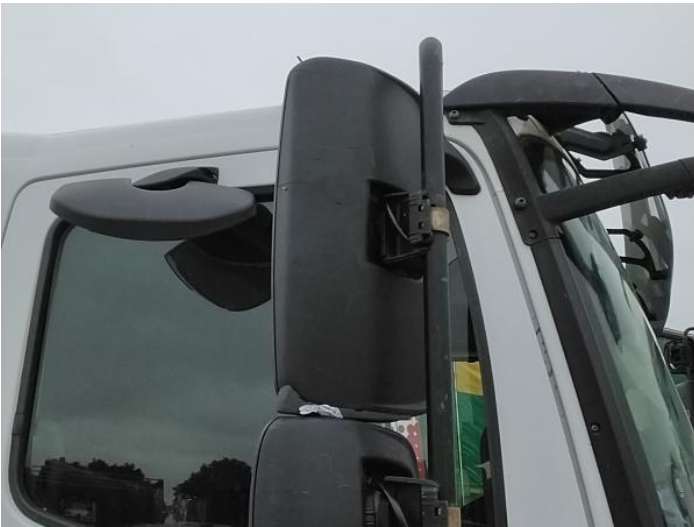
11: Door Mirror Assy osf
Broken
Replace
