# VEHICLE INSPECTION REPORT

**NK150EE**

## Mercedes-Benz Econic

### Inspection

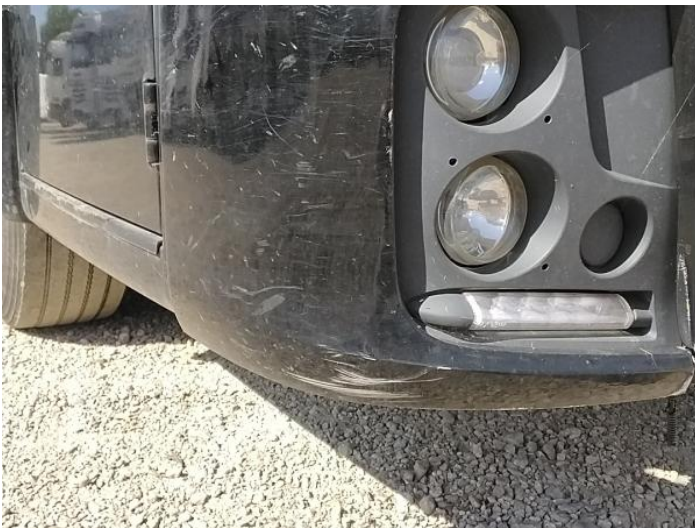
1: Fog Lamp Surround os  
Scratched (Painted)  
Over 25mm Thru Paint

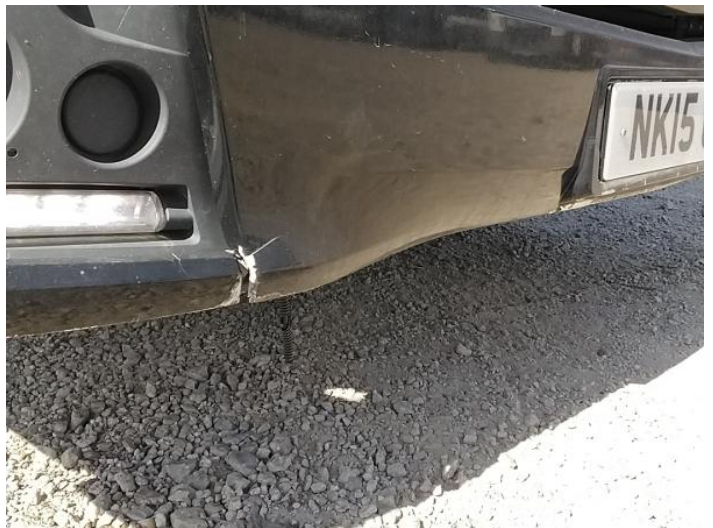
2: Bumper Front  
Cracked  
UpTo 25mm

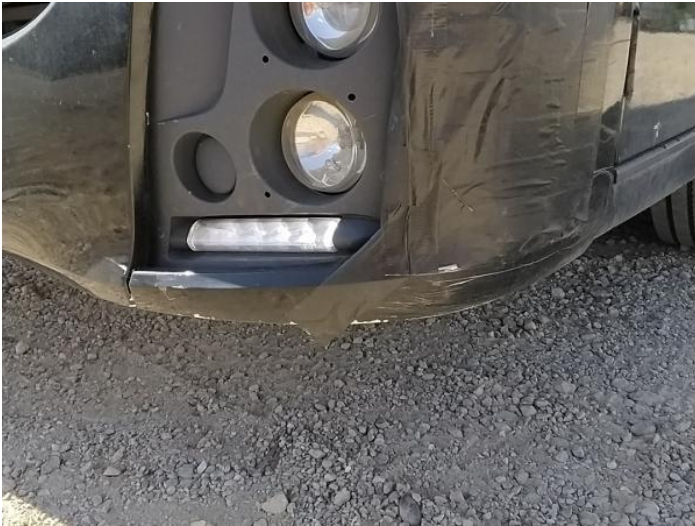
3: Fog Lamp Surround ns  
Broken  
Replace

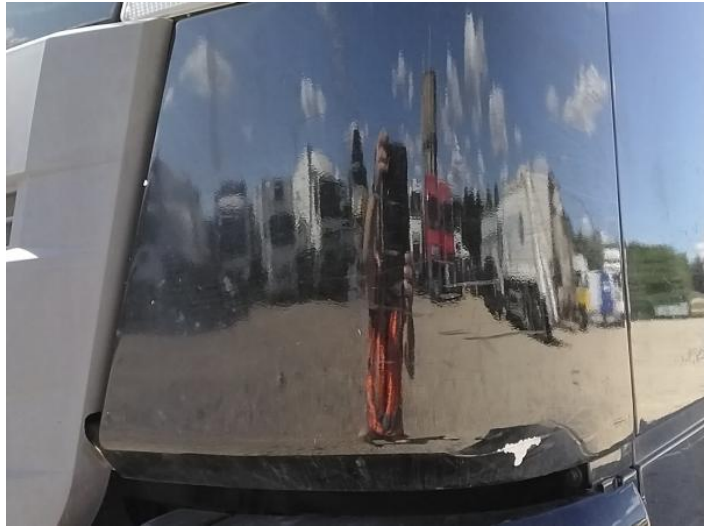
4: Wing nsf  
Scratched  
UpTo 25mm Thru Paint

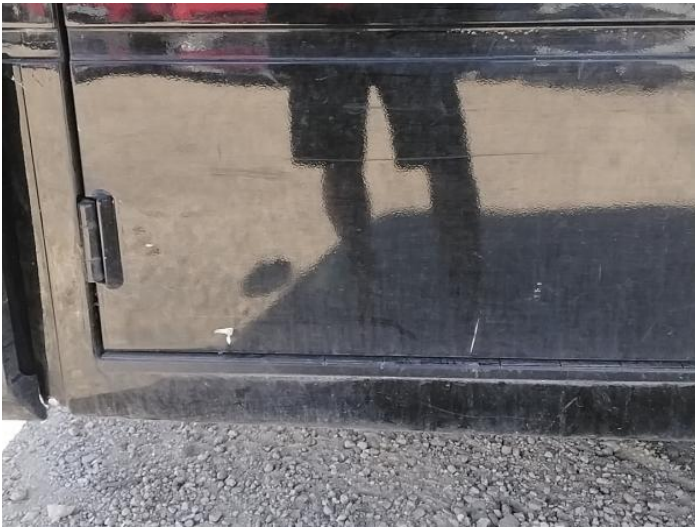
5: Door nsf  
Scratched  
UpTo 25mm Thru Paint

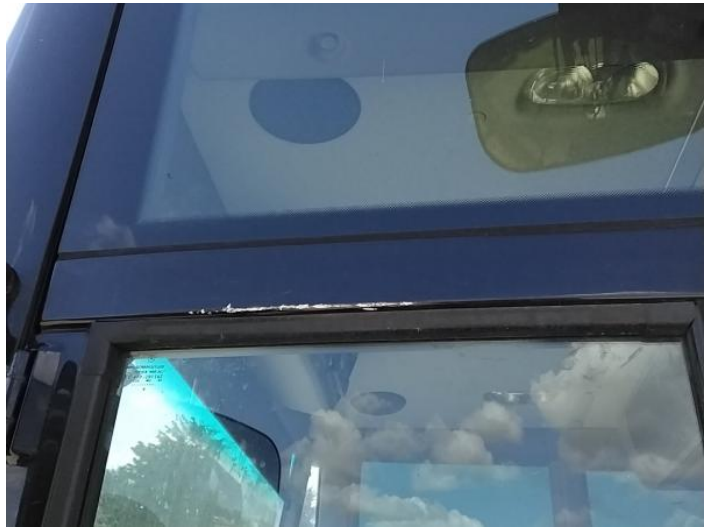
6: Door nsf  
Scratched  
UpTo 25mm Thru Paint

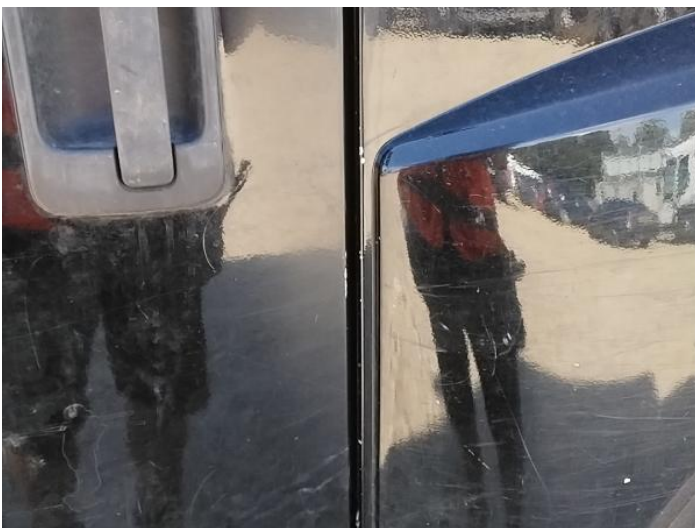
7: Door nsf  
Chipped  
Edge Chip

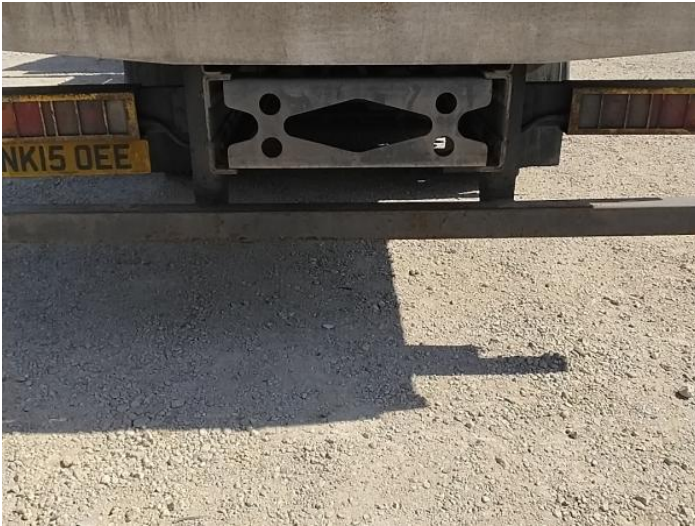
9: Bumper Rear  
Rusted  
Over 5mm

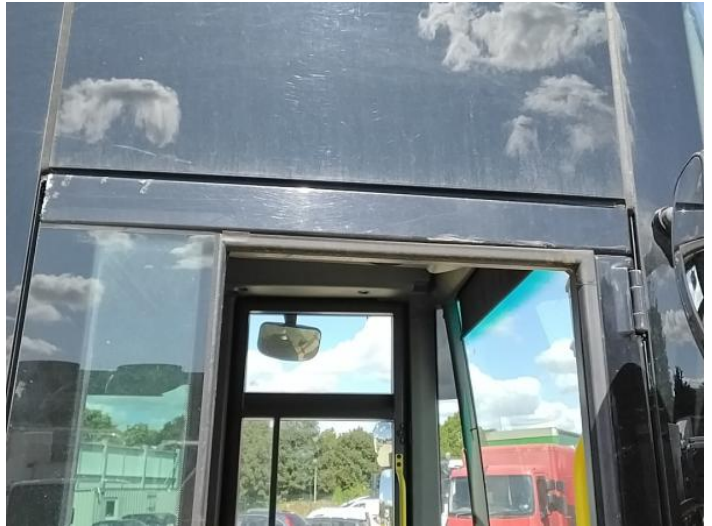
10: Door osf  
Scratched  
Over 25mm Thru Paint

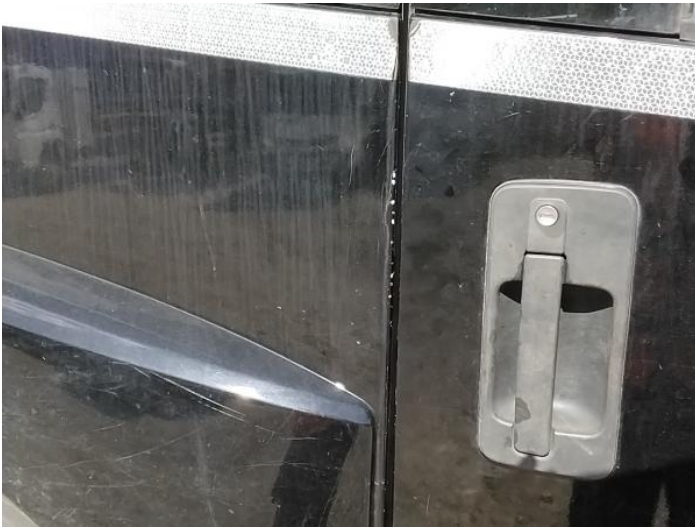
11: Door osf  
Chipped  
Edge Chip

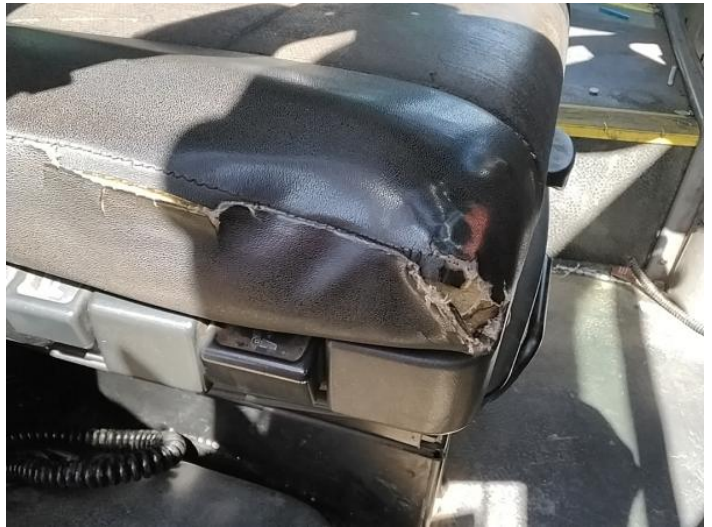
12: Seat Base Cover osf  
Torn  
Over 3mm

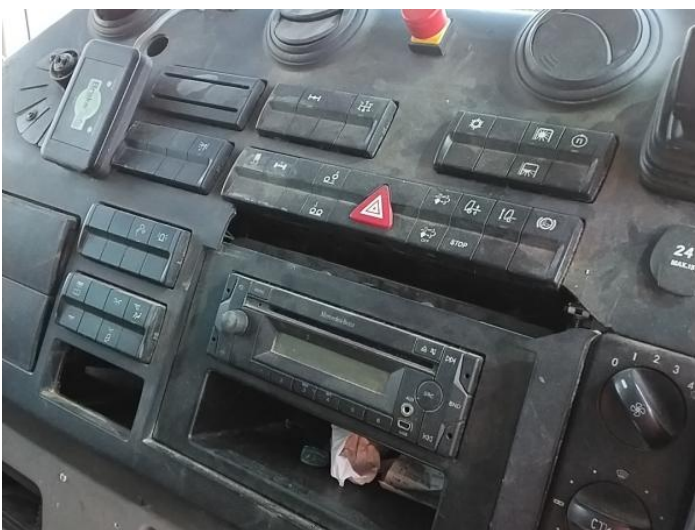
13: Fascia Panel  
Broken  
Replace

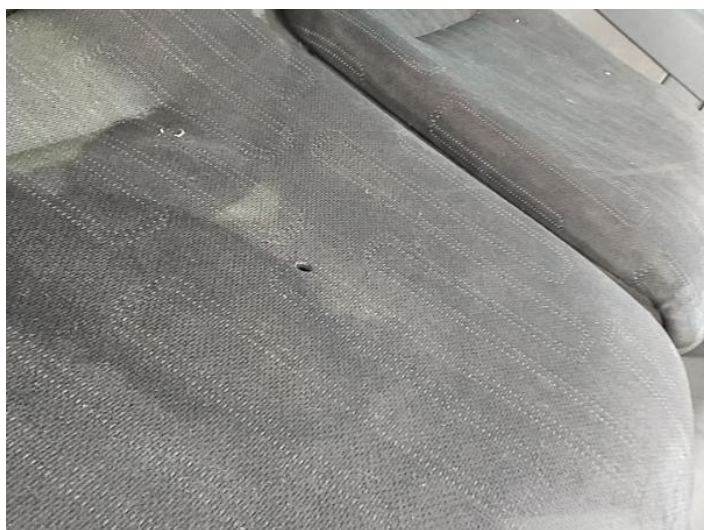
14: Seat Base Cover nsf  
Burn  
Over 3mm
