# VEHICLE INSPECTION REPORT

**YD19AOC**

## Fiat Ducato 35 2.3 MULTIJET 130PS

**Non Runner**  
Inspection

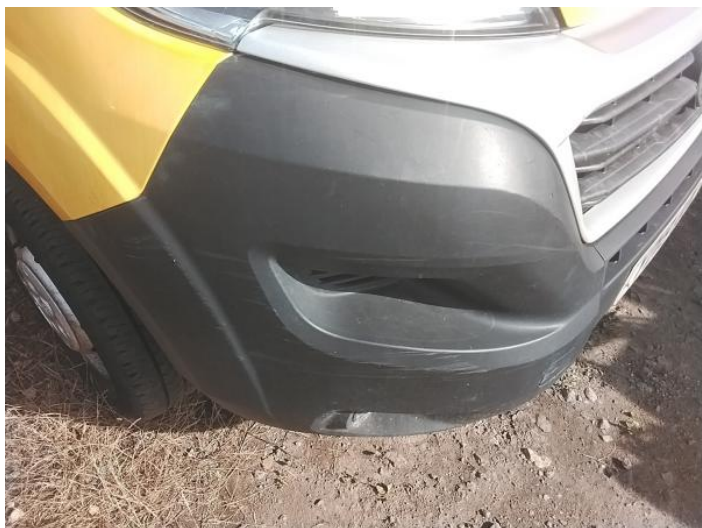
1: Bumper Front  
Scratched  
Over 100mm Thru Paint

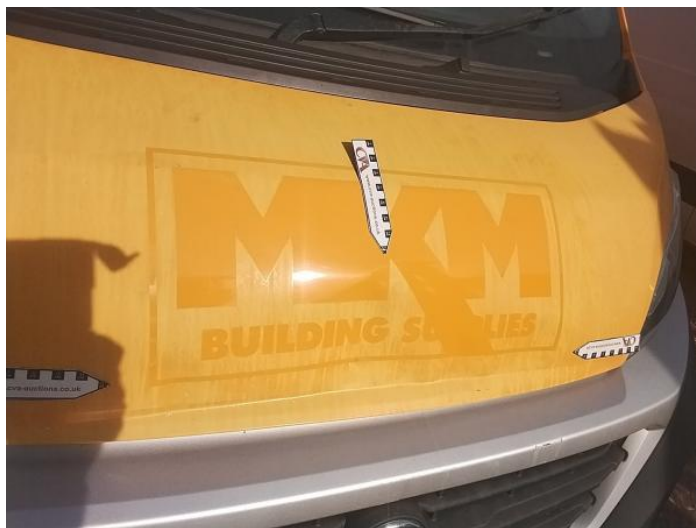
2: Bonnet  
Dented  
With Paint Damage

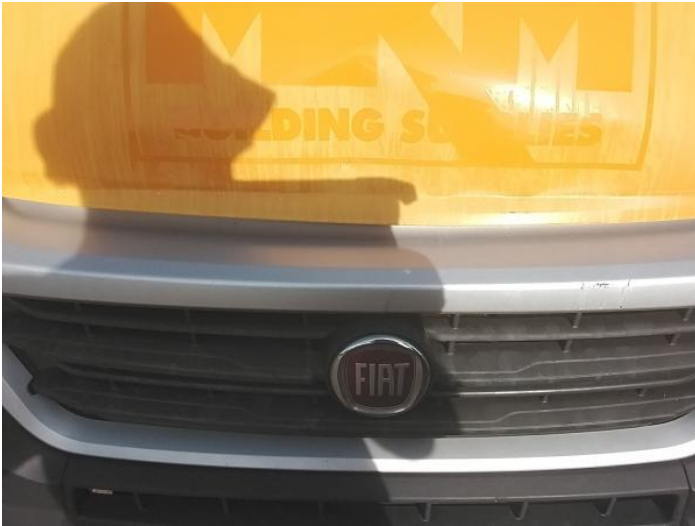
3: Panel Front  
Scratched  
Over 25mm Thru Paint

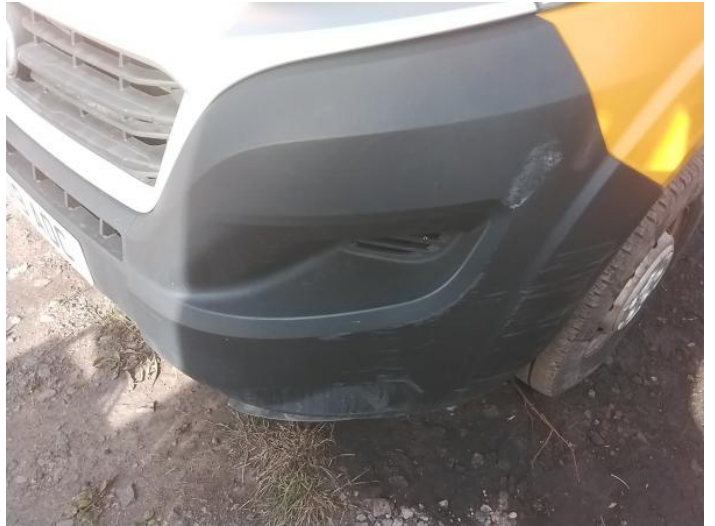
4: Bumper Front  
Scratched  
Over 100mm Thru Paint

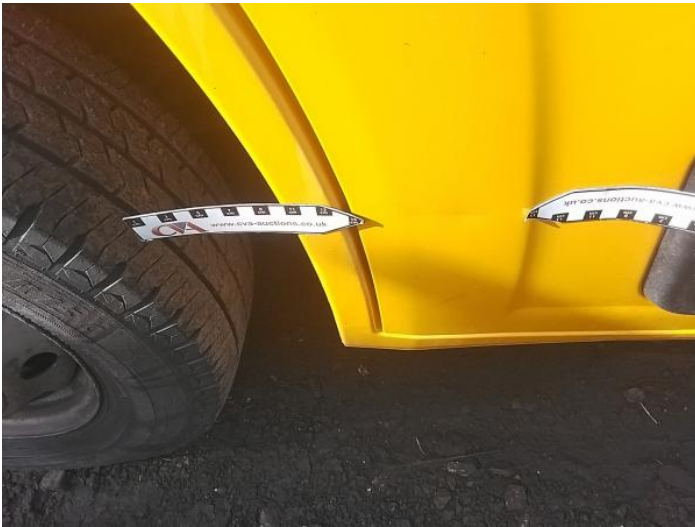
5: Door nsf  
Dented  
Over 30mm

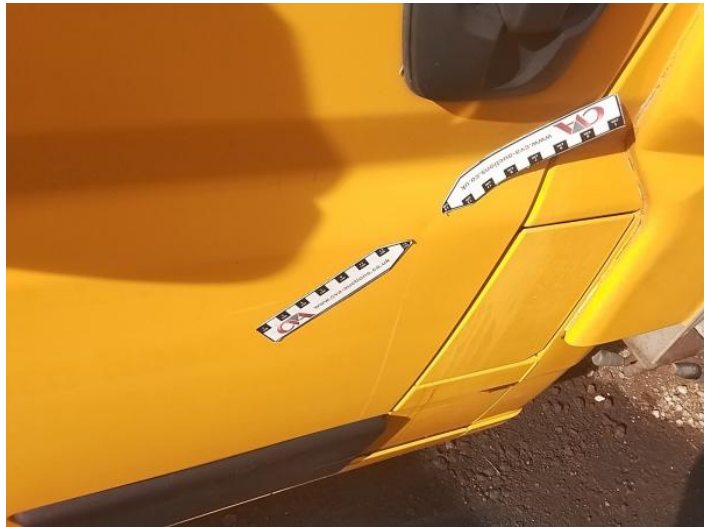
6: Door nsf  
Dented  
Over 30mm

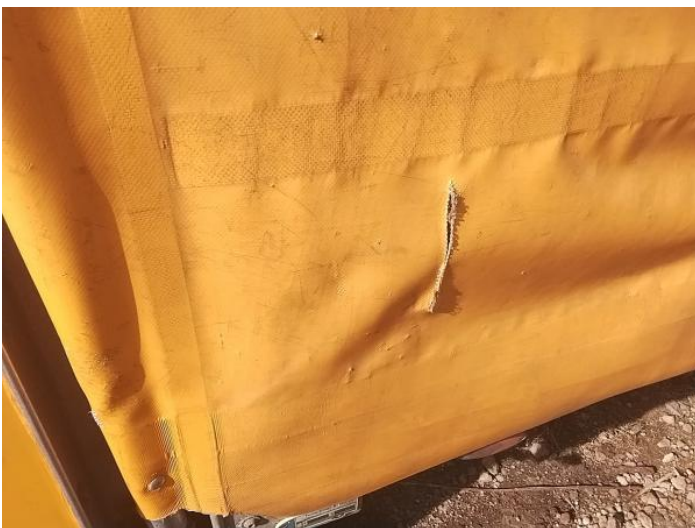
7: Qtr Panel nsr  
Hole  
Over 10mm

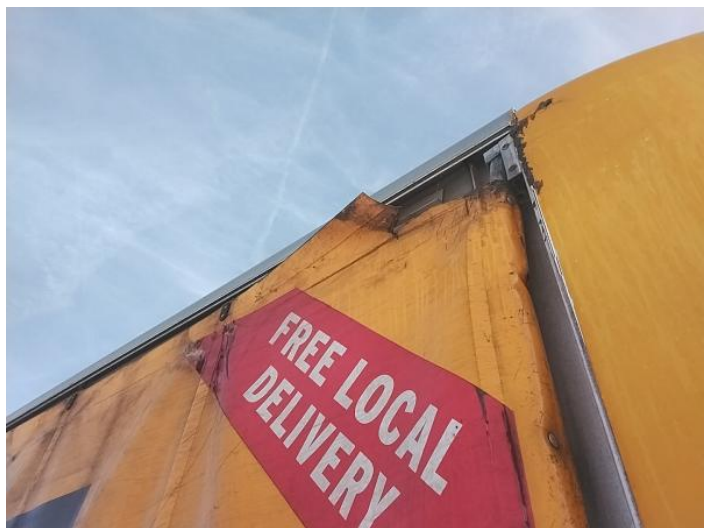
8: Qtr Panel osr  
Hole  
Over 10mm

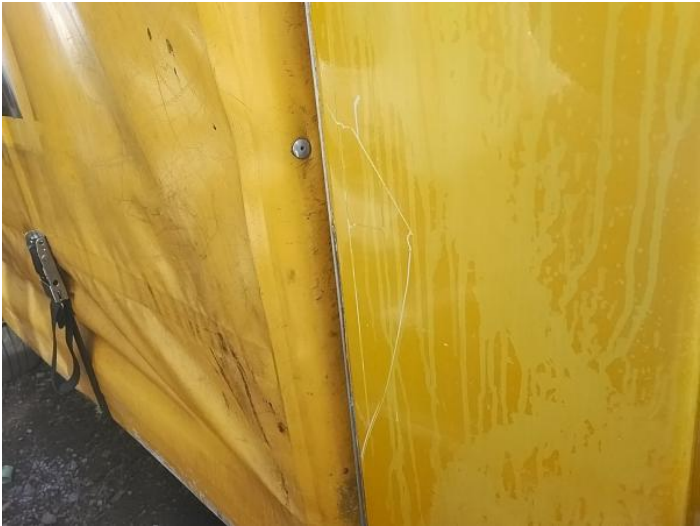
9: Qtr Panel Trim os  
Scuffed  
Over 25mm

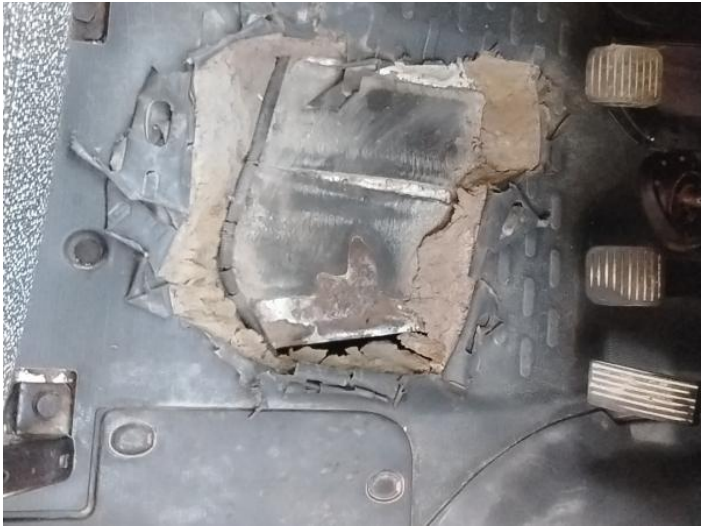
10: Carpets Front  
Holed  
Over 3mm

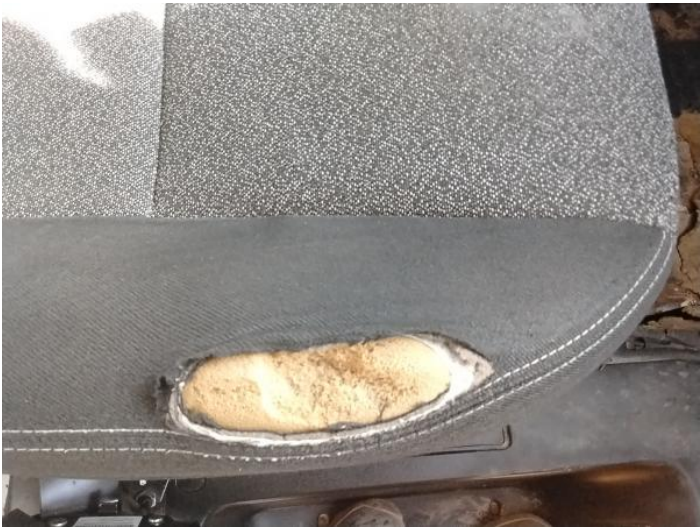
11: Seat Base Cover osf  
Torn  
Over 3mm
