VEHICLE INSPECTION REPORT

LT68FYU

Fuso Canter 7C15

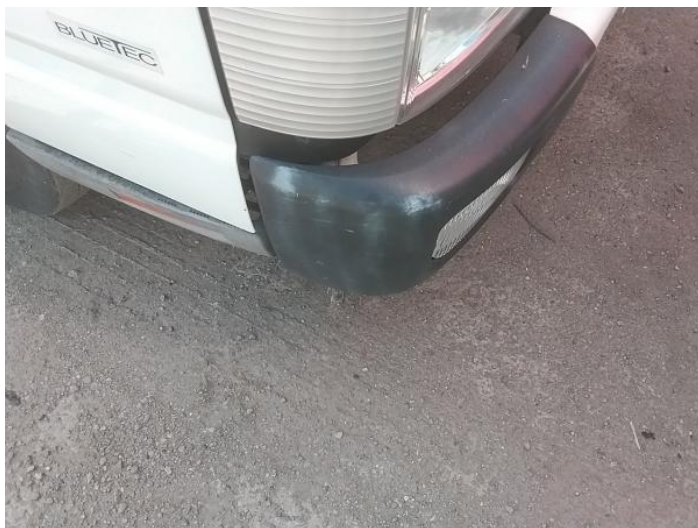
1: Bumper Front
Scratched
Over 100mm Thru Paint

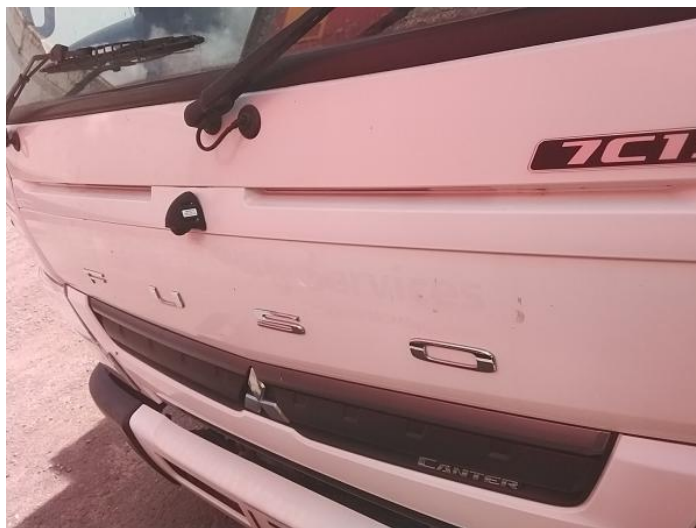
2: Bonnet
Chipped
Multiple Chips

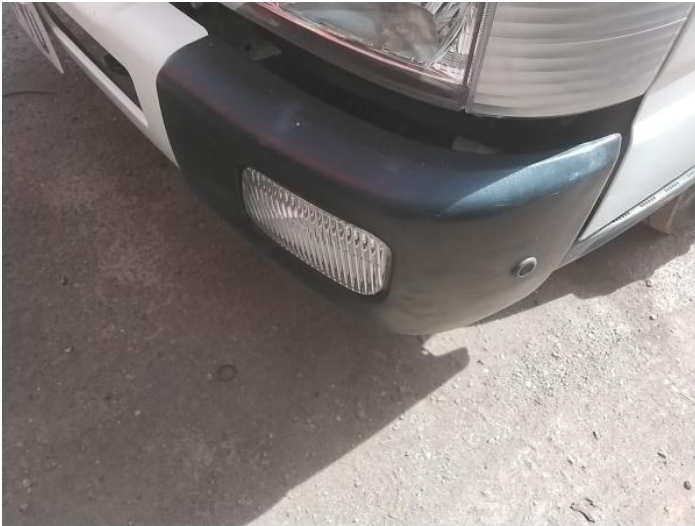
3: Bumper Front
Scratched
Over 100mm Thru Paint

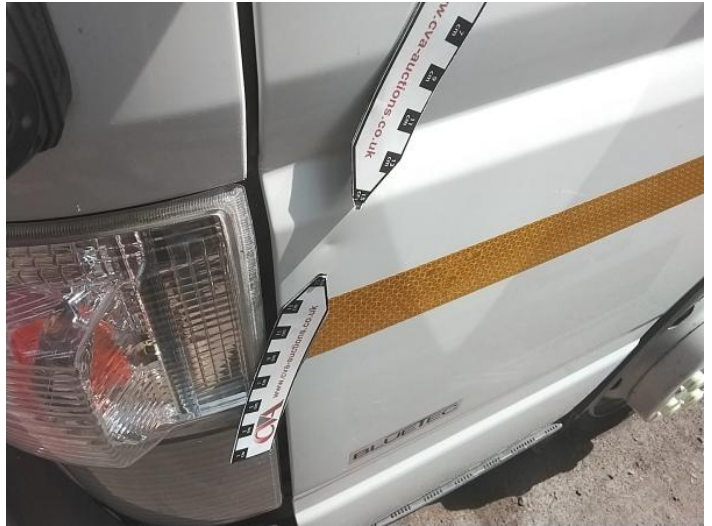
4: Door nsf
Dented
Over 30mm

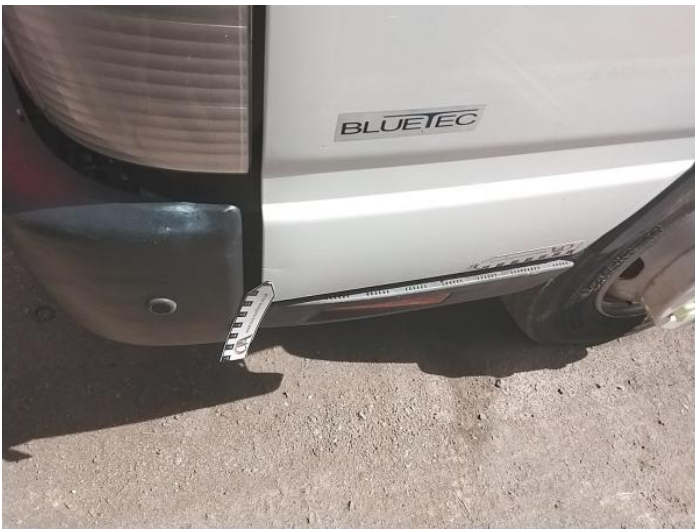
5: Door nsf
Dented
With Paint Damage

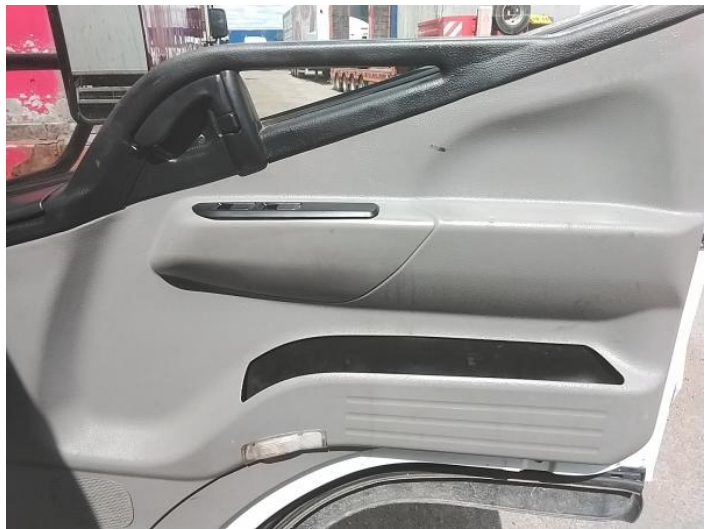
6: Door Pad osf
Soiled
Heavy

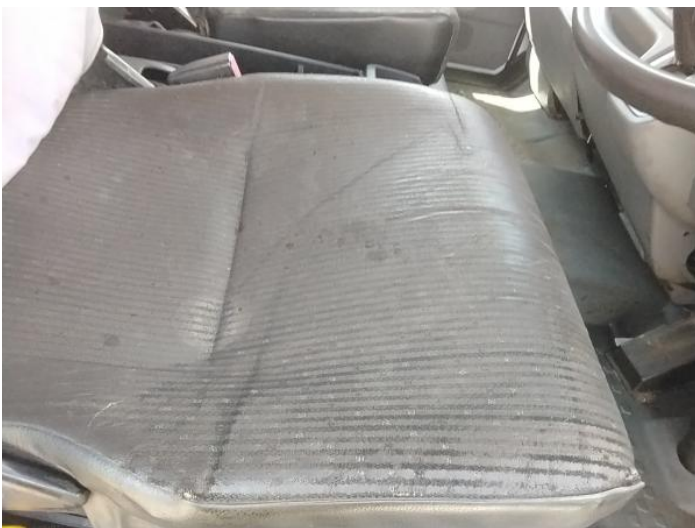
7: Seat Base Cover osf
Torn
Over 3mm

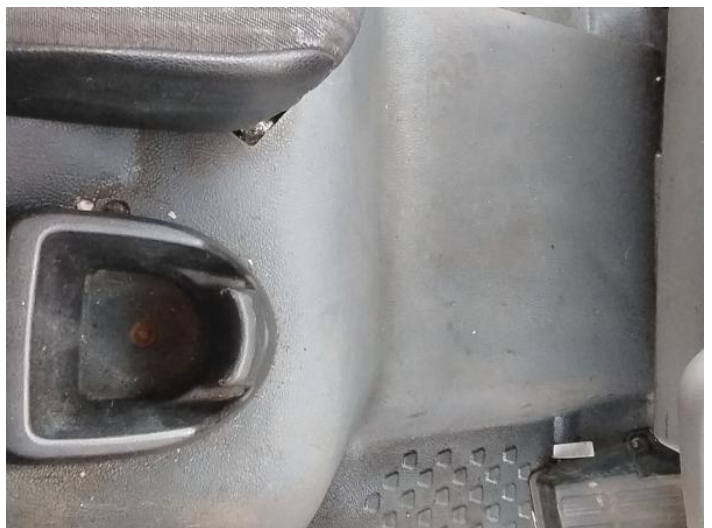
8: Carpets Front
Soiled
Heavy

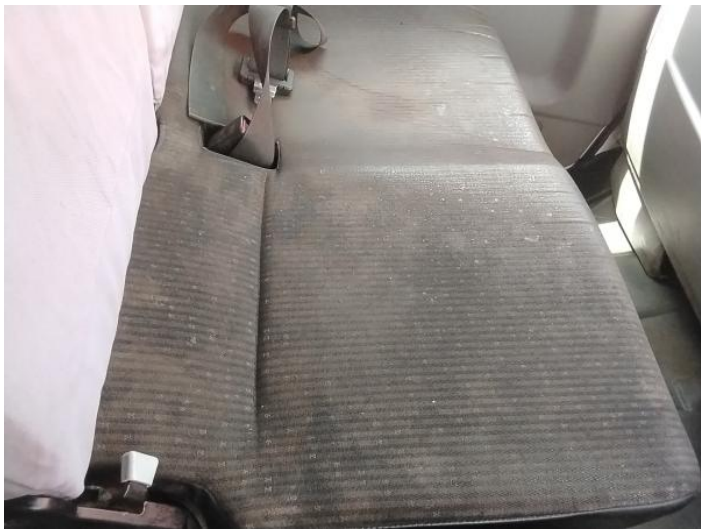
9: Seat Base Cover nsf
Soiled
Heavy
