VEHICLE INSPECTION REPORT

LT68FYW

Fuso Canter 7C15

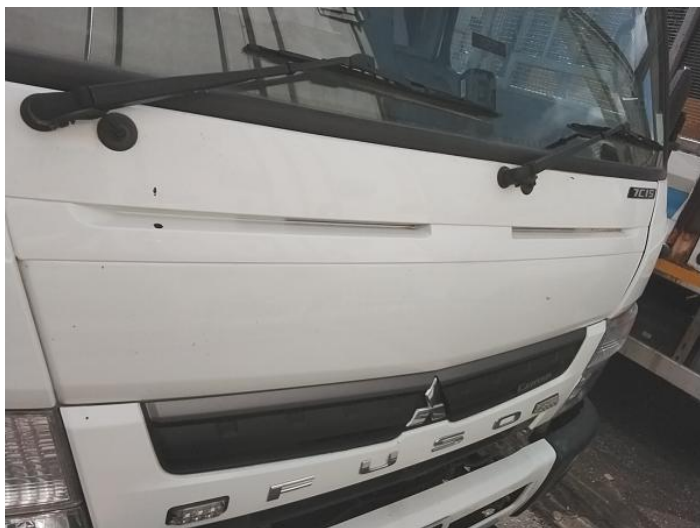
1: Bonnet
Chipped
Multiple Chips

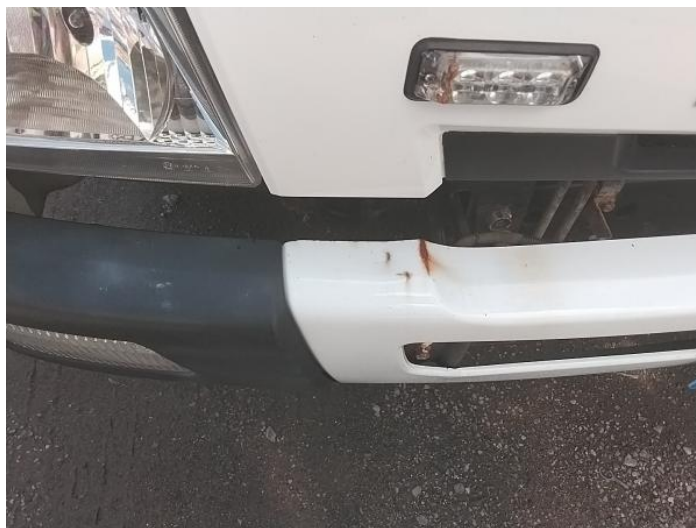
2: Bumper Front
Dented
With Paint Damage

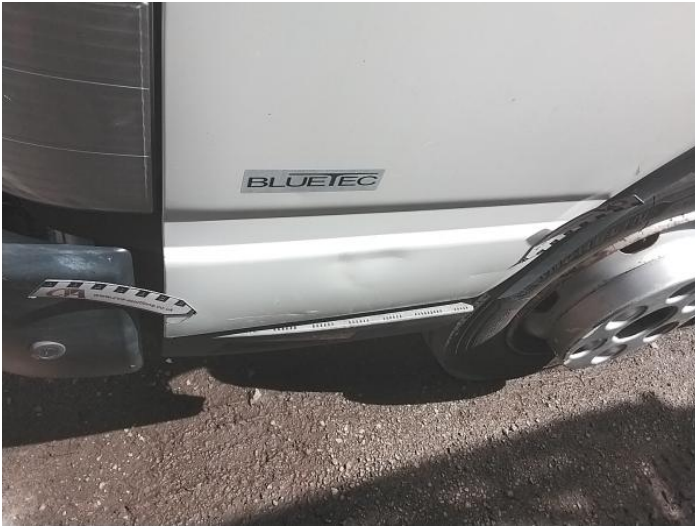
3: Door nsf
Dented
With Paint Damage

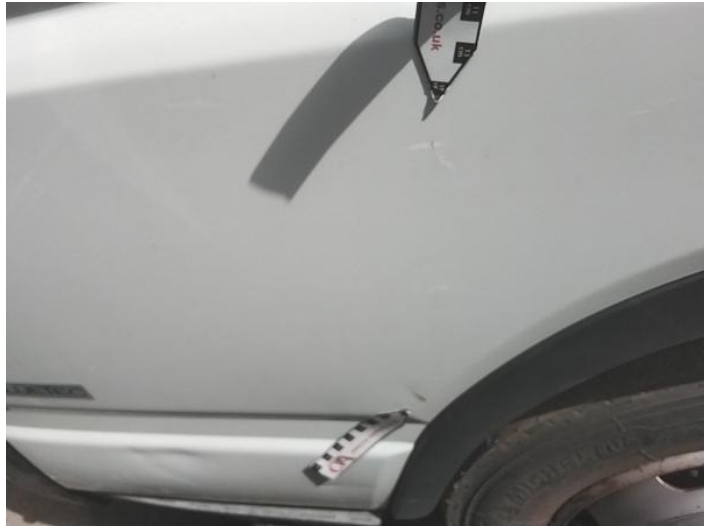
4: Door nsf
Scratched
Over 25mm Thru Paint

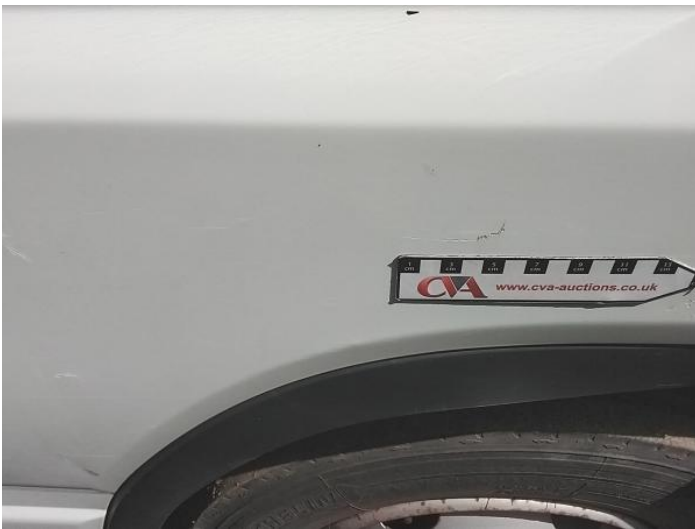
5: Door nsf
Scratched
Over 25mm Thru Paint

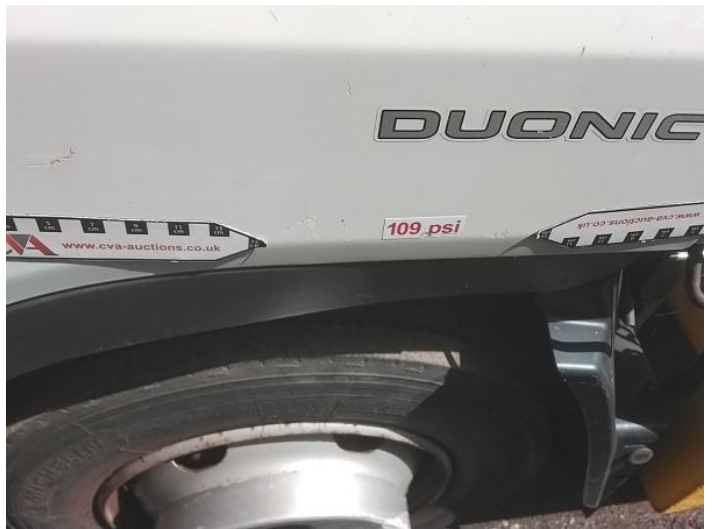
6: Door nsf
Scratched
Over 25mm Thru Paint

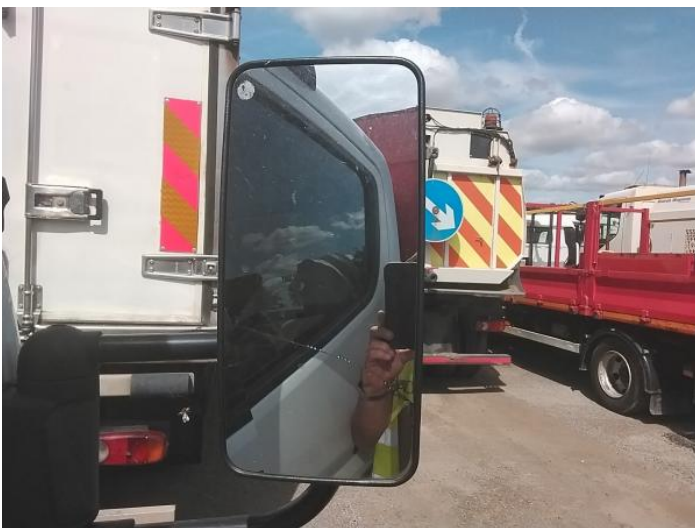
7: Door Mirror Glass os
Broken
Replace

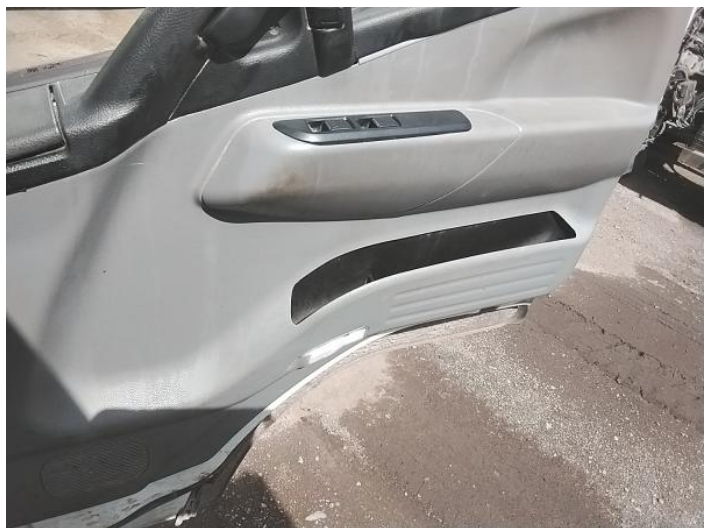
8: Door Pad osf
Soiled
Heavy

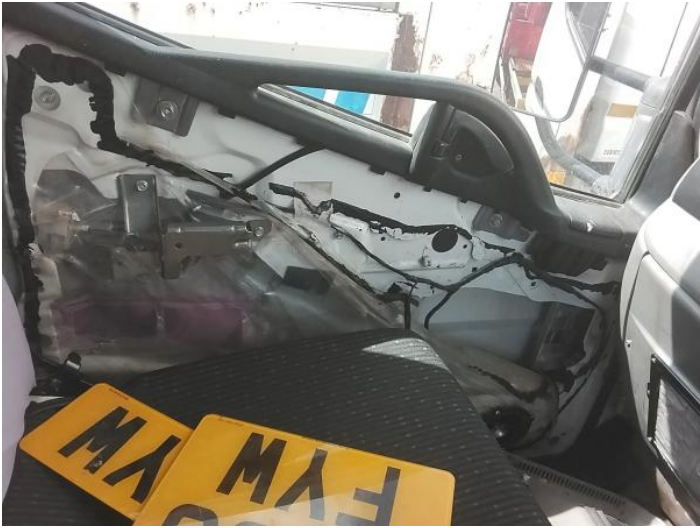
9: Door Pad nsf
Missing
Replace
