VEHICLE INSPECTION REPORT

LT68FZY

Fuso Canter 7C15

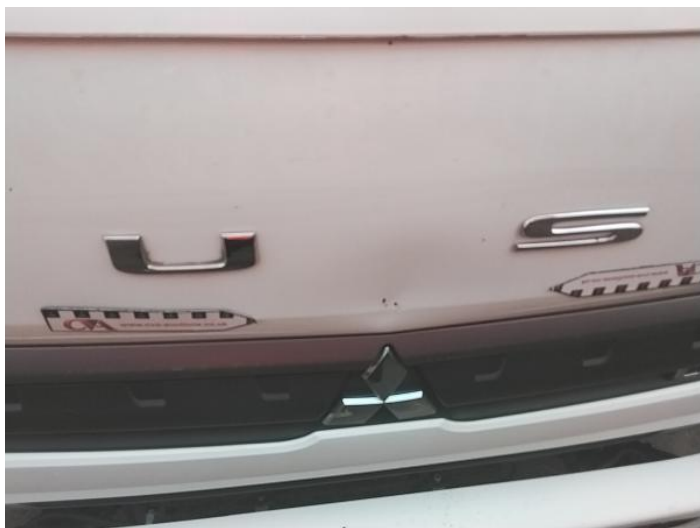
1: Bonnet
Dented
With Paint Damage

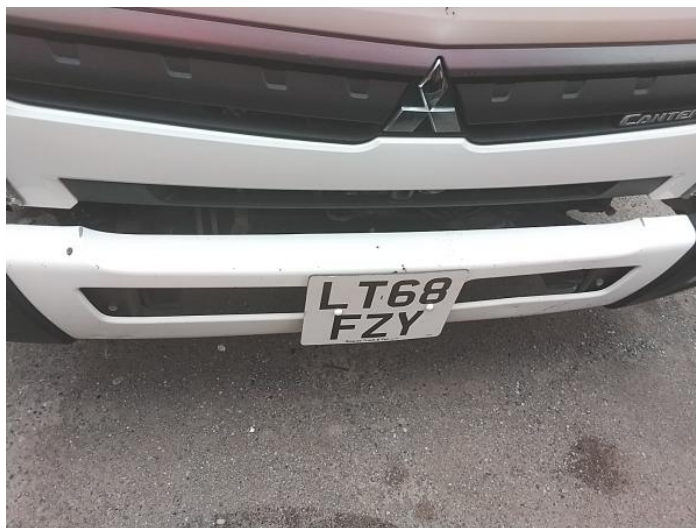
2: Bumper Front
Chipped
Multiple Chips

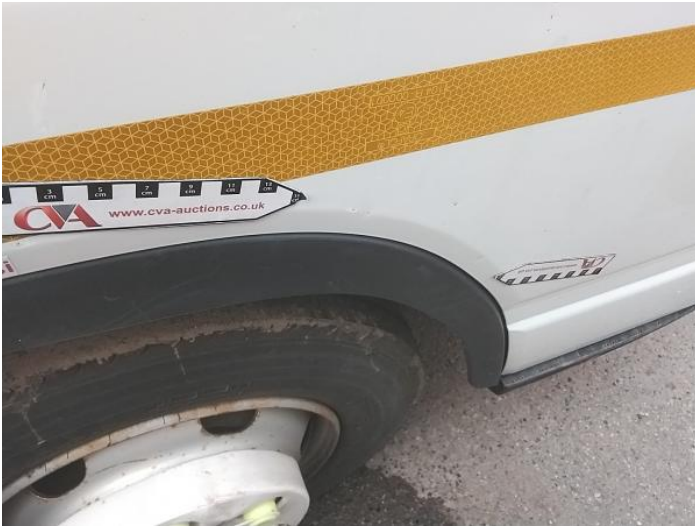
3: Door osf
Dented
Over 30mm

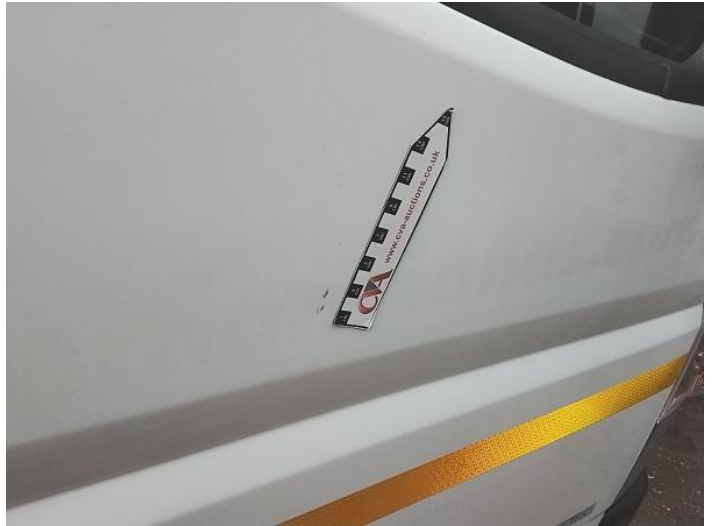
4: Door osf
Dented
With Paint Damage

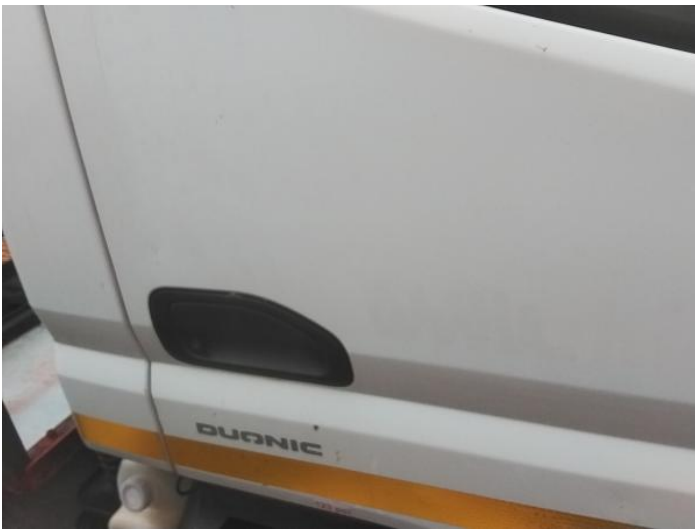
5: Door osf
Chipped
Multiple Chips

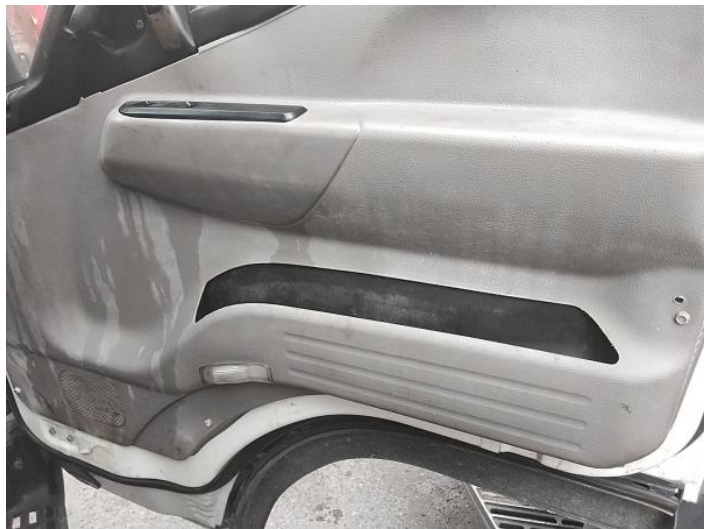
6: Door Pad osf
Soiled
Heavy

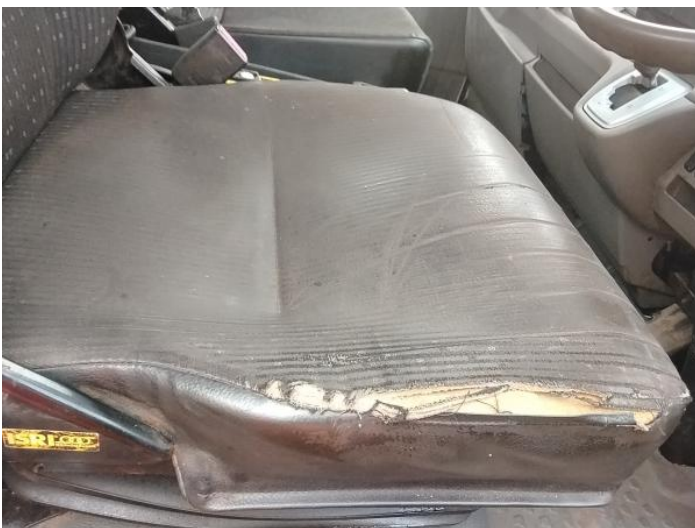
7: Seat Base Cover osf
Torn
Over 3mm

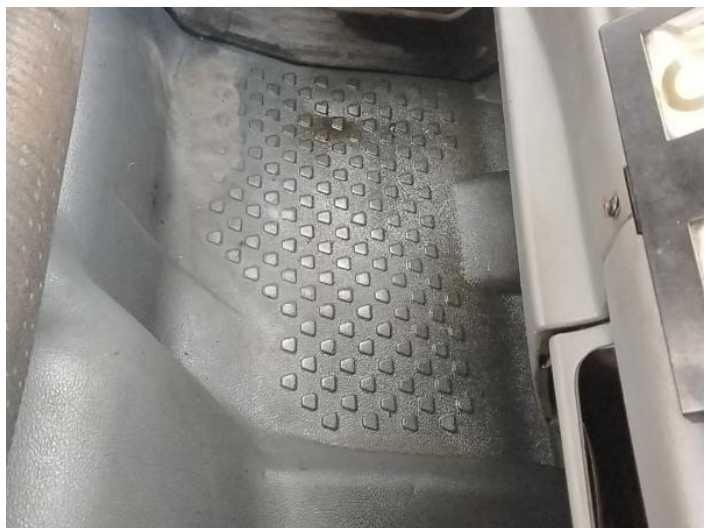
8: Carpets Front
Soiled
Heavy

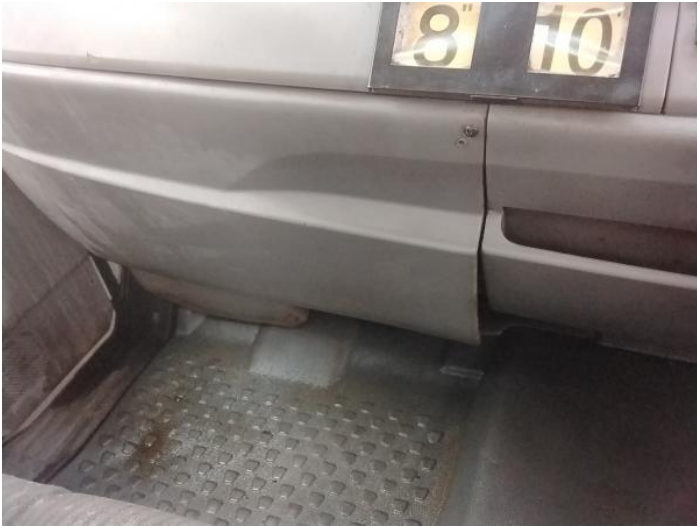
9: Fascia Panel
Broken
Replace

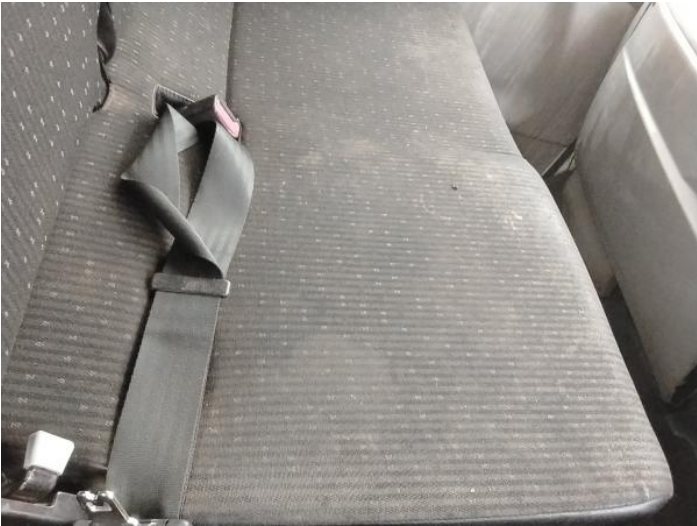
10: Seat Base Cover nsf
Soiled
Heavy

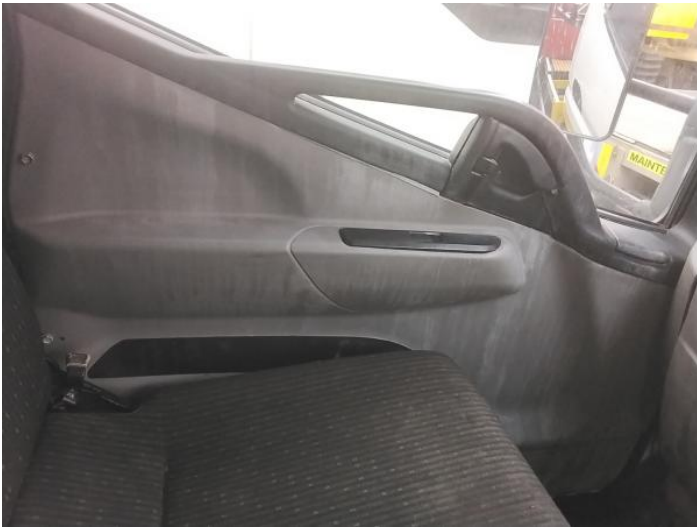
11: Door Pad nsf
Soiled
Heavy
