VEHICLE INSPECTION REPORT

WU67JCO

Mercedes-Benz Arocs 1824

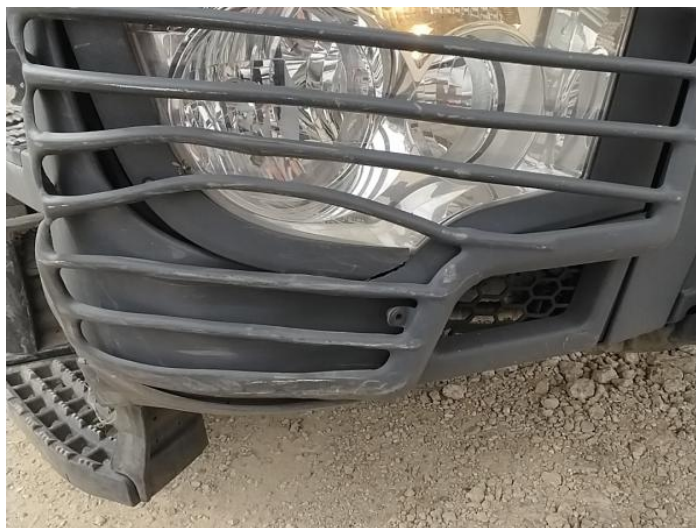
2: Fog Lamp Surround is
Broken
Replace

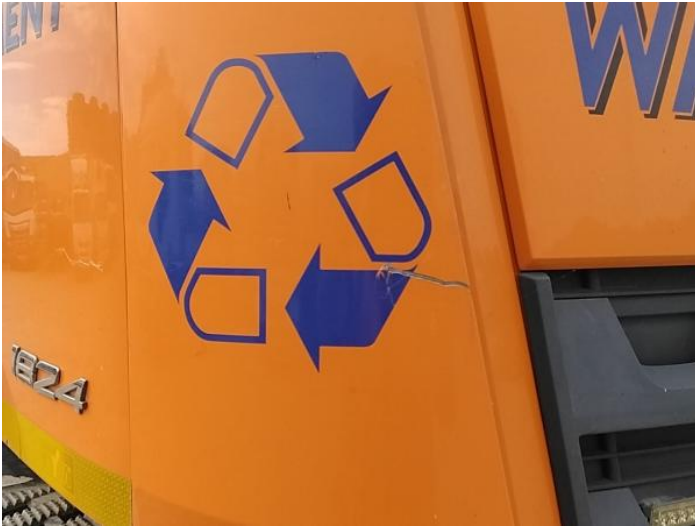
3: Moulding of Wing
Scratched (Painted)
Up To 25mm Thru Paint

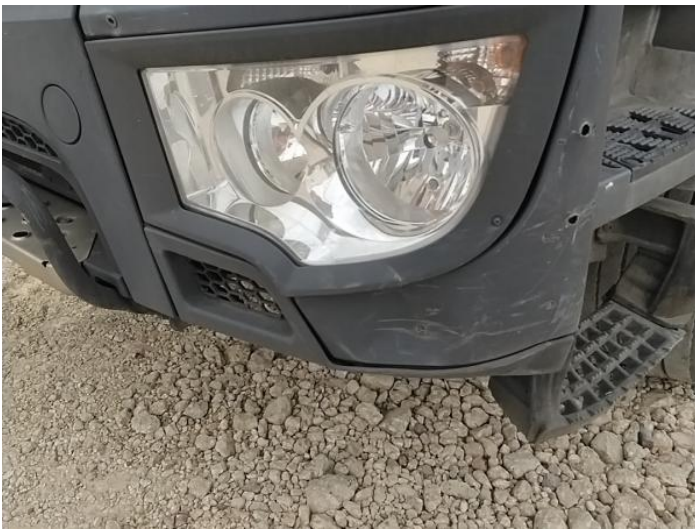
5: Fog Lamp Surround ns
Broken
Replace

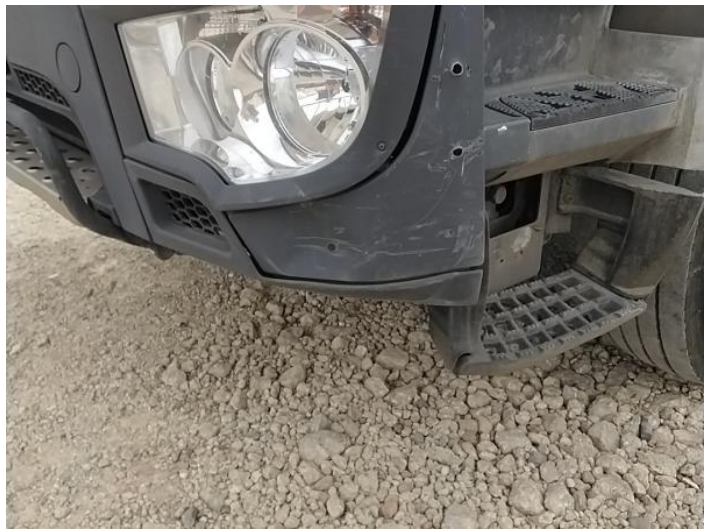
6: Bumper Front
Dented
Between 10mm + 30mm

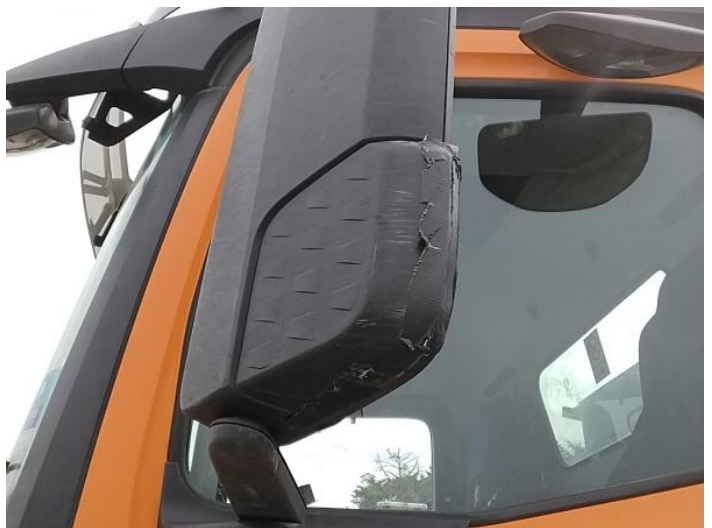
8: Door Mirror Assy nsf
Broken
Replace

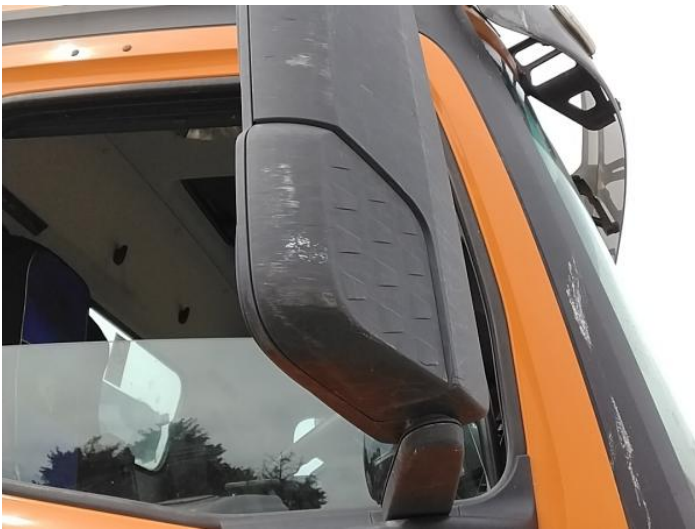
11: Door Mirror Assy osf
Scuffed (Unpainted)
Over 100mm

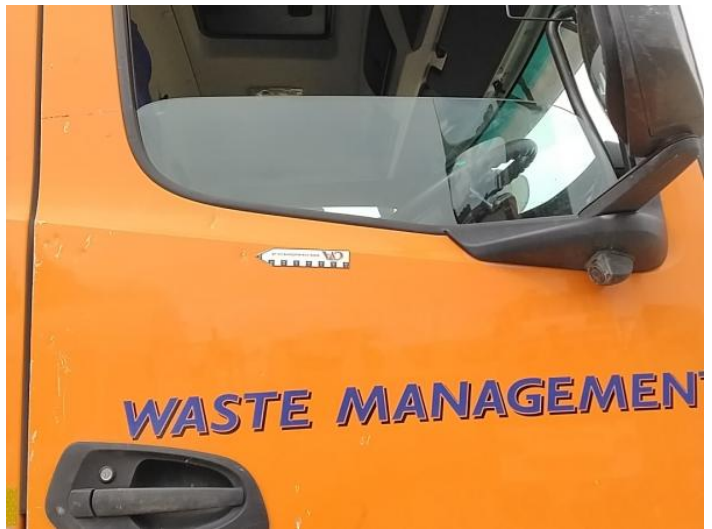
12: Door osf
Dented
With Paint Damage

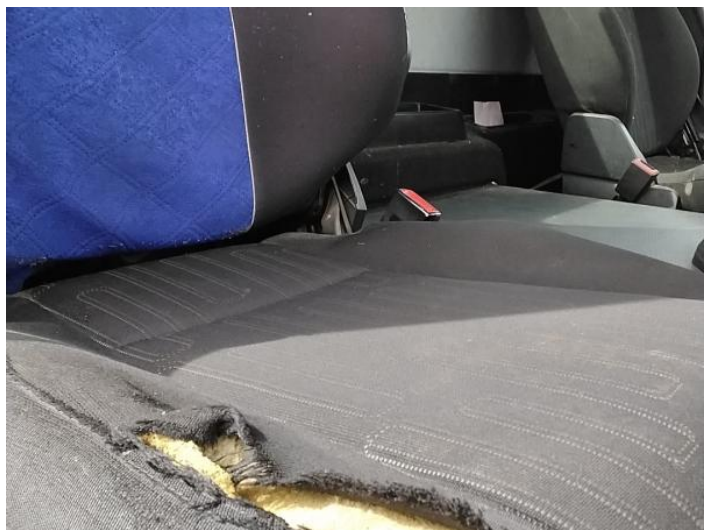
14: Seat Base Cover osf
Holed
Over 3mm
