VEHICLE INSPECTION REPORT

DK69WHW

Isuzu Gafter N35.125

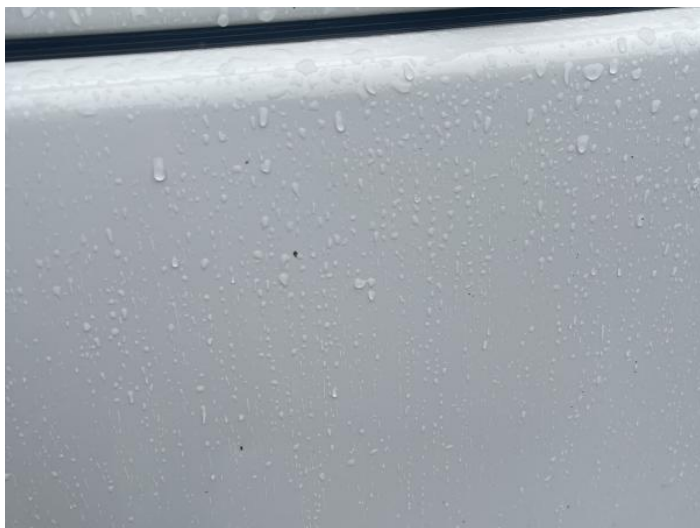
1: Bonnet
Chipped
Multiple Chips

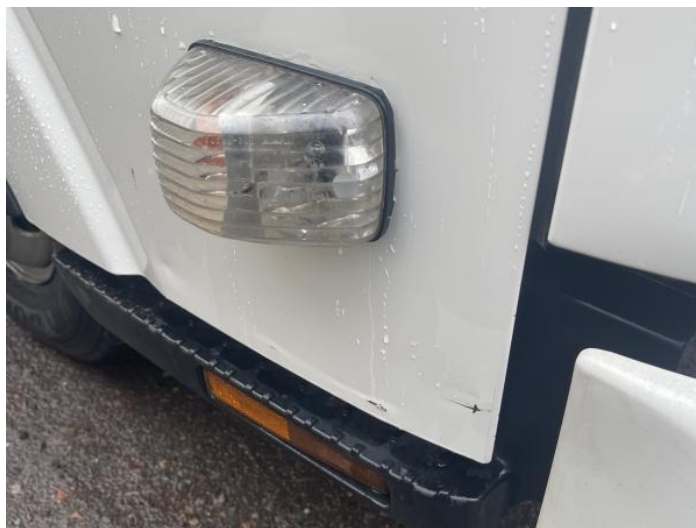
2: Door osf
Dented
Over 30mm

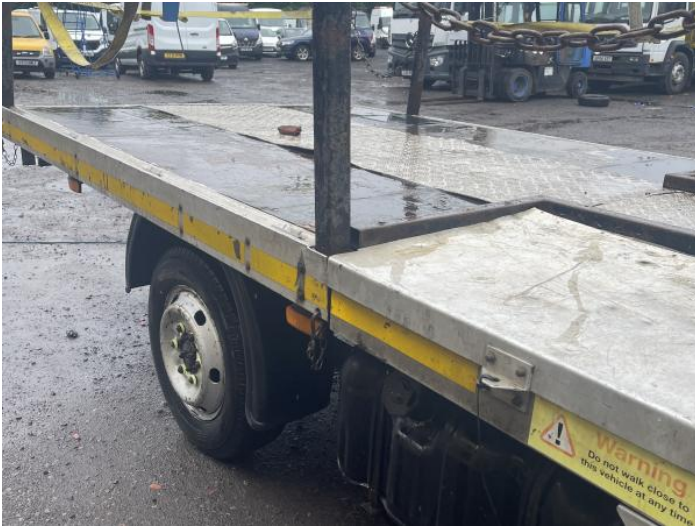
3: Qtr Panel osr
Dented
With Paint Damage

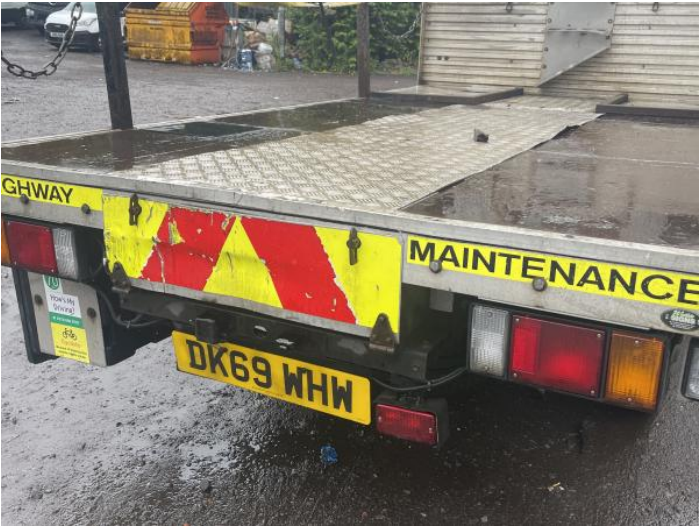
4: Tailgate
Dented
With Paint Damage

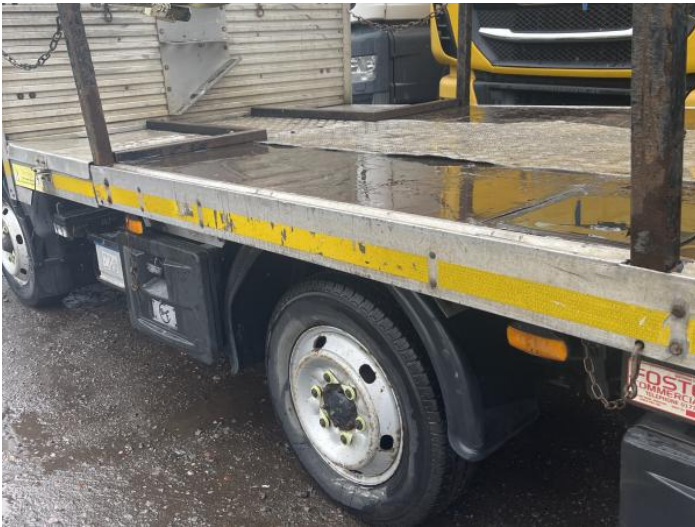
5: Qtr Panel nsr
Dented
With Paint Damage
