# VEHICLE INSPECTION REPORT

**YJ13HUV**

## Vdl Futura FHD2-129

### Serious Damage Inspection

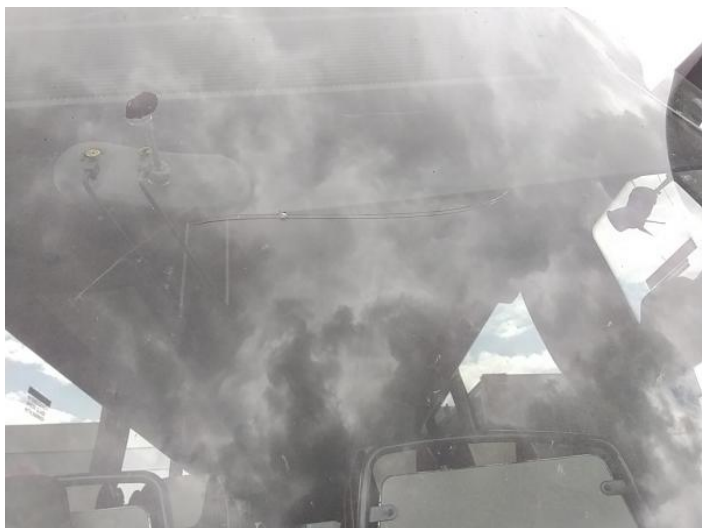
1: Screen Front  
Cracked  
Replace

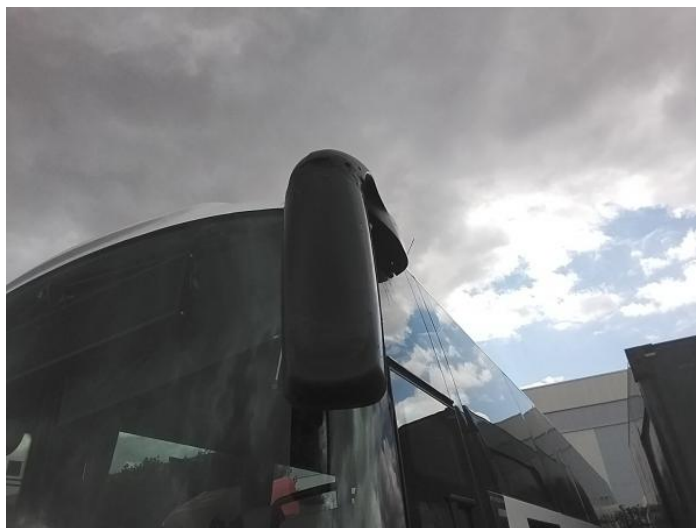
2: Door Mirror Assy nsf  
Broken  
Replace

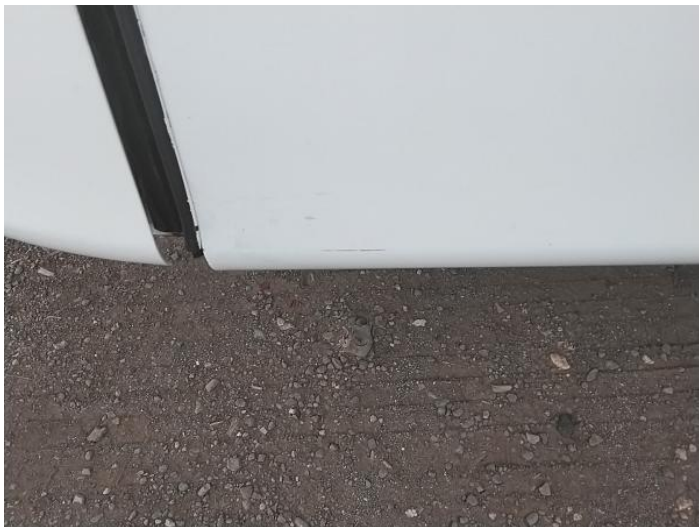
3: Door nsf  
 Scratched  
 Over 25mm Thru Paint

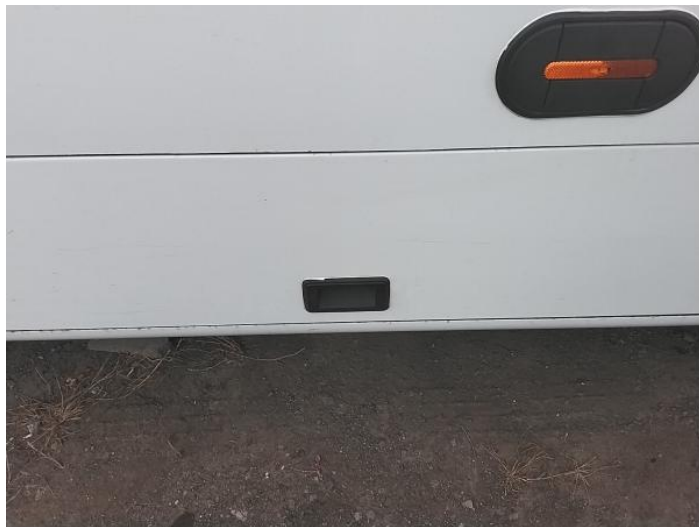
4: Qtr Panel nsr  
 Scratched  
 Over 25mm Not Thru Paint

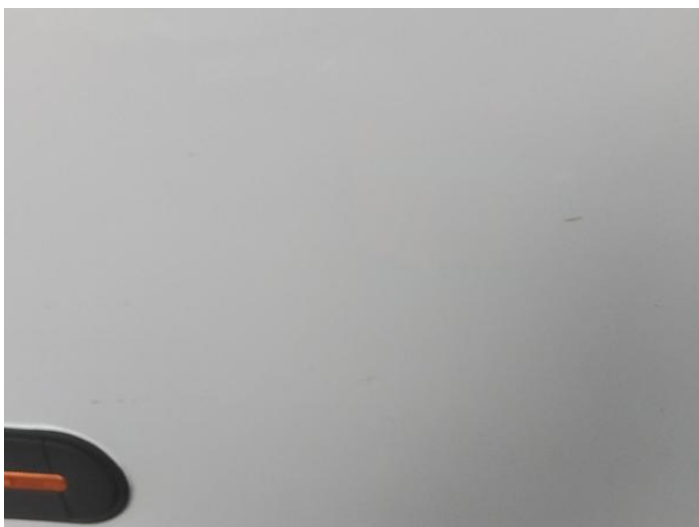
5: Qtr Panel nsr  
 Scratched  
 Over 25mm Thru Paint

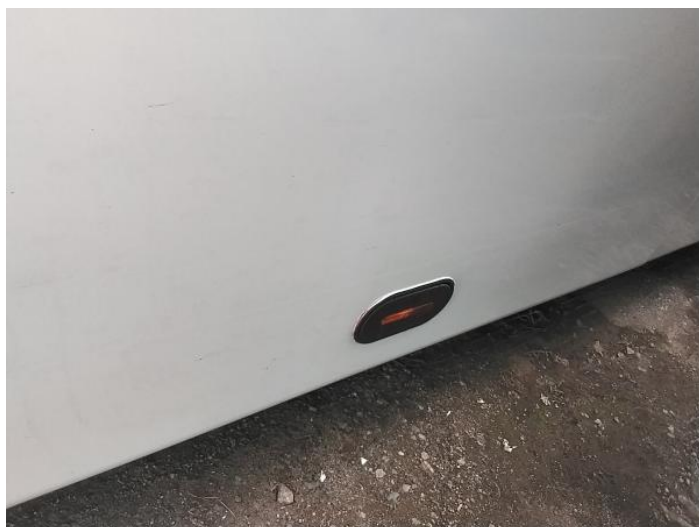
6: Qtr Panel nsr  
 Scratched  
 Over 25mm Thru Paint

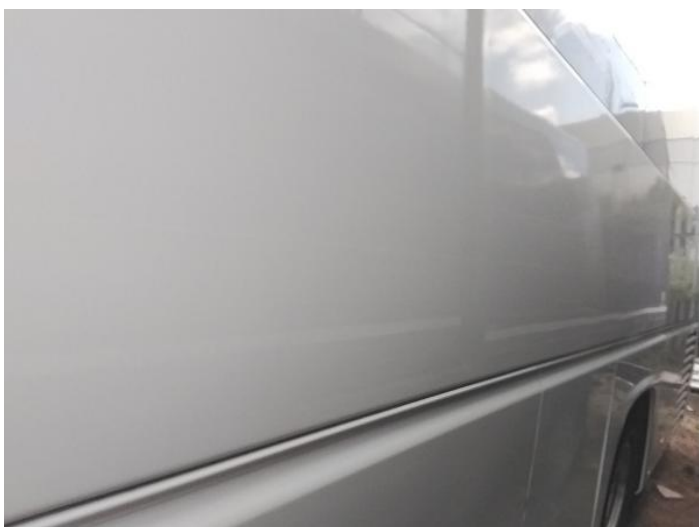
7: Qtr Panel nsr  
 Scratched  
 Over 25mm Thru Paint

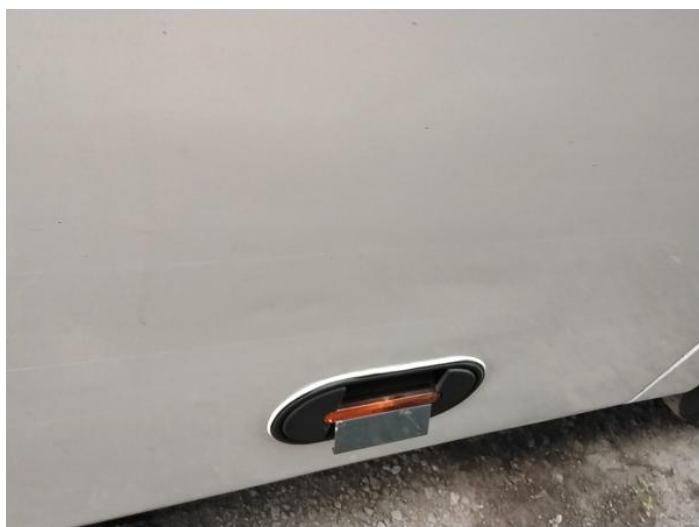
8: Qtr Panel nsr  
 Dented  
 Over 30mm

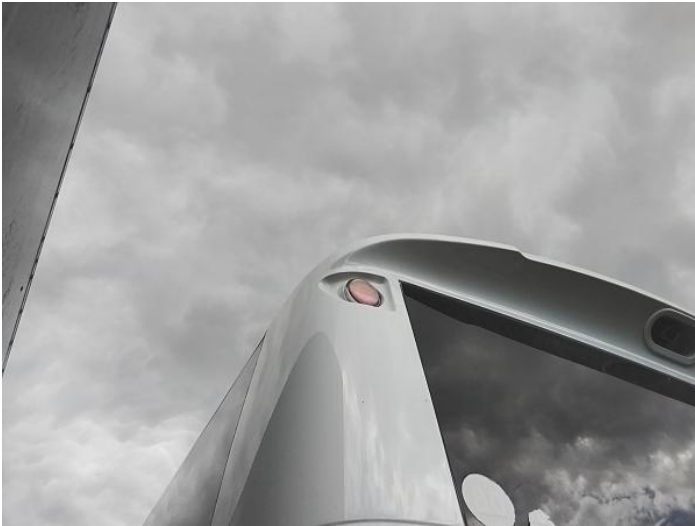
9: B Post ns  
Cracked  
Replace

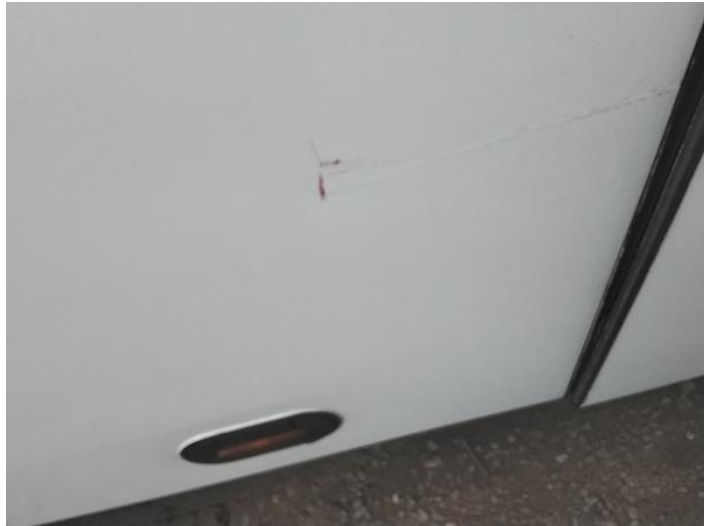
10: Qtr Panel osr  
Dented  
With Paint Damage

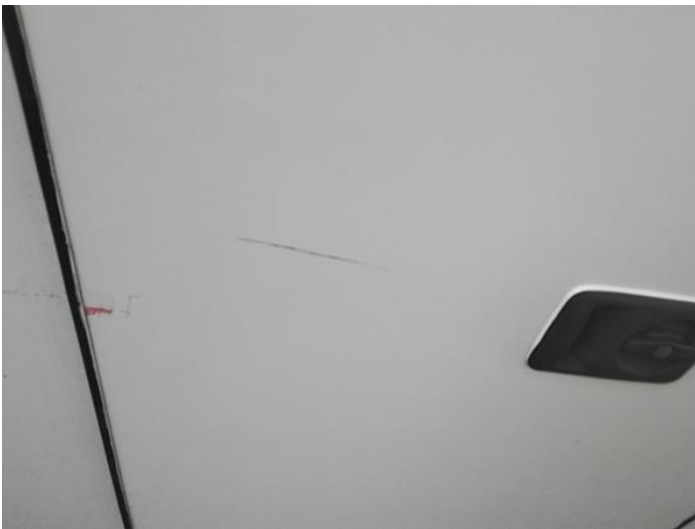
11: Door osr  
Dented  
With Paint Damage

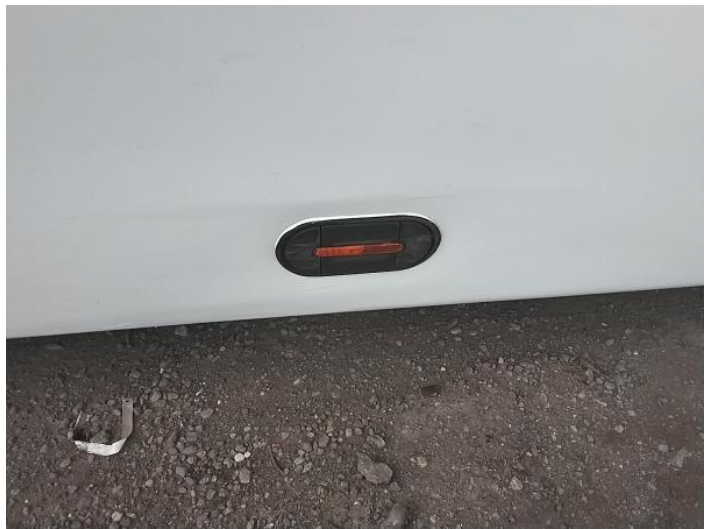
12: Qtr Panel osr  
Dented  
Over 30mm

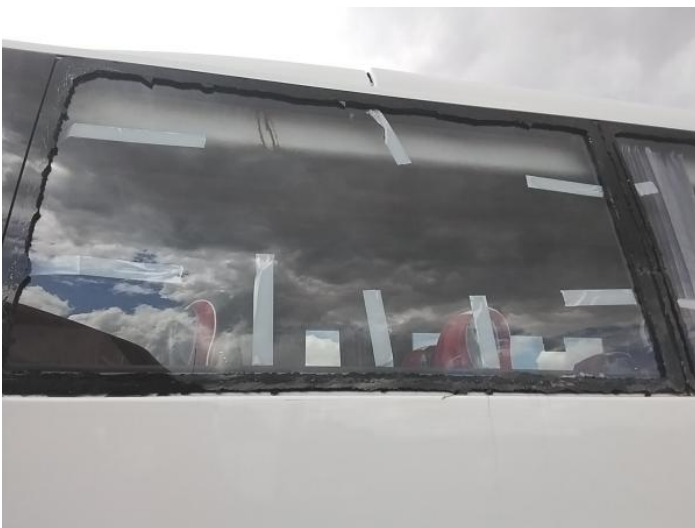
13: Door Window osr  
Missing  
Replace

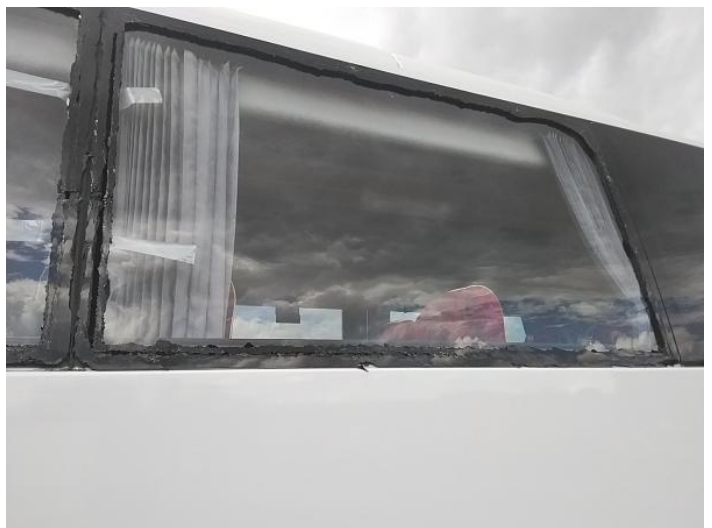
14: Door Window osr  
Missing  
Replace

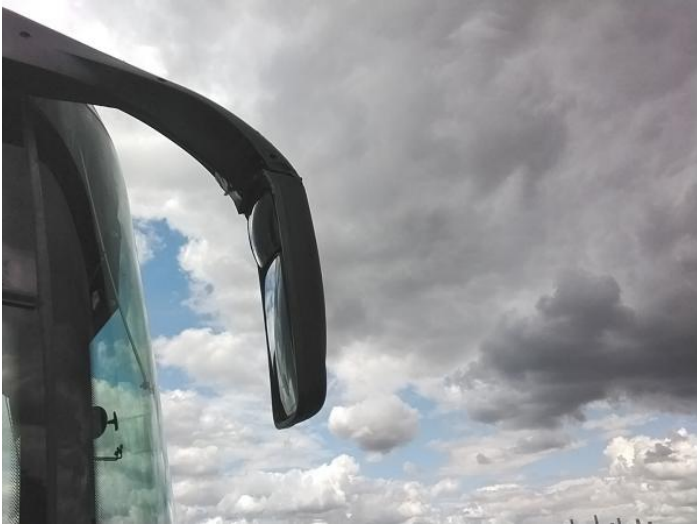
15: Door Mirror Assy osf  
Broken  
Replace

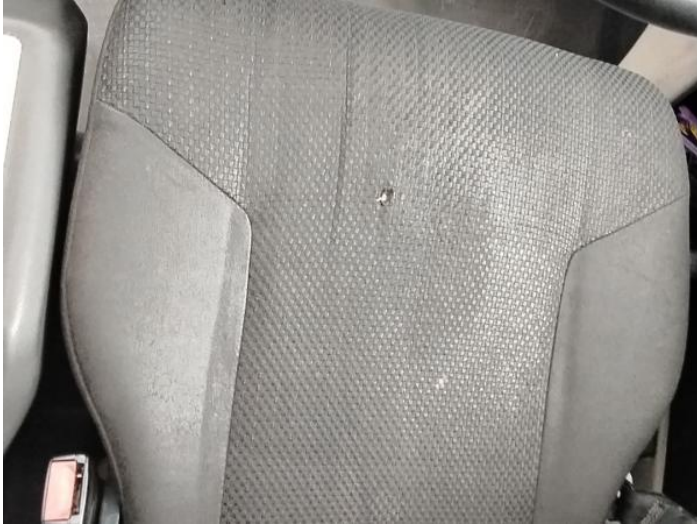
16: Seat Base Cover osf  
Holed  
Over 3mm
