VEHICLE INSPECTION REPORT

DK66KAX

Man TGS 26.360

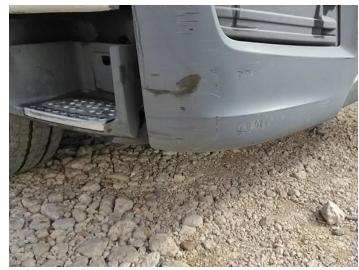
1: Bumper Front Moulding Scuffed (Unpainted) UpTo 100mm

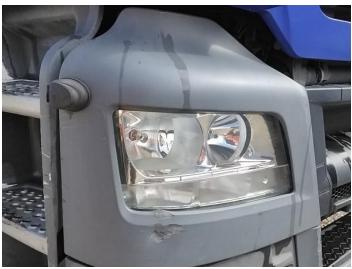
2: Fog Lamp Surround os Scuffed (Unpainted) UpTo 100mm

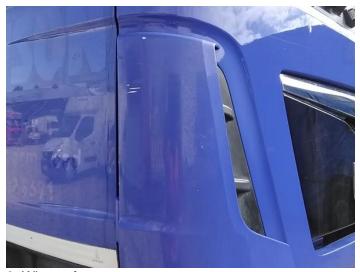
3: Wing osf Scratched UpTo 25mm Thru Paint

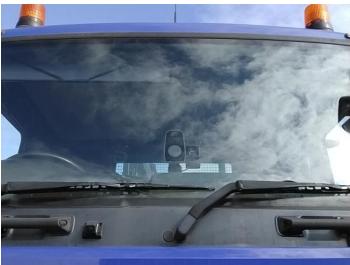
4: Screen Front Chipped UpTo 10mm

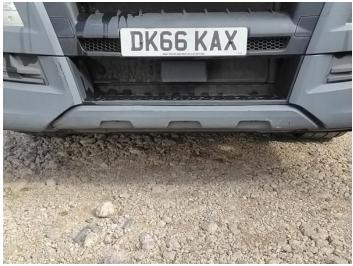
5: Bumper Front Cracked UpTo 25mm

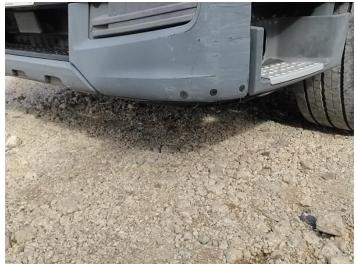
6: Bumper Front Moulding Scuffed (Unpainted) UpTo 100mm

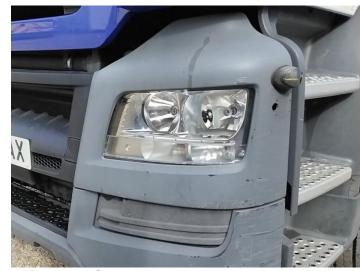
7: Fog Lamp Surround ns Scuffed (Unpainted) UpTo 100mm

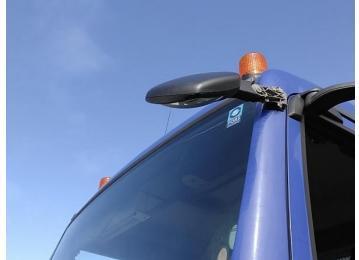
8: Door Mirror Assy nsf Missing Replace

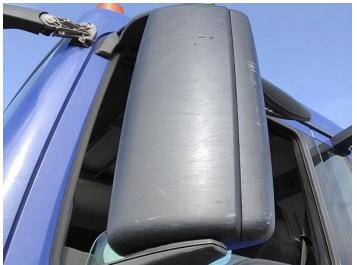
9: Door Mirror Assy nsf Scuffed (Unpainted) UpTo 100mm

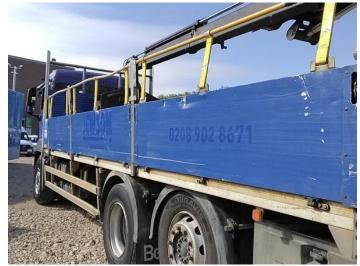
13: Qtr Panel nsr Dented Over 30mm

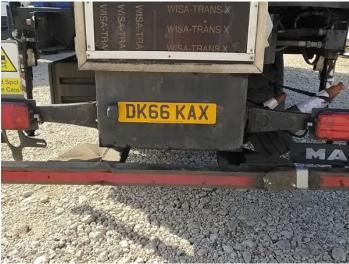
14: Bumper Rear Rusted Over 5mm

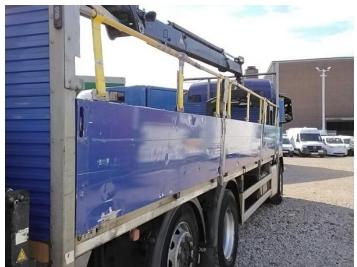
15: Qtr Panel osr Dented Over 30mm

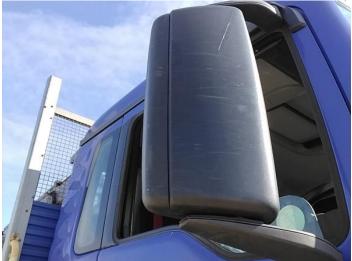
20: Door Mirror Assy osf Scuffed (Unpainted) UpTo 100mm

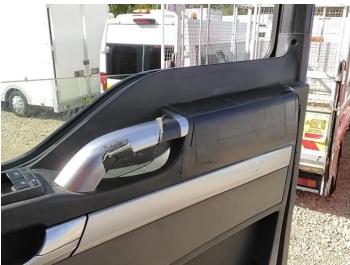
22: Door Pad osf Broken Replace
